Despite Stanton: AAR from denial to remedy in the UK, Europe & the World

Abstract

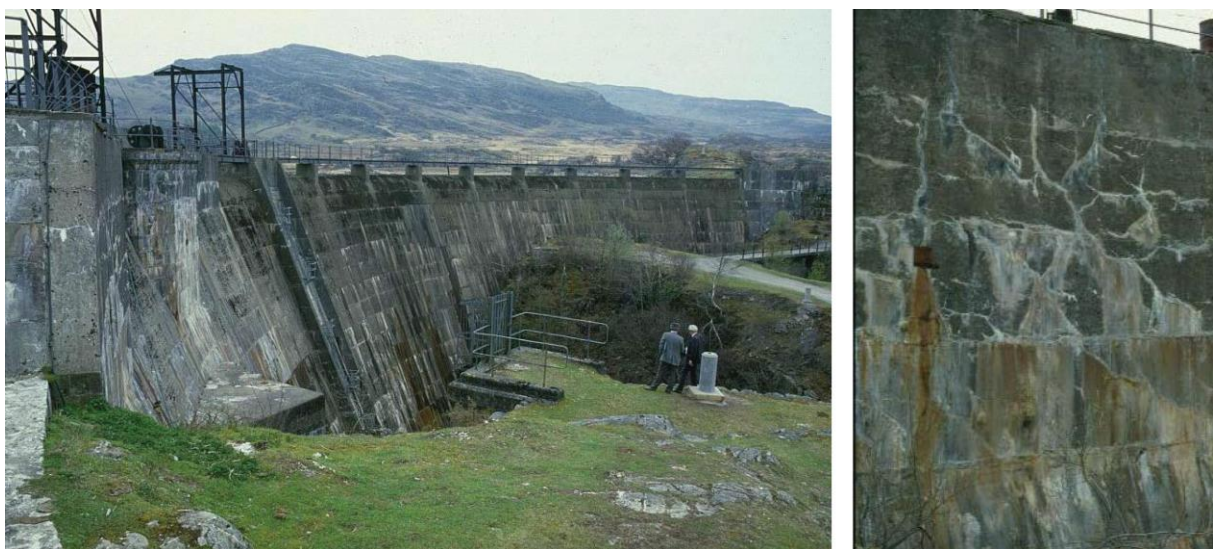
Figure 2.2: Maentwrog Dam, North Wales (left), showing cracking caused by ASR, but also suffering long-term water leaching and localised freeze-thaw damage (right).
