## Diagnosis and repair of electrical transmission tower foundations affected by DEF and AAR

**Keywords:** alkaline aggregate reaction; delayed ettringite formation; ISR; repair concrete structures; self-consolidating concrete

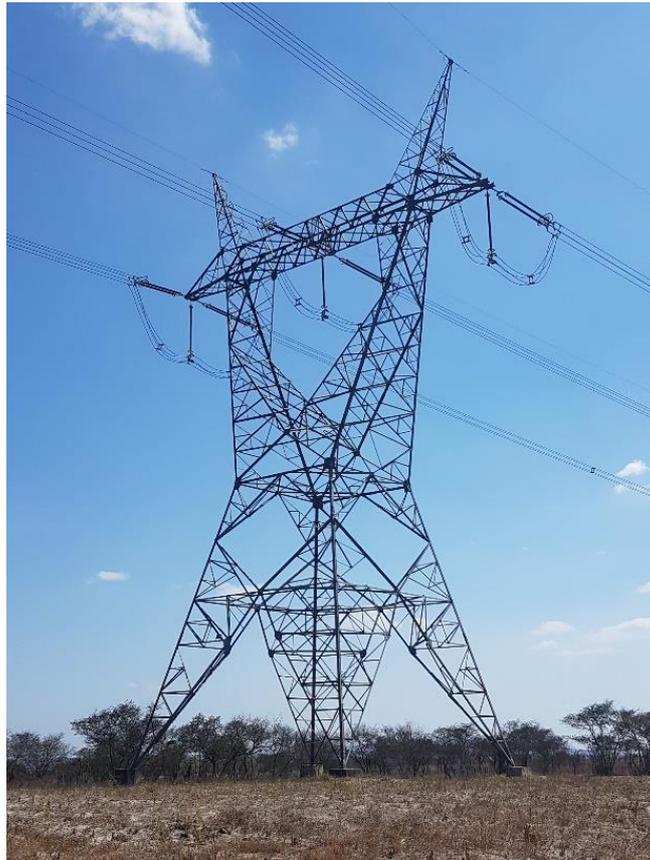
Along high-voltage electrical power transmission lines, supporting structures serve to provide uphold to lightning rods and conductors and are designed to support the loads and transmit them to the foundations. These supporting structures are generally formed by latticed towers with metallic frames, concrete or wooden poles, [10]. The lines usually stretch over hundreds of miles and cross the most varied climates and environments; they often power several states of the Federation, and the distances between the support towers may vary from a few feet to almost one mile, which indicates that these structures are subject to the most varied types of foundation settlement soils and types of environments.

Figure 2.1: Transmission line tower with supports

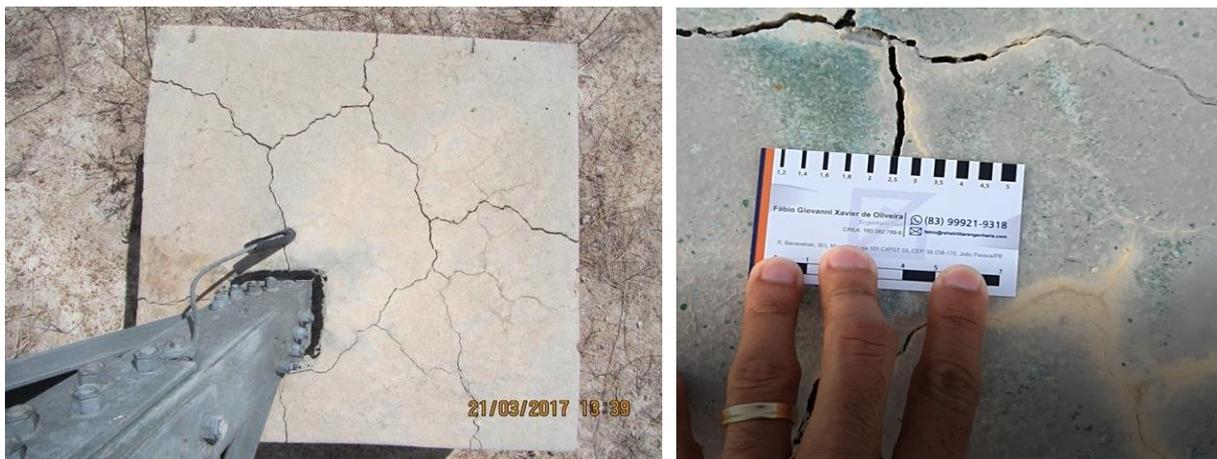
The most common symptoms on the related elements were geometric cracks mapped over the entire length of the foundation element, which varied between 0.5 mm and 3.0 mm in width; stains due to efflorescence (leaching of calcium hydroxide).

Figure 2.4: Images of the foundation element of supporting tower 003 (Foot B) of the LT500kV Xingó/Angelim II-line (a) overview of the cracks (b) detail of crack width

Some support towers showed wider cracks and an age of construction of 10 years, although some others were over 30 years of age. The cracks on other towers seemed to be superficial, despite the age of construction dating back to more than 30 years. In most cases, the cracks had a mapped geometry, were 2mm wide and penetrated about 100mm into the structural element.

The work would primarily consist of injecting a low viscosity epoxy resin with a high-pressure device (22,5 MPa) and applying a 10 cm wide layer of reinforced concrete, which would jacket the foundation element designed to generate a restraint stress and restricting internal swelling. In a restricted structure, passive rebars and self-compacting concrete with characteristic compressive strength of 60MPa would be used.

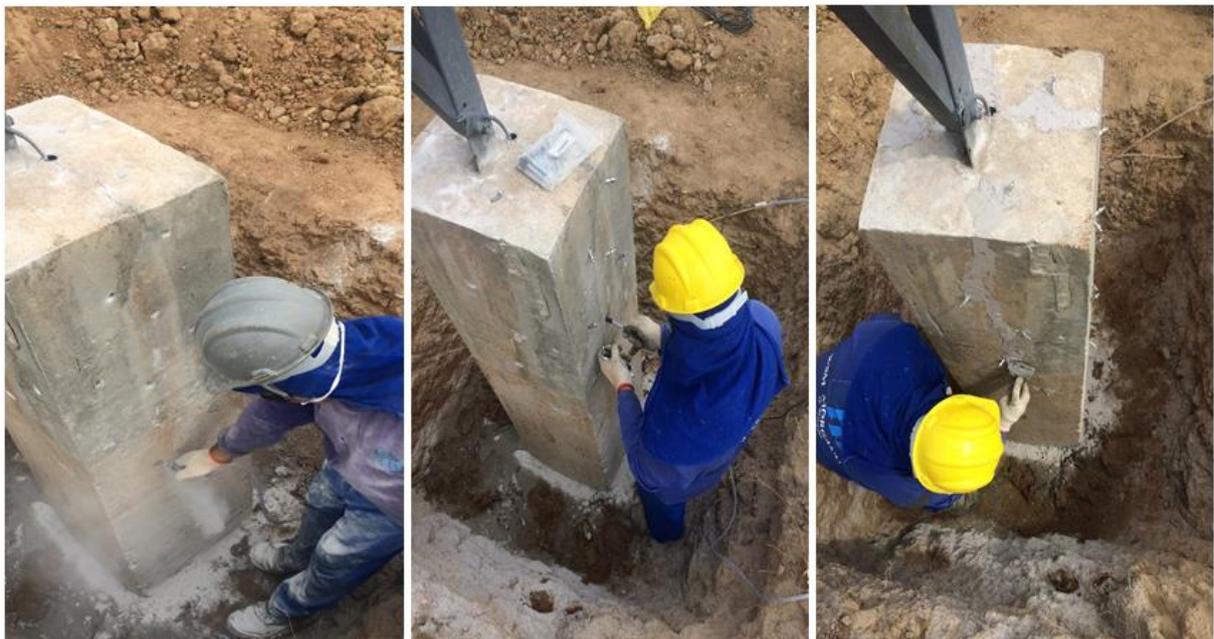
Figure 4.2: Nozzle installation sequence: (a) drilling and dry cleaning; (b) applying the nozzles; (c) sealing the crack surface with thixotropic epoxy resin

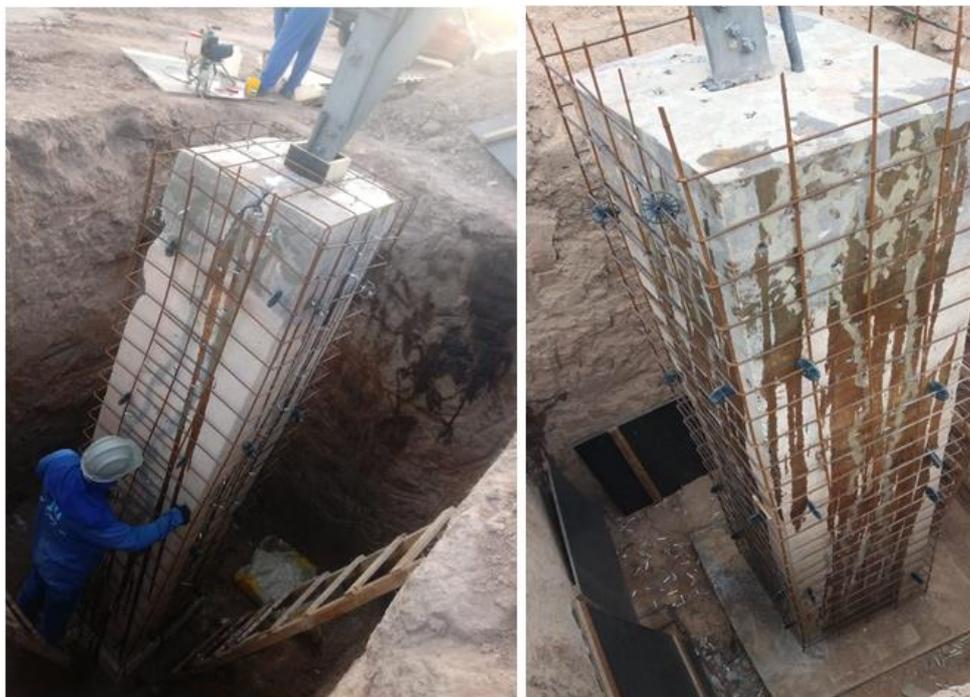
Figure 4.3: Assembling reinforcement rebars for the foundation elements

With these parameters - final expansion and residual expansion - the reinforcement rebars were dimensioned using, for this purpose, the Anchorage Zone Method exposed by Fusco [21], which aims to determine the transversal reinforcements to resist the tangential efforts as a result of the residual potential of expansion, in the particular case of partially loaded foundation elements. The transversal stresses induce longitudinal cracking in foundations blocks that are resisted by reinforcement calculated in each dimension by:

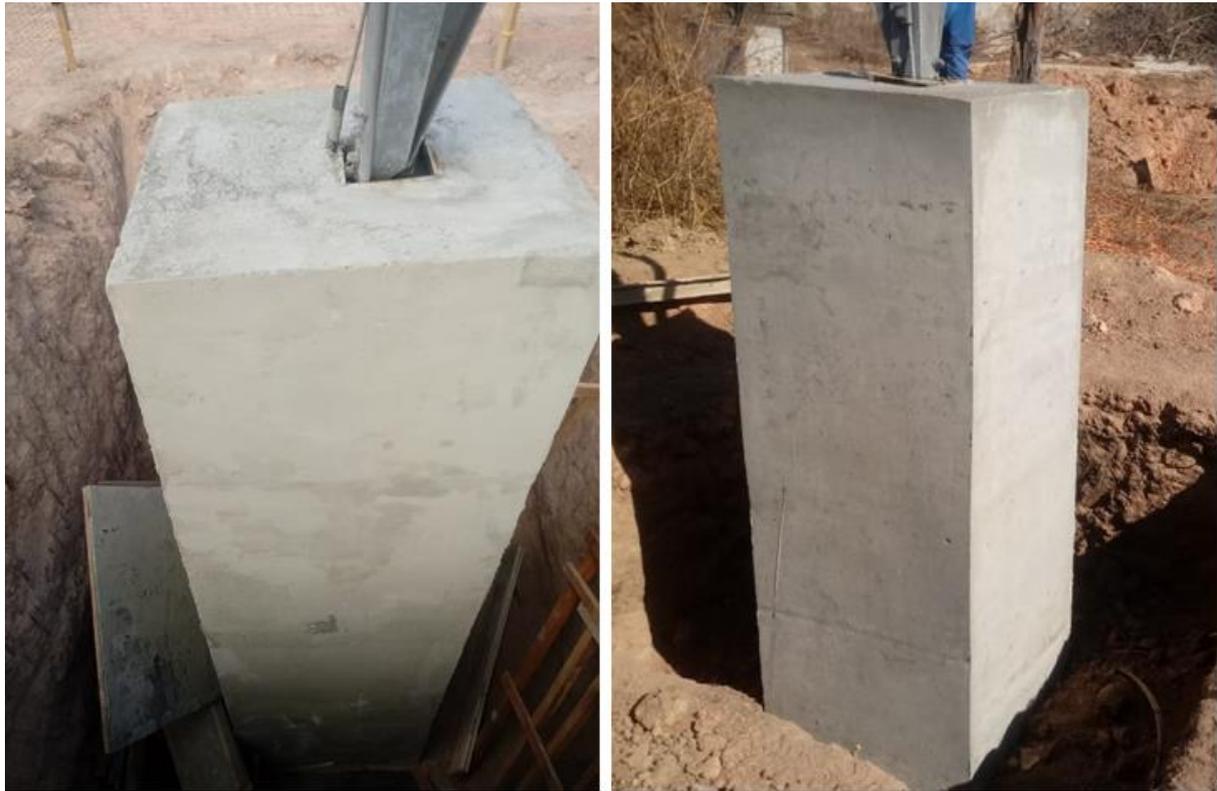
Figure 4.4: (a) Concrete work, (b) and (c) concreted foundation element

The choice for self-compacting concrete was due to the small wide layer of reinforced concrete (10cm) and the high concrete drop height, so the need for a highly cohesive concrete. The materials utilized in the concrete - fine aggregate and coarse aggregate - were not tested for reactivity, thence the high cement replacement content with added silica fume, which is a pozzolanic material with low aluminate and alkali contents. A concrete composition was also dimensioned to reduce the aluminate and alkali contents in the mixture and the alkali content of the concrete, given that the region is famous for having various aggregates identified as potentially reactive.

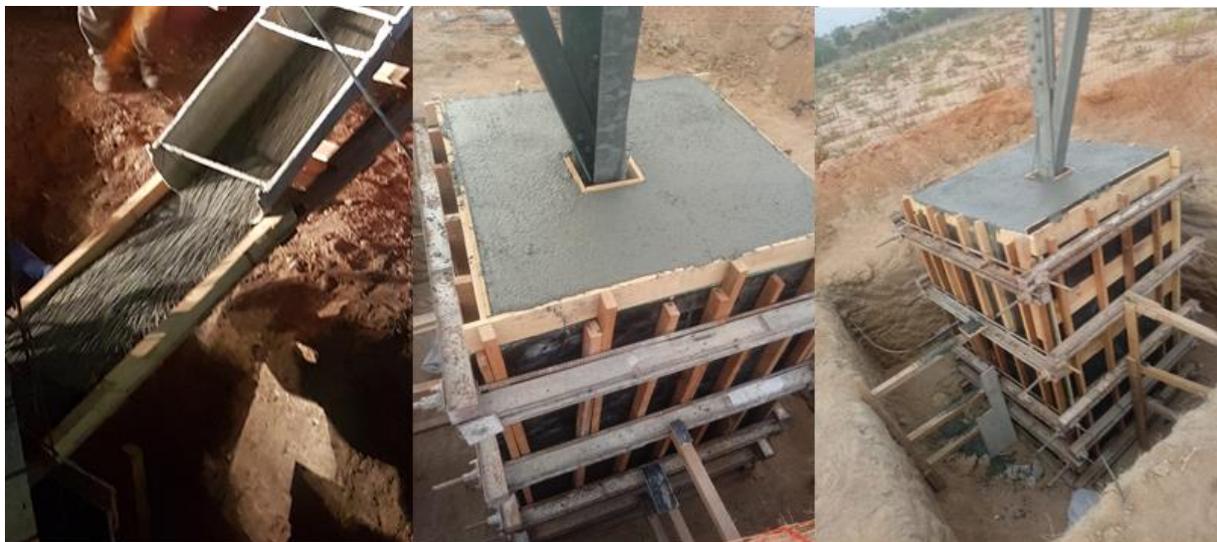
Figure 4.5: Concreted foundation elements (a) and (b)
