CHARACTERIZATION OF AAR IN FAGILDE DAM

Abstract

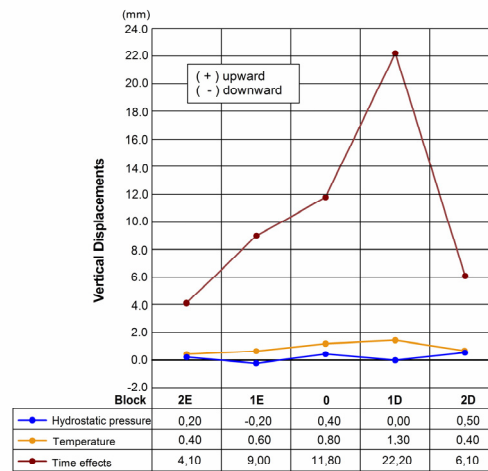
The monitoring system in the dam is designed for the measurement of the water level in the reservoir, atmospheric temperature, uplift water pressure, horizontal and vertical displacement by geodetical methods, joint movements and drainage flow in the foundation. In the beginning of the 1990's, irreversible displacements were registered vertical and upstream, indicating incipient deformation. Figure 1 lists the main results of the statistical model applied to the vertical displacements obtained by levelling on five points at the dam crest, between 1985 and 2006.

| (mm)					
(+) upward					
(-) downward					
Block	2E	1E	0	1D	2D
Hydrostatic pressure	0,20	-0,20	0,40	0,00	0,50
Temperature	0,40	0,60	0,80	1,30	0,40
Time effects	4,10	9,00	11,80	22,20	6,10

Figure 1: Main results of statistical model of the vertical displacements observed between 1985 and 2006.

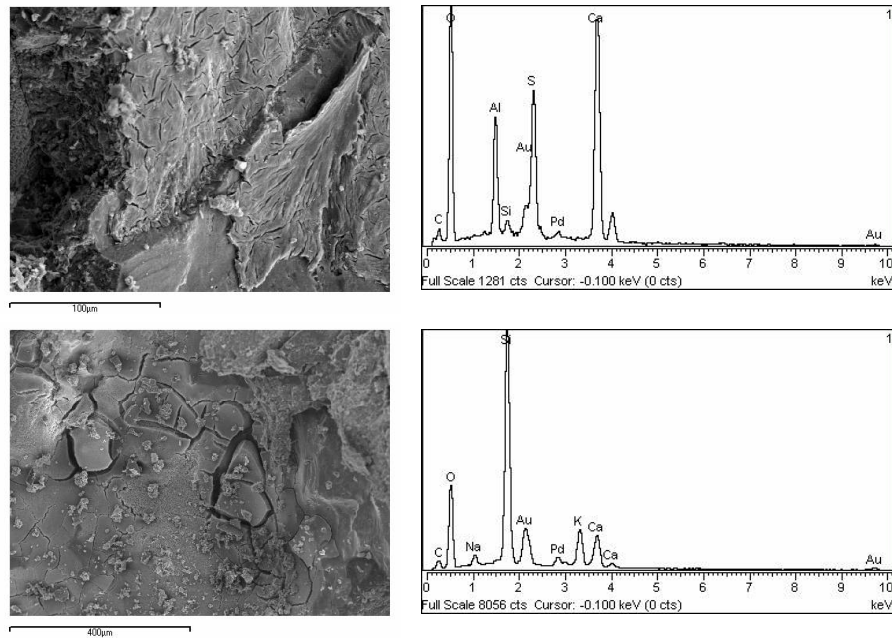
The specimens were observed by SEM after the completion of the tests. The SEM revealed the presence of ettringite in all specimens, occurring in a compressed form in the paste-aggregate interfaces, which was attributed to an internal sulfate reaction (Figure 4). Besides the presence of ettringite, some ASR products were detected, with characteristic shrinkage cracks and a smooth surface. Determination of residual internal sulfate reactivity of the Fagilde concrete was commeced in 2007, results are not available at present.

Figure 4: Samples observed by SEM after the residual alkali-silica reactivity tests. Spectra obtained by EDX confirm the presence of ettringite and alkali-silica gel.

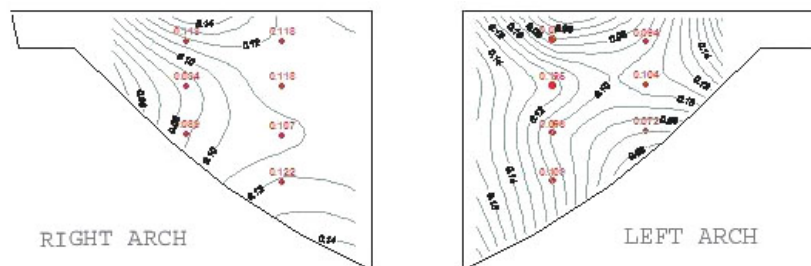
In order to determine if the alkalis content would be sufficient to maintain the ASR and to evaluate possible variations on soluble alkalis in the structure, specimens were selected close to the sites where samples for residual expansion were taken. It was verified that the higher alkali soluble contents were obtained in core number 11, which was located a greater distance from the upstream wall, where damage is more intense.

Assuming a concrete density of 2400 kg·m^{-3}, values of 1.73 and 3.00 kg of Na$_2$O$_{eq}$/m^3 are calculated for the concrete in the arch sections, with a greater range of values in the left section (Figure 5). The buttresses contain calculated values between 1.62 and 4.28 kg of Na$_2$O$_{eq}$/m^3.

Figure 5: Distribution of soluble alkalis in percentage of bulk concrete on the right and left arch sections.

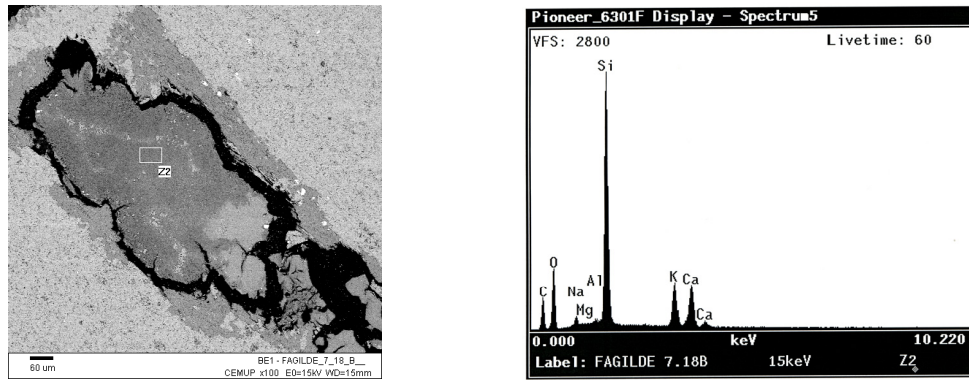
The composition and nature of the aggregates were identified by the examination of thin sections. The coarse aggregates are composed dominantly by micritic (carbonated mudstone) limestone containing veinlets of sparitic (crystalline) calcite. In some grains there are individualized crystals with interstices filled by brownish minerals. The observation of these particles by SEM/EDX permitted the detection of finely dispersed microsilica and silicates that might correspond to mica or clay minerals. In the limestone rock, remains of fossils were identified filled by a mineral of radial texture and low birefringence. It was concluded by SEM/EDX that the fossils are filled by chalcedony and calcium carbonate and alkali-silica gel is also present (Figure 6).

Figure 6: Fossil remains included in a particle of micritic limestone are composed of chalcedony. The EDX analysis shows the presence of alkali-silica gel (image in XPL, SEM and spectrum by EDX) (SEM image and spectrum obtained by CEMUP).

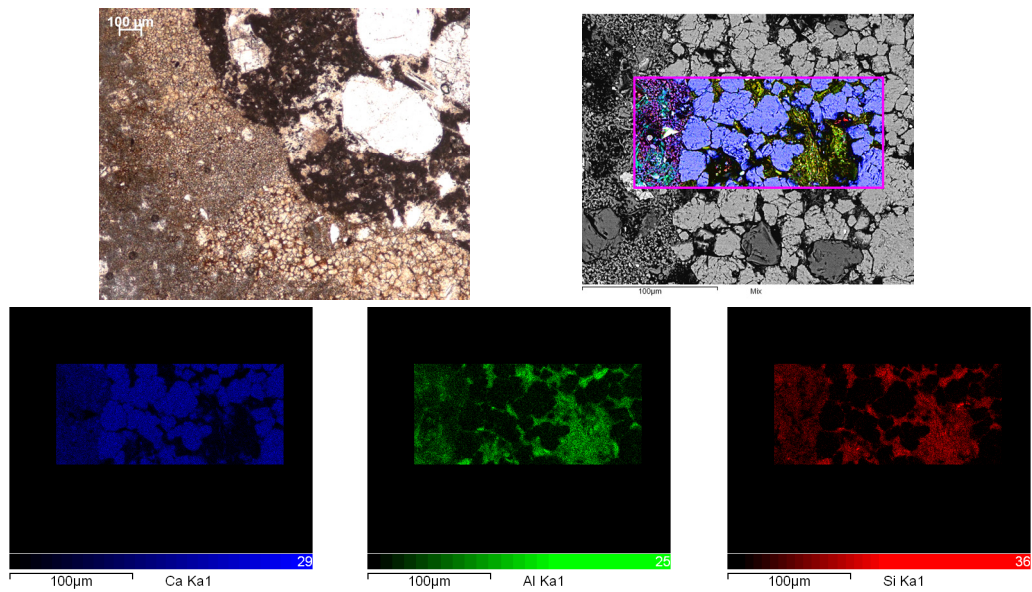
In some places the coarse aggregate particles of limestone show diffuse boundaries (Figure 7) or carbonate halos. These grains contain microsilica and silicates in the interstices, as above referenced. Element maps produced show the presence of calcium in different concentration, as well as silicon and aluminium. The contents of sodium, potassium and magnesium are very low.

Figure 7: Interfaces between coarse aggregate particles and the cement paste are in some places diffuse (images in PPL and by SEM). Maps of elements obtained by EDX (SEM image and spectra obtained by CEMUP).

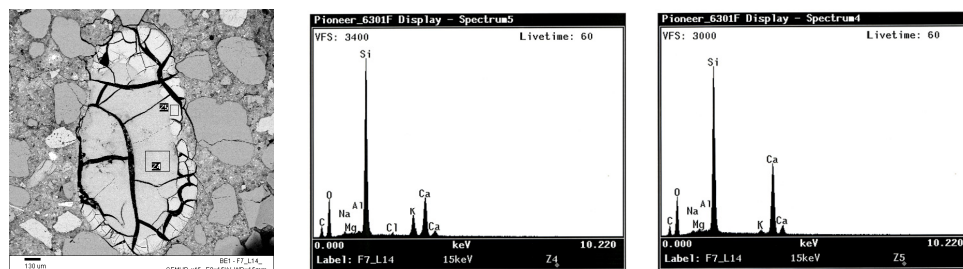
The gel is present in some cracks but dominantly substitutes siliceous particles of the sand fraction. It is a colourless gel in the rims of the particles and voids, isotropic, with typical shrinkage cracks. In the interior of the substituted particles, the gel is brownish. SEM/EDX observation showed that the gel is composed mainly of silicon, calcium, potassium, and some aluminium, sodium and magnesium (Figure 8).

Figure 8: Alkali-silica gel replacing completely a quartz particle (SEM/EDX) (image and spectra obtained by CEMUP).
