CHARACTERISTIC BEHAVIOUR OF THE PORTUGUESE LARGE CONCRETE DAMS BUILT WITH GRANITE AGGREGATES AND AFFECTED BY ASR

António Lopes Batista1*, José Piteira Gomes1

¹Laboratório Nacional de Engenharia Civil (LNEC), Lisbon, PORTUGAL

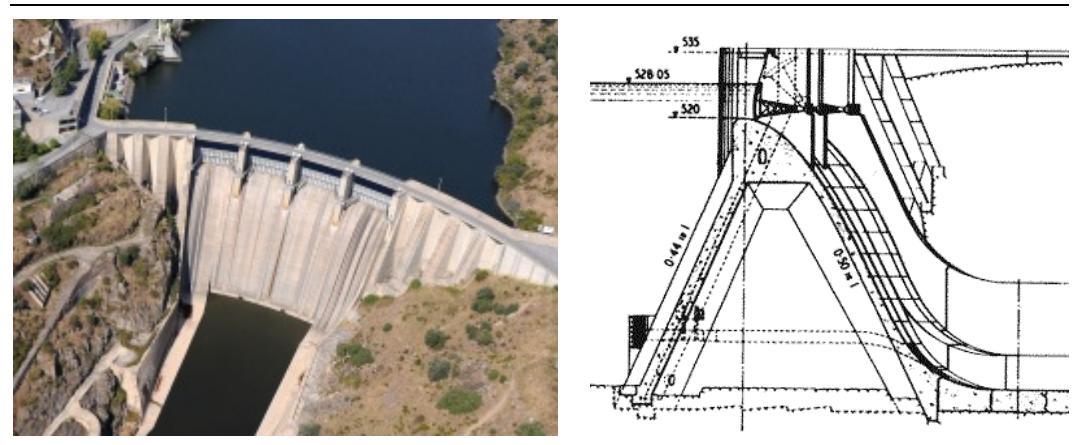
FIGURE 2: Miranda dam. Downstream view and buttress profile.

The Miranda dam is a buttress structure, 80 m high, located in the beginning of the international stretch of the Douro River (which is shared by Spain and Portugal), that is founded on a granite and schist rock mass (Figure 2). It was completed in 1961. Coarse and fine granite aggregates were used in the concrete mix. Evidences of the swelling phenomenon were identified in the eighties of the last century, about 20 years after the construction, by the detection of progressive vertical displacements upwards (Figure 3), as well as vertical sliding on the central contraction joints, near the top, and the increase of strains measured in the stress-free strain-meters. Linear and mapping cracking was detected on specific zones of the galleries and of the downstream surface. The ASR was
