MAINTENANCE AND REPAIRS ON THE WATER INTAKE OF JAGUARI HYDROPOWERPLANT AFFECTED BY AAR.

¹CESP – Cia. Energética de São Paulo, São Paulo, SP, BRAZIL

This paper presents the procedures, methodologies and results obtained after cracks repairs caused by AAR on the water intake, on the foundation block and columns that support the steel catwalk.

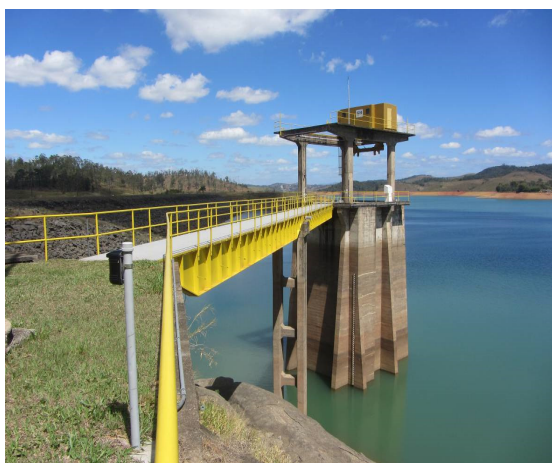
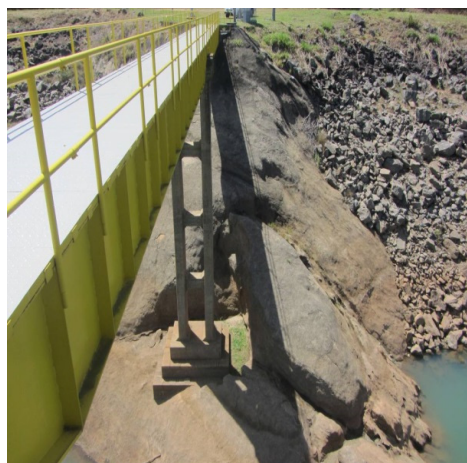
FIGURES 1 and 2: View of water intake and steel catwalk access, columns/beams and foundation blocks.

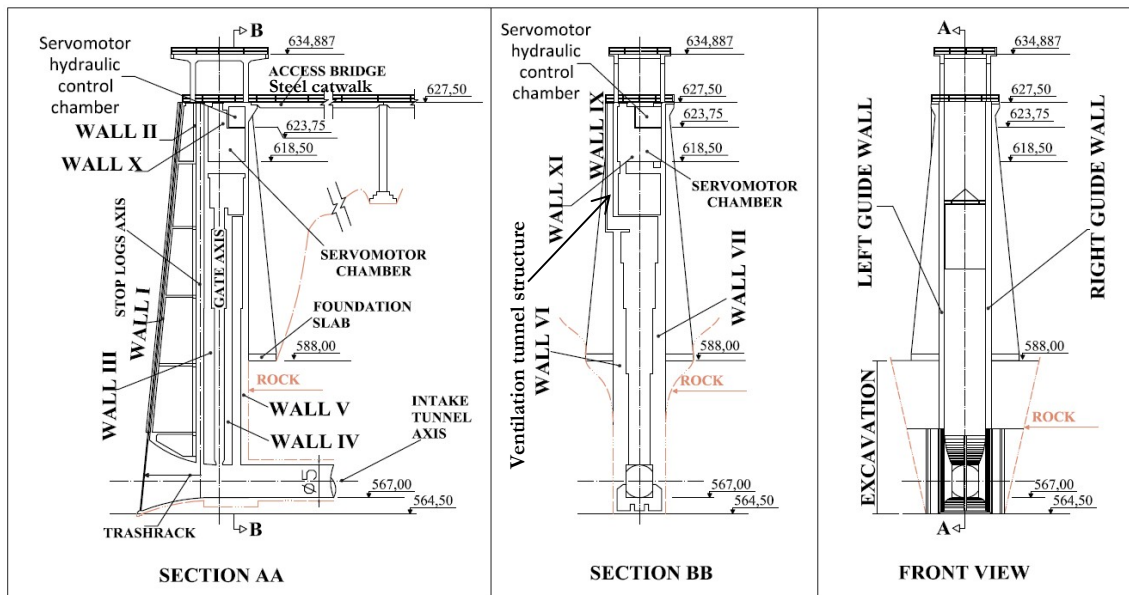
FIGURE 3: Jaguari HPP water intake showing front view and sections.

With the aim of improving the tunnel access conditions, divers conducted the first services of slant joints and some cavities in the water intake of the ventilation tunnel structure, with application of epoxy. However, the result of applying, didn't answer the objective of reducing significantly the infiltrations, depending on the water pressure of the reservoir to the inner side of the tunnel.

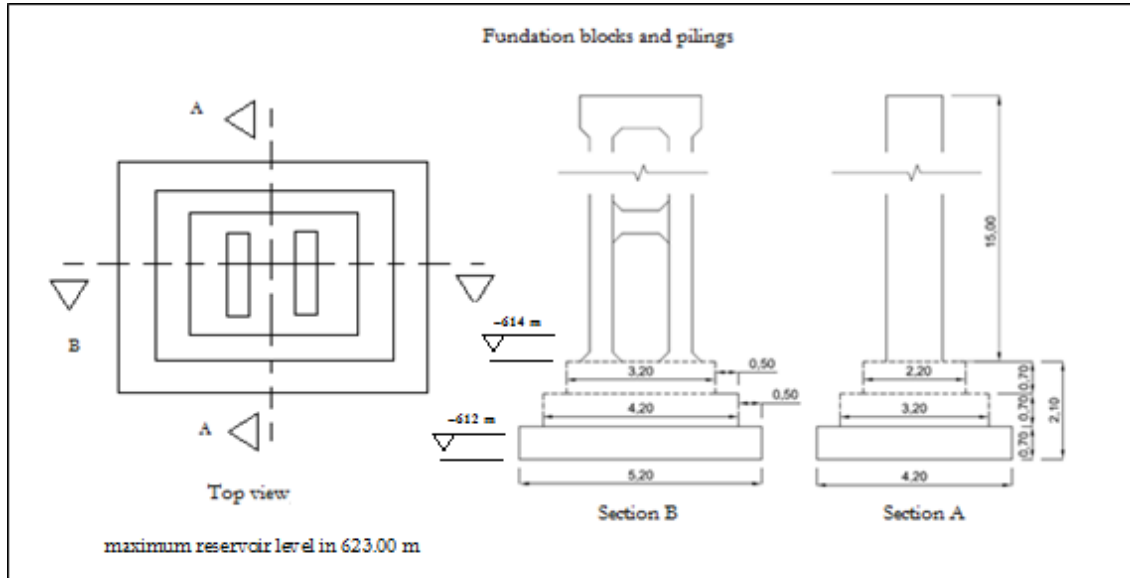
FIGURE 10: Dimensions of Foundation blocks and concrete columns.

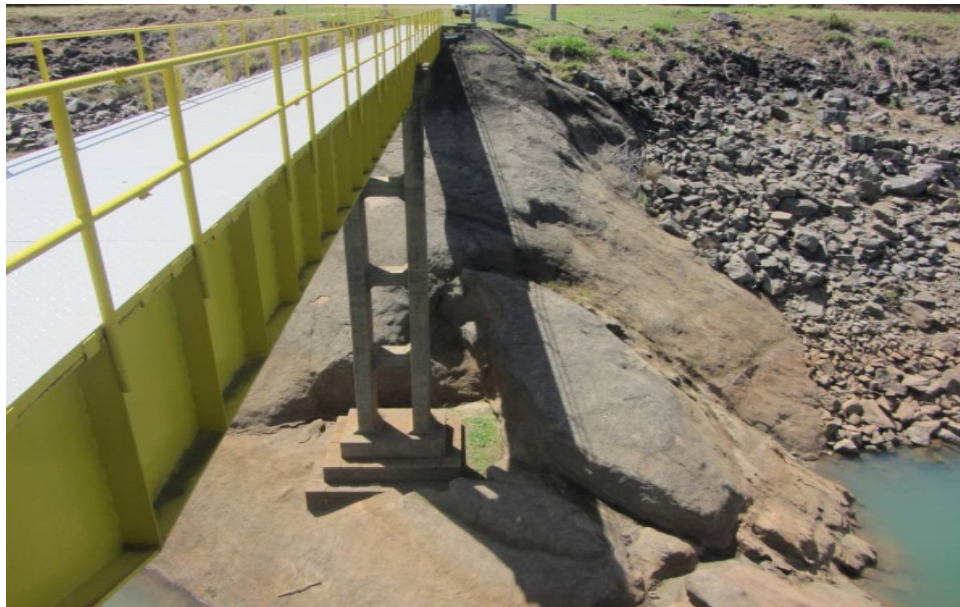
FIGURE 11: View from the footbridge, supported on concrete columns and foundation blocks.

In the technical visit, performed by the technicians of CESP, appeared the necessity to repair the blocks and concrete columns, which were heavily cracked with openings above 10.0 mm, which compromised the concrete strength, elasticity and durability. Figures 12 to 15 show the Foundation blocks and concrete columns of the steel catwalk, water intake access and highlighting the more pronounced cracks, with gaps between 1.0 mm to 4.0 mm. There were also points of aggregate segregation on the basis of the concrete columns surface, and on the surface of the Foundation block.

It was decided to inject a structural epoxy based adhesive because, despite blocks and concrete columns presented cracks due to AAR, they required repairs in order to restore structural integrity and monolithicity. The structural epoxy has high compressive and tensile strength, and was used to bond the structure. To make the injections with resin, it was necessary to caulk the cracks with structural epoxy - adhesive - bi-component.
