SPILLWAYS AFFECTED BY ALKALI-AGGREGATE REACTION : TWO CASE STUDIES FROM HYDRO-QUEBEC

Nathalie Ishak^{1*}, Stéphane Meunier², Fateh Boussaha¹, Claudia Correa¹

¹Hydro-Québec Production, Structural dam engineers, Montréal, Québec, CANADA

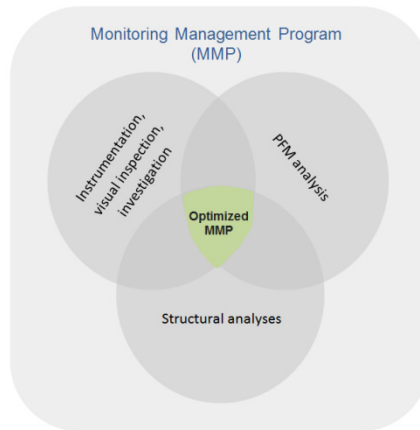
FIGURE 1: Monitoring Management Program (MMP).

Once the presence of AAR is confirmed, the Monitoring Management Program (MMP) is implemented and adapted according to the intensity of the swelling and induced disorders. The aim is to ensure appropriate functional and structural behavior. Among other tools, the MMP includes instrumentation, visual inspection and investigation (FIGURE 1).

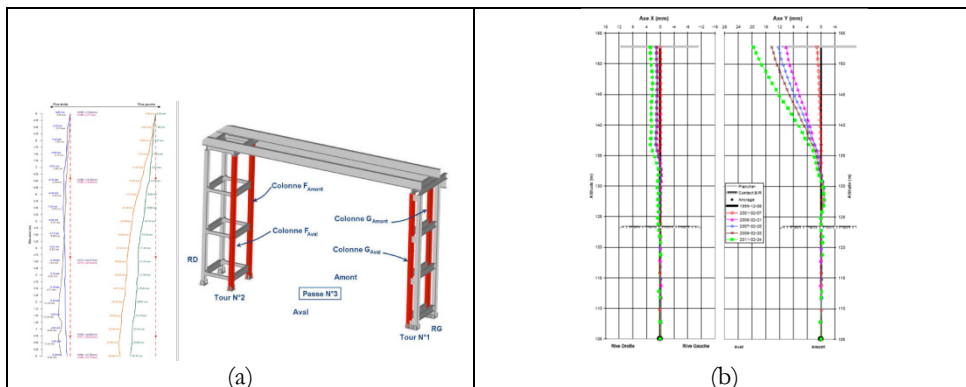
FIGURE 3 : Displacement and deformation measurements:
(a) deformation of permanent hoist supporting structures (b) displacement along a pendulum wire.

Verticality and flatness of spillway piers' grooves can also be measured in order to check if gates are stuck, or to predict the time remaining before that will occur (FIGURE 2(b)). These measures may also be performed on permanent hoist supporting structures (FIGURE 3(a)).

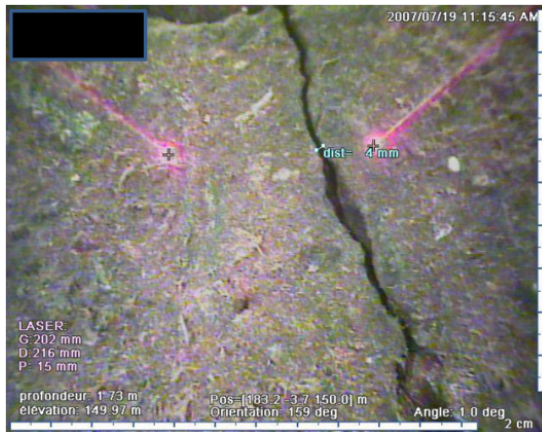
FIGURE 4 : Inspection using underwater robots.

If the intensity of the AAR is important, structural cracking can occur. The surface cracks on downstream faces are easily observable. However, this is not the case whether they are internal or immersed at the upstream side. Hidden cracks may be deduced by visual observation of a new downstream infiltration, the growth of existing infiltration measured by weirs or displacement measured along a pendulum wire (FIGURE 3(b)). It is also possible to identify upstream cracks with divers or underwater robots (FIGURE 4). In addition to that, internal cracks can be characterized using vertical drilling from the crest. If necessary, strain gauges can be set up to monitor the opening of these structural cracks. Structural analyses may then be performed using investigation and instrumentation data, in order to determine if performance criteria are met and to recommend rehabilitation.

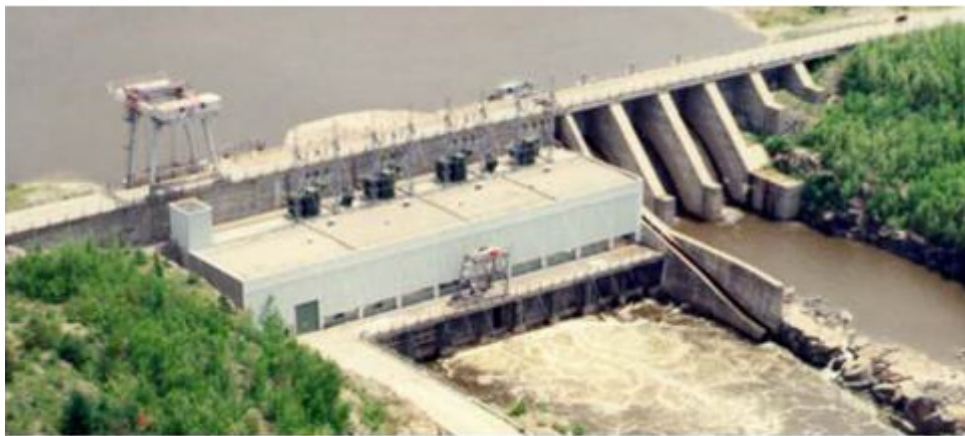
FIGURE 5: Downstream aerial view of Rapide-des-Iles.

The hydropower facility of Rapide-des-Îles is located on the Ottawa River at about 500km of the city of Montreal, Quebec, Canada. The secondary spillway, as shown in FIGURE 5, is on the left side of the intake structure. It was built in 1967 with three vertical lift gates operated by a gantry crane.

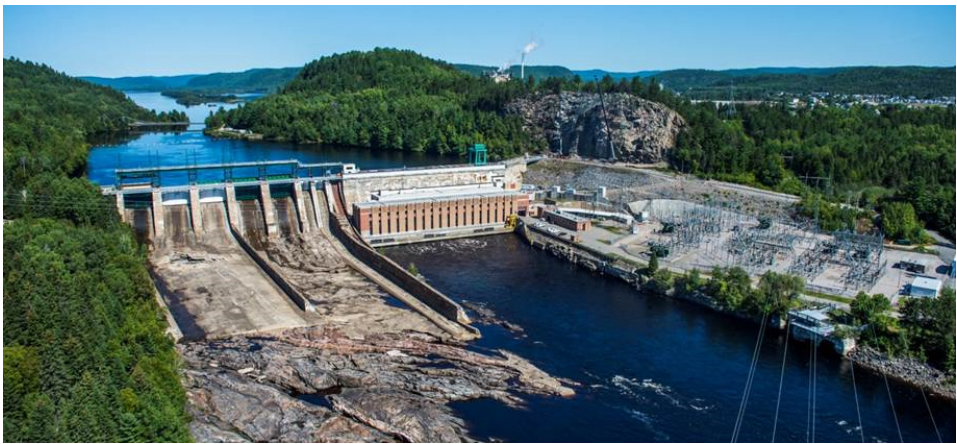
FIGURE 8: Downstream aerial view of La Tuque.

The hydropower facility of La Tuque, built in 1940, is located near the town of La Tuque on the St-Maurice River about 300km north of the city of Montreal, Quebec, Canada, as shown in FIGURE 8.

It consists, as shown in FIGURE 8, of a retaining wall, a right bank gravity dam, a spillway, a log chute (disused), an intake and a power house, and a left bank gravity dam. The facility is approximately 420m long and founded on rock.

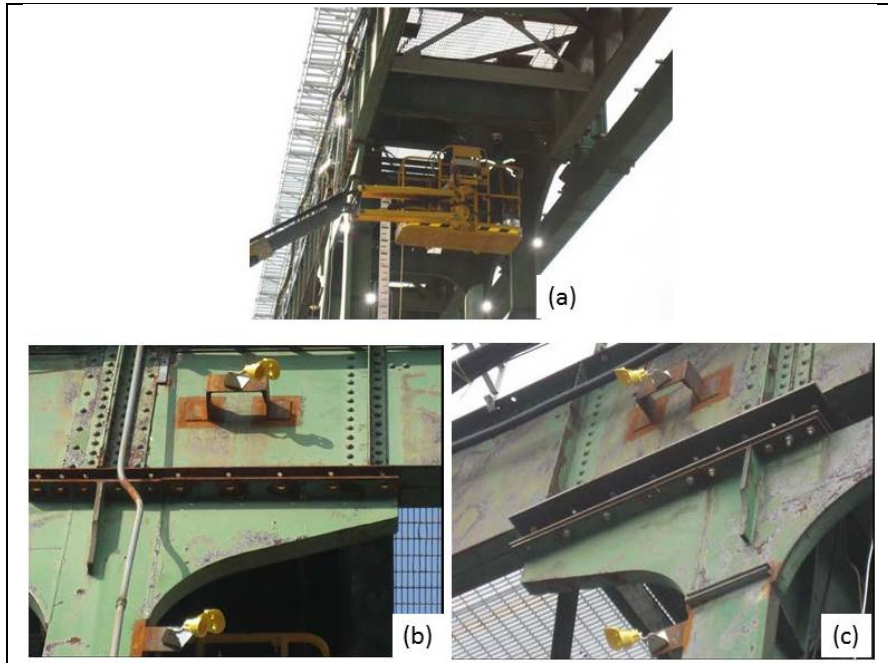
FIGURE 12: La Tuque hoist supporting structure: bridge or beam supports
 (a) uplift of bridge (b) rehabilitation of mobile support (c) rehabilitation of support.

- At the base of the towers RG1, RG2, T5 and T6. After the temporary support, the columns of these towers are cut. When the tension is released, the adjustable base is assembled. The device is removed after the adjustment and stored (FIGURE 10);
- In the lower chords of towers T4, T3, T2 and T1, the same procedure as for the fixed end column is performed except that the adjustable device is different and permanent. (FIGURE 11);
- At the supports of the bridge over the gate VE-3: mobile support and fixed support rehabilitated according to the RAG (FIGURE 12);
- At the hoist's support: adjustable bases (FIGURE 13)
- In a few places: Strengthening or replacing elements that are distorted or highly stressed according to structural analysis.

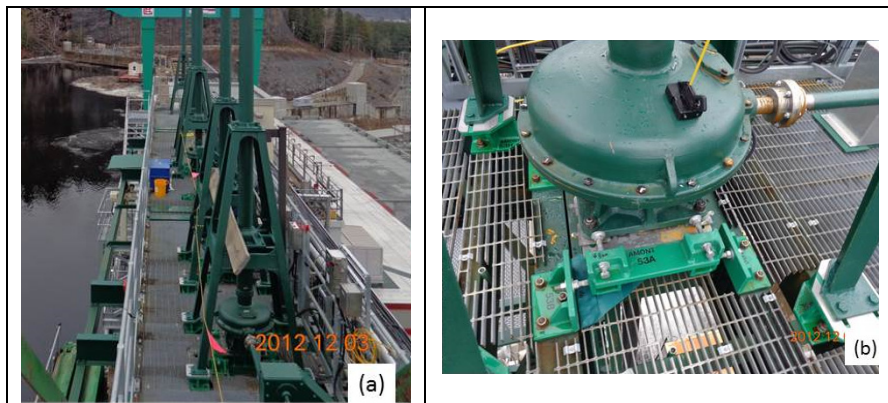
FIGURE 13: La Tuque hoist supporting structure: adjustable hoist's support
 (a) general view (b) support.
