THE REINFORCEMENT OF AN ASR AFFECTED INTAKE TOWER USING POST-TENSIONED TENDONS

Tetsuji Kubo^{1*}, Toshiharu Shibata¹, Chikao Sannoh¹, Kazuyuki Torii²

¹Hokuriku Electric Power Co. Ltd., <u>IAPAN</u>

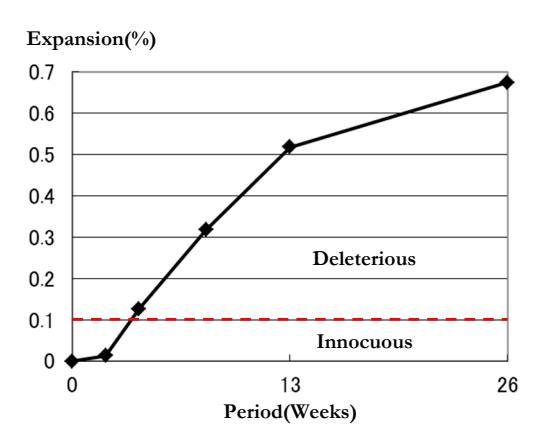
FIGURE 4: Result of chemical test.(JIS A1145)

Hokuriku district river sand and gravel from one river in the region was used in the intake tower. This aggregate is considered to be the most reactive in Japan. Figure 4 shows the result of chemical test according to JIS A 1145. The outcome of the aggregate classification was 'deleterious,' indicating that the alkali-silica reactivity of both the fine and coarse river aggregates is similar when their soluble silica content (Sc) is more than 100 mmol/l. Furthermore, Figure 5 shows the result of the accelerated mortar bar test for a specimen using the river gravel according to JIS A 1146. As shown in this figure, the specimen expanded significantly with curing. In this manner, we confirmed that this gravel was deleterious.
