FIELD AND LABORATORY EXAMINATIONS OF AN ASR-AFFECTED BRIDGE – VARIATION IN CRACK EXTENT AND WATER CONTENT

Eva Rodum*, Bård M. Pedersen, Ragnhild Holen Relling

Norwegian Public Roads Administration, Trondheim/Bergen/Ålesund, NORWAY

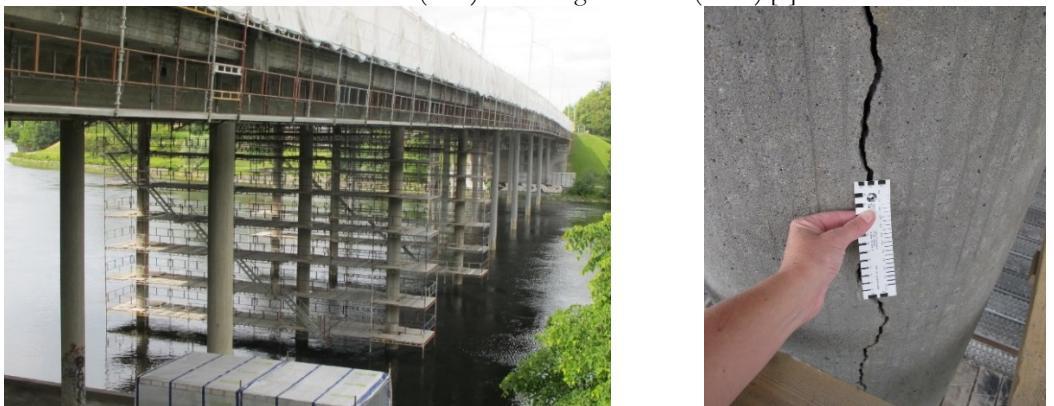
Measurements of maximum crack widths on the western face of column 1 in axis 3 were performed from each scaffolding platform levels 1-6 (FIGURE 6), showing a decrease in max. crack width with increasing height above the protection sleeve (FIGURE 8, left).

FIGURE 6: Left: Scaffolding raised in axes 3 (nearest) and 4. Surface crack indexes were measured and cores drilled in axis 4, approx. 4.5 m above ice protection sleeve (platform level 3). Right: Maximum crack widths on western side of column 1 in axis 3 were measured on each platform level. Crack width
