THE EFFECT OF ALKALI-AGGREGATE REACTION ON THE STRENGTH  
AND DEFORMATION OF A REINFORCED CONCRETE STRUCTURE

G E Blight and M G Alexander  
Department of Civil Engineering  
University of the Witwatersrand  
Johannesburg, South Africa

1. ABSTRACT

A portal that forms part of a major double deck road structure in Johannesburg has deteriorated, as a result of alkali-aggregate reaction, to an extent that is visually alarming. The upper portions of the columns and the upper beam of the portal show the greatest degree of deterioration, and an ultrasonic pulse velocity survey indicated that the visible surface cracking deeply penetrates the concrete.

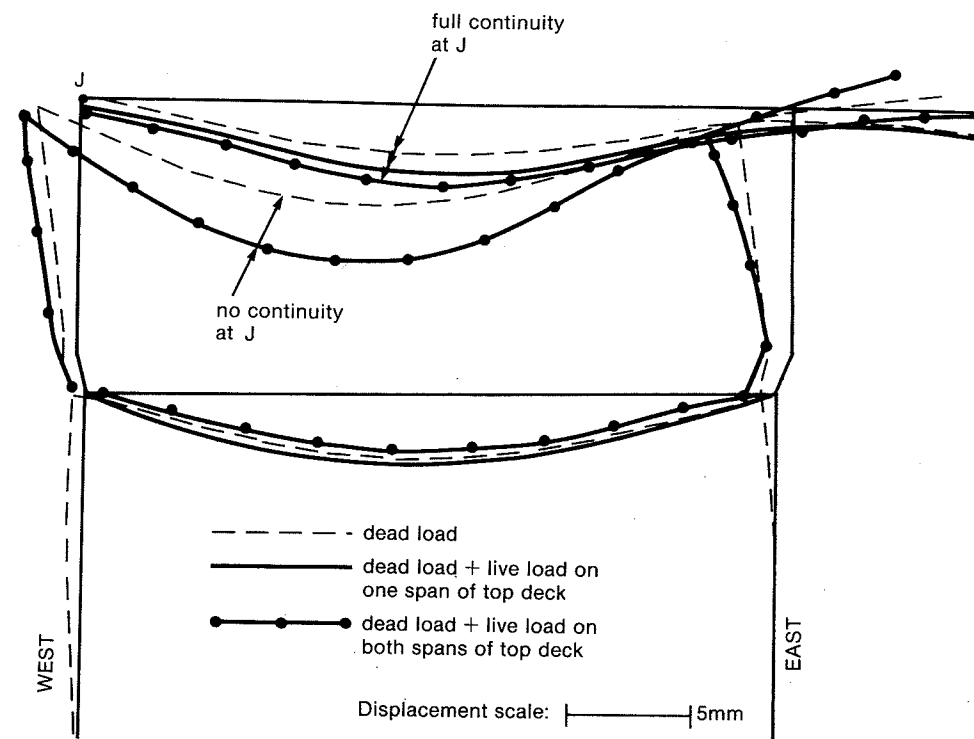
The results of the computed deflections are shown in Figure 4. In the first series of analyses full continuity was assumed at every joint of the portal.

Because of the severe deterioration at the west end of the top portal beam, some concern was felt lest moment continuity had been partially or completely lost at this point. (J in Figure 4). For this reason, the analysis was repeated assuming no moment continuity at J.

FIGURE 4. Calculated displacements of the portal members under load.

slopes under dead load and those under dead plus live load. In numerical terms, these differences are very small. The maximum expected displacement of the top beam was only 1,2 mm. The maximum rotation at point J was expected to be only  $70 \cdot 10^6$  radians if full moment continuity existed and  $365 \cdot 10^6$  radians if continuity had broken down.

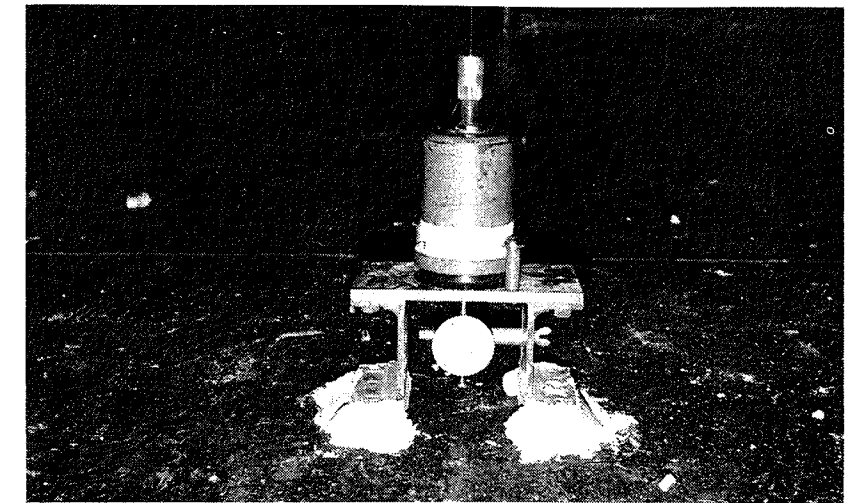
FIGURE 5. Displacement gauge bedded on lower deck of portal.

ure 1) by means of the instruments illustrated in Figure 5. An invar wire was attached to the soffit of the beam at the point of measurement by means of a masonry bolt. The lower end of the wire was attached to a heavy weight that was able to slide freely in a vertical direction guided by a ball bushing. The bushing, in turn, was attached to a base that was bedded down on the road surface of the lower deck vertically below the point of measurement. Figure 5 shows the lower extremity of the invar wire attached to the cylindrical

weight. The bushing was attached to the base, the channel legs of which were bedded down in the white plaster of paris visible in the photograph. The underside of the weight was attached to a spindle, the vertical movement of which was measured to the nearest 0,01 mm by means of the dial gauge visible in Figure 5. Because of possible displacements of the lower deck, the arrangement of wires and displacement gauges was repeated between the soffit of the lower beam of the portal and the road surface at ground level.

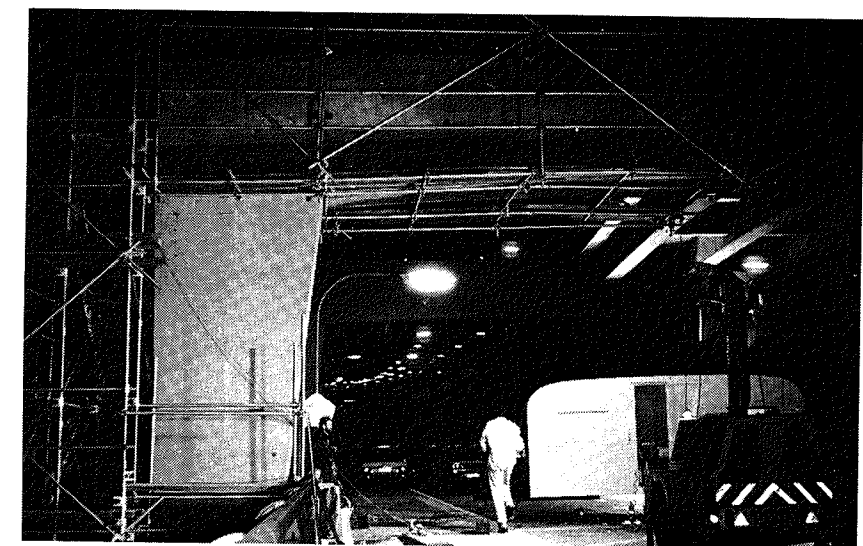
Figure 7 is a general view of the site during the course of the test. The

caravan was used to house the instrument readouts. Figure 8 shows the loaded trucks being arranged on the upper deck.

FIGURE 7. General view of site during test.

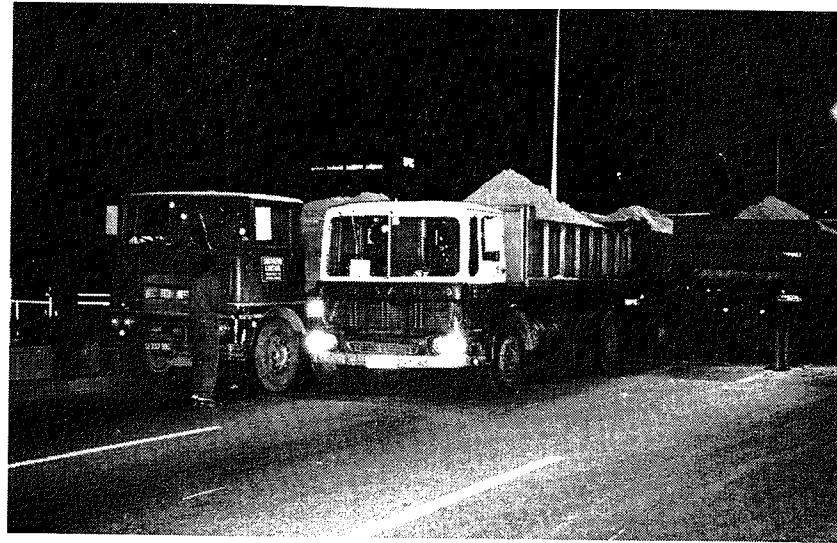
FIGURE 8. Arranging the loaded trucks on the upper deck.

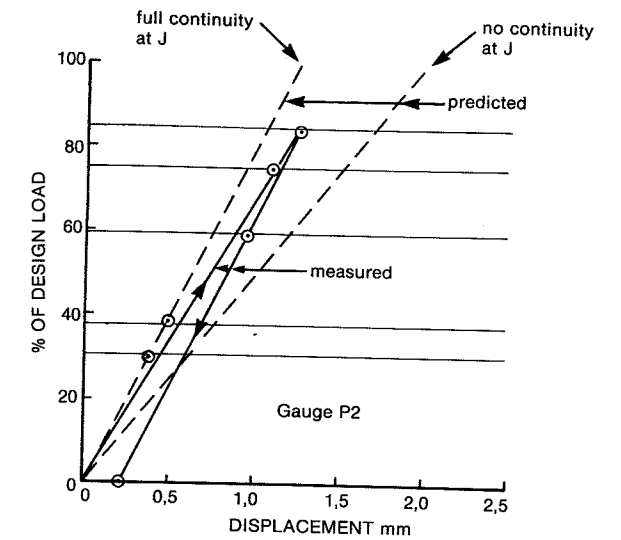
Comparisons of measured and predicted displacements at point P2 are illustrated in Figure 9. If full continuity at J is assumed, the measured displacements are slightly larger than predicted. A decrease in the elastic modulus of the concrete from 18 GPa to 15 GPa would account for the difference. Results for points P1, P3 and P4 were similar and all indicated that full continuity existed at J.

FIGURE 9. Comparison of measured and predicted displacements.

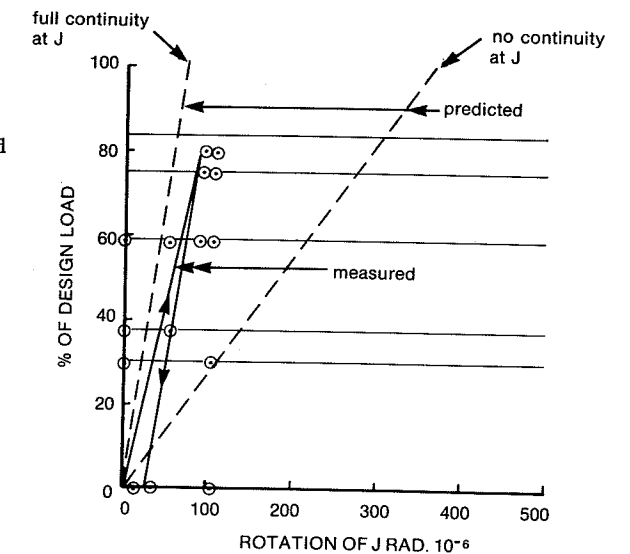
The results of the rotation measurements at J are compared with predicted rotations in Figure 10. Although the slope gauges were being used at the limit of their accuracy, the results appear consistent and show that full amount continuity exists at J. The measured and predicted results can be reconciled by reducing the modulus of elasticity of the concrete from 18 GPa to 12 GPa - again a perfectly possible value.

FIGURE 10. Comparison of measured and predicted rotations at point J.

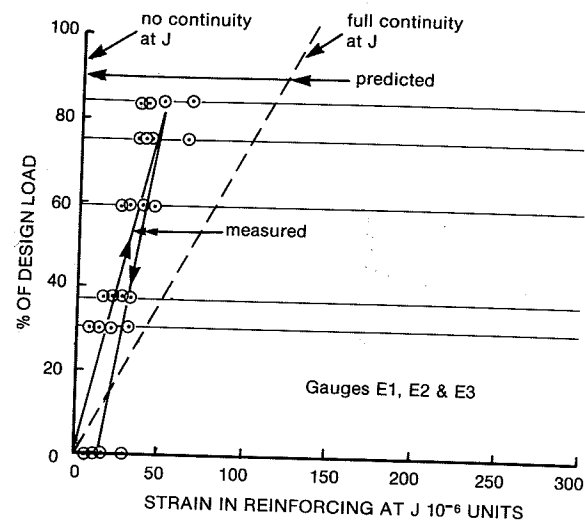
Figure 11 shows strains measured in the reinforcing at the west beam to column joint (J). As far as continuity at J is concerned, a lack of continuity would be indicated by low or zero strains at E1 and E3 and a difference in strains between E1 and E2. In fact, the readings taken at all three locations cannot be distinguished, although strains are lower than predicted if full continuity applies. Measured strains were also lower than predicted at midspan, thus supporting the conclusion that full continuity exists at J.

The measured strains cannot easily be reconciled with the predicted values. The predictions were based on the usual straight-line, no tension theory. The most likely explanation of the discrepancy is that although the concrete is very obviously cracked, the cracking does not penetrate to the neutral axes of the beam and column sections and the structure is behaving as if partly cracked.

FIGURE 11. Comparison of measured and predicted tensile strains in reinforcing at J.

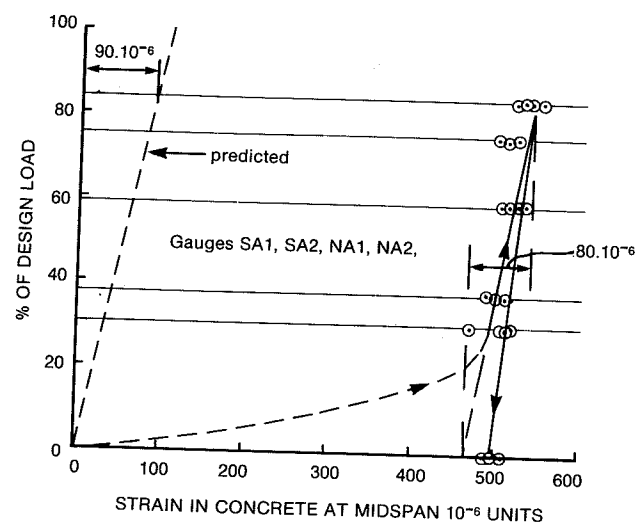
Comparisons of measured surface compressive strains and compressive strains predicted on the basis of the straight line, no tension theory for conditions at midspan are shown in Figure 12.

The initial strain increment appears to have resulted from a closing up of the surface cracks in the concrete. This view is supported by the observation that there was a large residual strain on unloading. If the initial 'closing-up' strain is discounted, the measured compressive strains are remarkably close to those predicted on the basis of an elastic modulus of 18 GPa for the concrete. Similar results were found at the west column-to-beam joint J.

FIGURE 12. Comparison of measured compressive surface strains and predicted compressive strains in concrete.
