SERVICE LIFE PREDICTION AND ALKALI-SILICA REACTIONS

Anders Nielsen
civ.ing.,tekn.dr.

Technological Institute, Building Technology
Taastrup, Denmark*)

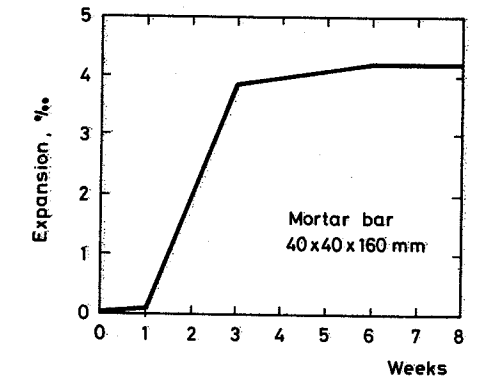
The development of the cracks on the bridges is shown qualitatively on fig. 5. This is the same type of crack development as we have seen on the roof structure treated above (fig. 1). In fact we see the same time of crack development on our mortar bar experiments (fig. 6).

Fig. 6. Development of expansion in experiment with mortar bar 40 x 40 x 160 mm in saturated NaCl-solution according to the TI-method. Mogenstrup gravel.

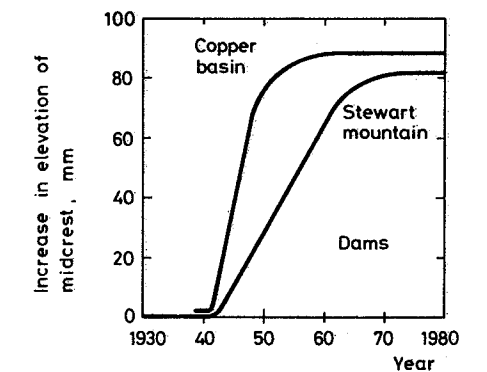
Recently measurements from USA on the deformations of concrete dams suffering from ASR have been published /6/ (fig. 7). Again we have the same type of time curves with a period of initiation, of propagation and of rest.

Fig. 7. Increase in elevation of midcrest of two concrete dams in USA /6/.

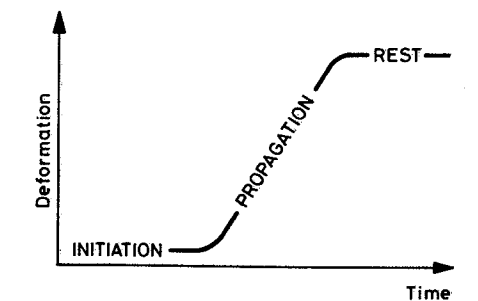
Fig. 8 shows a principal diagram of the development in time of deformations due to pure ASR.

Fig. 8. Principal development of deformation and cracks in concrete suffering from damages caused by pure alkali-silica reactions.
