## DAMAGES TO SWIMMING POOLS DUE TO ALKALI SILICA REACTIONS

Svend E. Petersen, Civil Engineer  
Cowiconsult, Copenhagen, Denmark

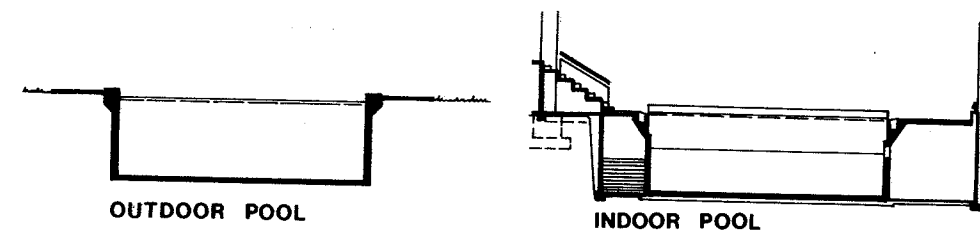
Fig. 1

It is noticeable that design and construction practice for the concrete pools was developed for the outdoor pools and later used for the indoor pools although significant differences between the conditions, to which the concrete is exposed, are present. A typical cross section of an outdoor and an indoor swimming pool are shown on fig. 1.

Both are typically supported on the ground but whilst the outdoor pool has earthfill along its walls, the indoor pool is usually surrounded by a corridor used for piping and as inlet duct for the ventilation system of the swimming hall.

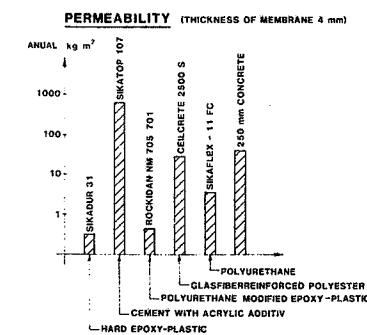
Fig. 6

To investigate this possibility a number of such membranes have been tested in the laboratory of the Danish Engineering Academy. The properties we wanted to test were the permeability, the elasticity i.e. the ability to bridge concrete cracks, the adhesion and the durability.

- The permeability should be of another order of magnitude than that of the concrete wall. We suppose some 10 - 100 times less. It was tested with the so called cup-method, a method in which it is the capillary suction in the porous material to which the membrane is fixed that drives the water through the membrane. On fig. 6 can be seen that the permeability of the most impermeable membrane in a thickness of 4 mm is 1/100 of the permeability of 250 mm first class concrete.

The second and third repair method is based on the establishment of a membrane. In principle there are two possibilities, either a membrane of sheets or foils, e.g. bituminous sheets, or a membrane built up on the spot e.g. of epoxy. A foil membrane whatever material it is made of, will require an inner wall to carry the lining, normally tiles. This disadvantage makes the use of a membrane that can support the lining very attractive.
