**EFFECT OF COATING TO INHIBIT ALKALI-AGGREGATE REACTION
OF CONCRETE STRUCTURES**

Manabu Fujii*, Toyoaki Miyagawa**, Minoru Tomita***,
Koichi Ono**** and Mamoru Imae*****

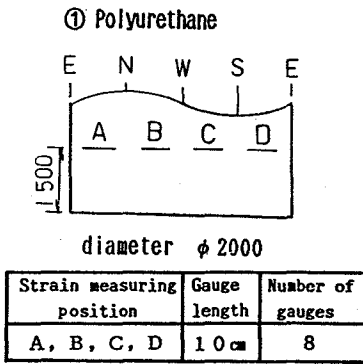
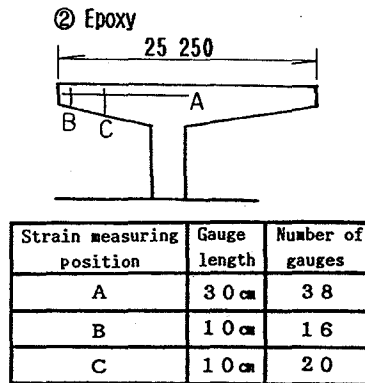
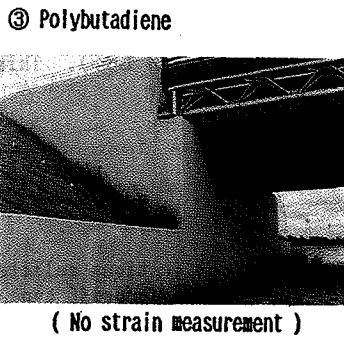
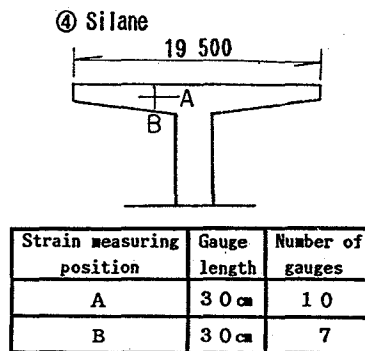
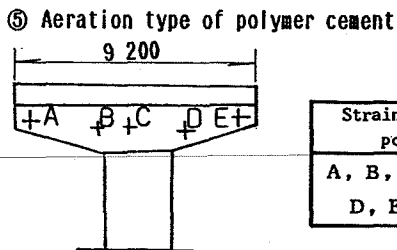
Figure 1 Test structures

Piers and an abutment of highway bridges are selected as the test model. Before repair by coating, crack width and depth, corrosion of steel, reactive aggregate used and expansion of core drilled from the structure were investigated. After coating, strain measurement and crack observation were carried out periodically. The strain measurement was carried out by contact strain gauge. Figure 1 shows the test structures for each coating materials and position of strain measurement.

Strain measuring position	Gauge length	Number of gauges
A, B, C, Vertical	10 cm	4
D, E Horizontal	10 cm	4
