THE IDENTIFICATION OF ASR IN THE CONCRETE COOLING TOWER  
INFRASTRUCTURE OF THE TARONG POWER STATION

Alan Carse

Transport Technology Division of Queensland Transport Brisbane,  
Australia

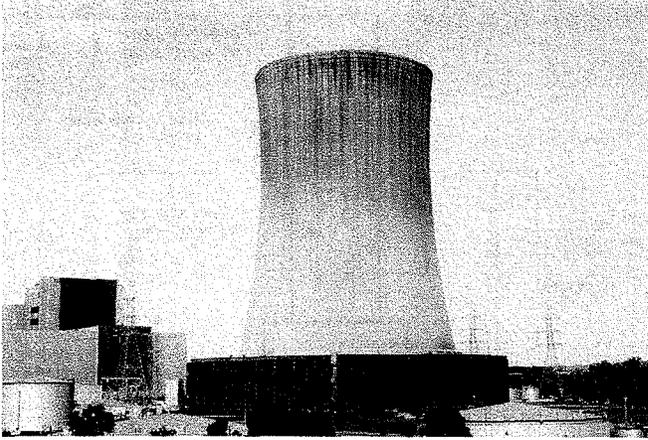
Figure 1 General view of cooling tower no. 1

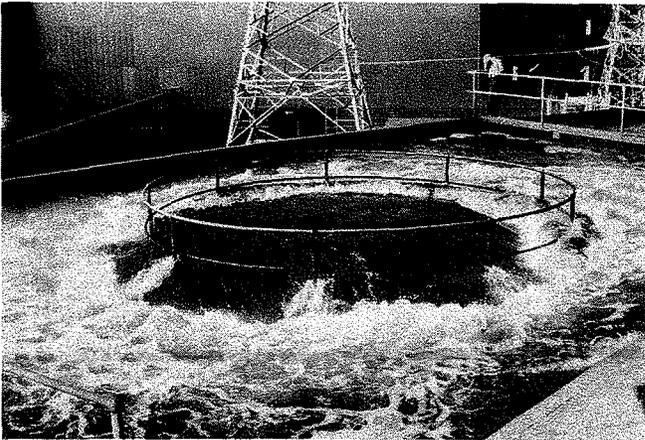
This investigation was conducted to determine the mechanism causing the observed vertical cracking in the precast columns supporting the hot water ponds of the Tarong Power Station Cooling Towers. It represents the continuation of a broader project previously completed by Carse and Dux (1) investigating Australian concrete structures affected due to ASR. These columns were cast in 1981/82 and were 8 years old at the time of this inspection in August 1990. Tarong Power Station has two cooling towers which were completed in March 1984 and December 1985 respectively. The power station was brought on line in 1986. Fig. 1 shows a general view of cooling tower No. 1 in operation and Fig. 2 shows the hot water at 40°C being delivered to the pond from the power station condenser.

Figure 2 View of hot water (40°C) being delivered to the pond from the power station condenser
