EXPERIENCES FROM EXTENSIVE CONDITION SURVEY AND FEM-ANALYSES OF TWO NORWEGIAN CONCRETE DAMS WITH ASR

This paper presents the experiences from an extensive condition survey and FEM-analyses of two about 40 years old Norwegian concrete dams with ASR, one slab concrete dam and one arch dam. The background for the project was that the slab in the mid corner of the slab dam suddenly lifted from the supporting pillar due to expansion. In 2006 this slab concrete dam was rehabilitated, and in 2008 a monitoring program is planned to be established.

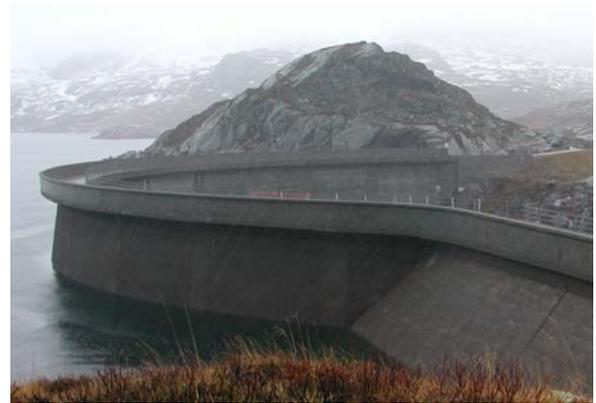
Figure 1: Cross-section of the arch dam (Votna 1). The maximum height is 55 m and the thickness increases from 0.95 m in the top to 4.0 m in the bottom part.
