EARLY DAMAGES DUE TO ALKALI AGGREGATE REACTIONS IN A SWIMMING POOL – DIAGNOSIS AND RATE OF EXPANSION

Eva Rodum^{1,2,*}, Jan Lindgård², Hans Stemland², Marit Haugen², Ola Skjølsvold²

²SINTEF Building and Infrastructure, N-7465 TRONDHEIM, Norway

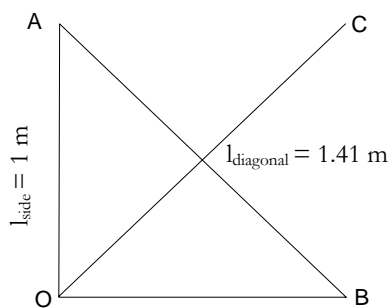
In order to measure the development of crack widths, i.e. the expansion, over time, two reference areas were established in November 2006. The reference areas were defined as square areas of 1 x 1 m², with two side lines (OA and OB) and both diagonals (OC and AB) representing the measuring lines, see Figure 8. Reference area 1 was established on the underside of the pool bottom, while reference area 2 was established on the outside face of the pool wall.

Figure 8: Reference area with four measuring lines.

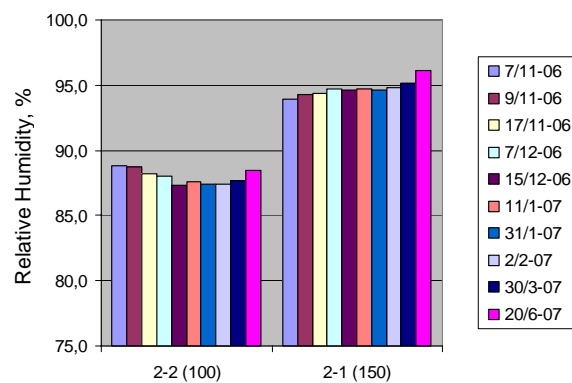
Measuring points, ref.area 2 (depth from surface, mm)

Two of the sensors in area 2 were installed in November 2006, the rest of them in February 2007. Measurements have been performed until June 2007. Measurements performed regularly on two of the sensors from November 2006 to June 2007 show small variations over the period, see Figure 9, which indicates rather stable humidity conditions in the concrete. The RH values in the different measuring points in February 2007 are presented in Table 3, together with the corresponding measured temperatures.

Figure 9: Variation in Relative Humidity in two measuring points over the period November 2006 - June 2007. The measuring points are located 100 mm and 150 mm, respectively, from the outer surface of the 250 mm thick pool wall.

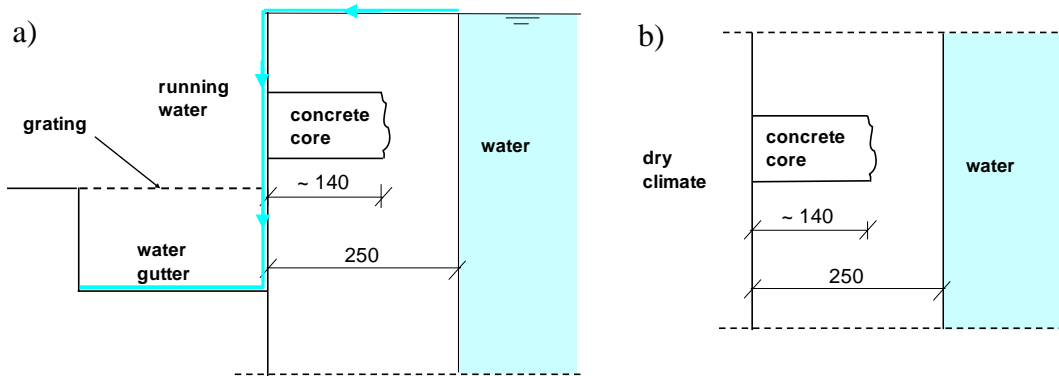
The preliminary examination in May 2006 included structural analyses of one core drilled from the upper vertical face of the pool wall, see Figure 10. During the main inspection in November 2006 two concrete cores were drilled from each of the two reference areas. The cores were wiped off immediately after drilling, tightly wrapped in plastic bags and transported to SINTEF's laboratory. The laboratory examinations included material structural analyses, porosity measurements and determination of the degree of capillary saturation. The results from the material structural analyses are presented in section 4.

The diameter of the cores was 83 mm (near top of the wall), 92 mm (reference area 2) and 98 mm (reference area 1), while the length of the cores was approximately 140 mm. The localization of the drilled cores in the concrete sections is illustrated in Figure 10.

Figure 10: Localization of the drilled cores in the concrete sections. a) Near the top of the pool wall, exposed to water on three sides and b) the lower part of the pool wall and the bottom plate, exposed to water on one side.
