A SURVEY ON ASR-AFFECTED BRIDGE PIERS WITH FRACTURE OF STEEL BARS ON NOTO EXPRESSWAY

Kazuyuki Torii^{1,*}, Shingo Wasada², Teruhiko Sasatani³, Toshihiko Minato⁴

The brittle fracture of steel bars caused by an excessive expansion of concrete due to alkali-silica reaction (ASR) has recently been discovered in large numbers of bridge piers on the Noto expressway. At present, the maintenance and rehabilitation for such severely damaged bridge piers are a great concern especially for bridge engineers in Japan. The authors have been carrying out the series of investigation on both the deterioration of concrete and the fracture of steel bars in ASR-affected bridge piers with reactive andesite stone. The paper describes the investigation in field on seven bridges with the fracture of steel bars and their rehabilitation on the Noto expressway. The asset management for ASR-affected bridges on the Noto expressway is also discussed.

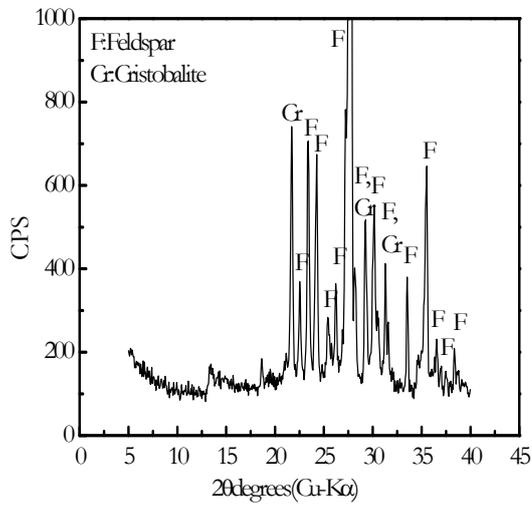
The concrete of bridge piers was made of the non reactive river sand and reactive andesite stone as the fine and coarse aggregate, which are all produced in the Noto peninsula. In this district, the andesite stone has been used for a long period because the river gravel is required to carry a long way from Toyama Prefecture. It is well known that the andesite stone produced in the Noto peninsula is the most reactive aggregate all over Japan. Figures 4 and 5 show the XRD pattern and polarization spectroscopy of typical andesite stone used. This andesite stone contained the cristobalite and volcanic glass as reactive components to a significant extent. The results of alkali-silica reactivity of this andesite stone used in concrete are presented in Table 1. The andesite stone is assessed as "Deleterious" by both the chemical test according to JIS A1145 and the mortar bar tests according to JIS A1146 and ASTM C1260. Furthermore, in the measurement of water soluble alkali content of andesite stone in the saturated calcium hydroxide solution at 38 °C, large amounts of alkalis, mostly Na⁺ ion, are released in the process of the reaction of volcanic glasses and/or some altered feldspars. Concerning the ASR mitigation method proposed by JIS A 5308, the total alkali content of concrete is required to be less than 3 kg/m³, which is the most popular one in Japan. Actually, the alkali content of concrete used in ASR-affected bridge piers ranged from 2.2 kg/m³ to 2.6kg/m³, but its mitigation method was ineffective for the andesite stone. It is likely that the alkalis released from the aggregate itself may also play an important role in both the formation of ASR gel and the following successive expansion of concrete due to ASR.

Figure 4: XRD pattern of andesite stone.

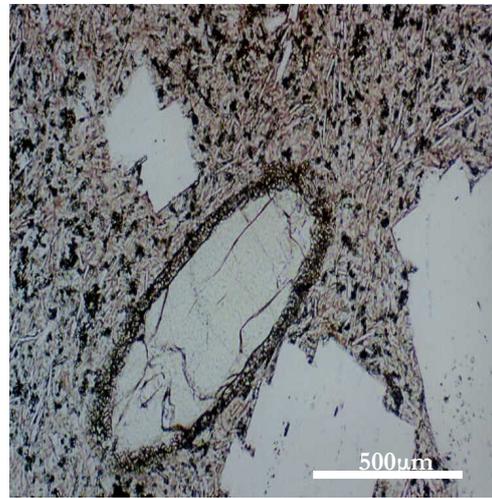
Figure 5: Polarization spectroscopy of andesite stone.

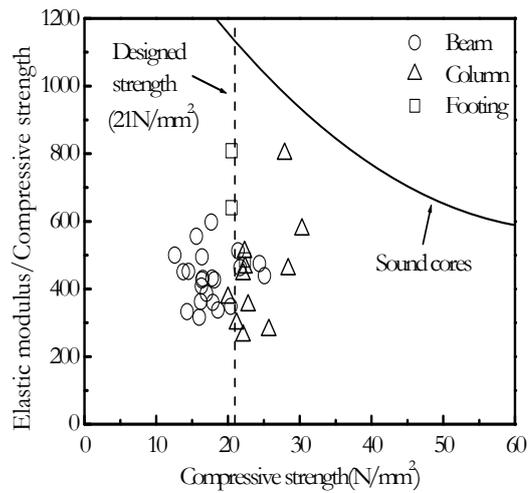
Figure 6 shows the compressive strength and elastic modulus of concrete cores taken from the pillow beam, column and footing of bridge piers on the Noto expressway. The reduction in compressive strength of pillow beam was more significant compared with that of column, in most cases, which is lower than the designed strength of concrete of 21 or 24 N/mm². This is attributable to the lower steel reinforcement ratio of pillow beam. It is also apparent that the reduction in the elastic modulus of concrete is also more remarkable than that in the compressive strength. It is likely that the lower the ratio of elastic modulus to compressive strength (E_c/f_c), the higher the degree of deterioration due to ASR. Figure 7 shows the change in compressive strength of concrete cores with time after construction. It was found out that the compressive strength of concrete gradually decreased with time, and that the compressive strength of about 10 and 20 N/mm² is acceptable as the designed one strengthening for the pillow beam and column, respectively, where the lower limit value in variations is adopted. Furthermore, the survey on the deterioration of bridge piers on the Noto expressway indicates that in many cases, the cracks tend to increase every year although the time of thirty years has already passed after construction, and that the residual expansion capacity of concrete remains still high.

Figure 6: Relations between compressive strength and elastic modulus of cores.

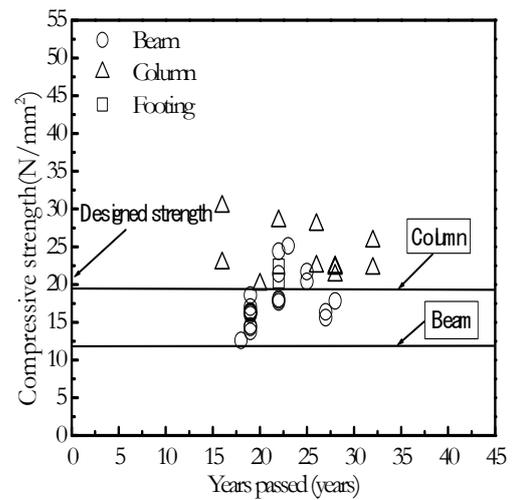
Figure 7: Change in compressive strength of cores with time.
