JAGUARI HYDROPOWERPLANT – EVALUATION, DIAGNOSIS AND CONTROL OF A STRUCTURE AFFECTED BY ALKALI-AGGREGATE REACTION

Abstract

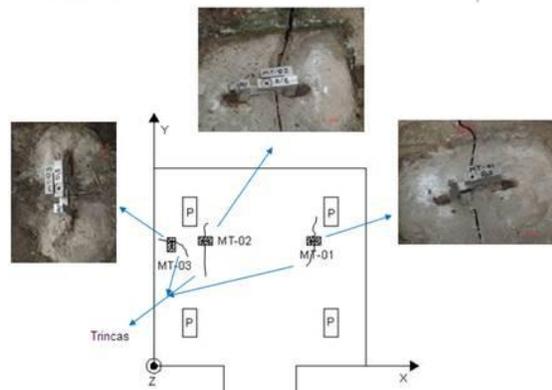
Seven triortogonal crack meters (TM) were installed to monitor cracks movements: opening and closing, vertical displacement and horizontal displacement. Three meters were located on the slab of the water intake, two in the downstream part of the powerhouse and two in the upstream part of the powerhouse. Figure 8 shows the location of some triortogonal meters installed in 2000 while the results are shown in Figure 9. The monitoring of cracks in the slab of the water intake indicates increasing trend of crack opening, about 4mm in ten years, suggesting that the alkali-aggregate reaction is evolving. The opening movement is linear and increasing, with no tendency to stabilize yet.

Figure 8: Location of triortogonal crack meters at the water intake slab.

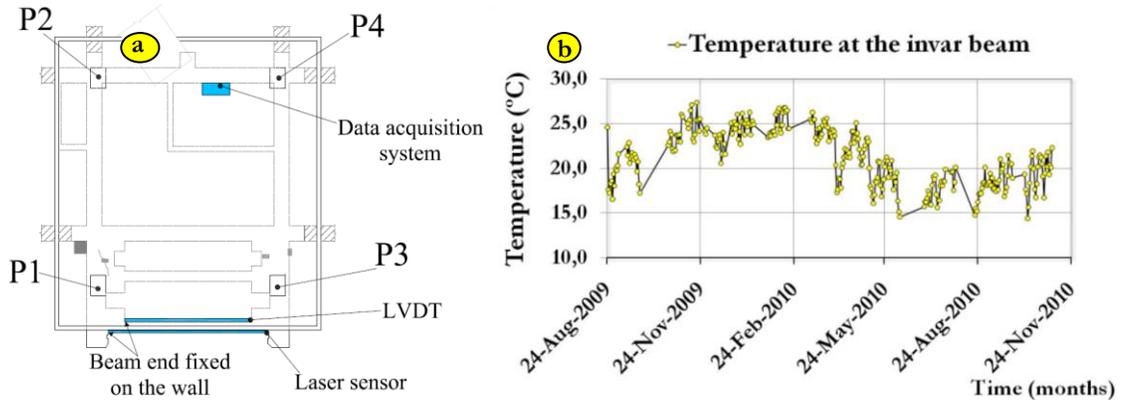
The level of deterioration shown by this structure requires extensive monitoring, mainly between the walls of the trashrack steel guide. The deformation at this location, coming from the AAR is likely to misalign and jeopardize in the long term the movement of the trashrack and of the stoplog. A possible differential displacement of the steel guide can be seen in Figure 11. To monitor and provide an estimate of relative motion between the walls a new device was installed. It consists of a laser sensor with analog and digital outputs and the measurements are based on laser triangulation sensors that operate with a laser diode which projects a visible light spot onto the surface of the measurement target. The sensor weights 100g, the measuring range is 50mm and its resolution is 10 μ m. As the distance between walls is 6,3m an invar steel beam was built and the sensor was fixed in one end, as shown in Figure 11. The readings are transmitted by wiring to an electronic data acquisition, which manages the readings using customized software. Three thermometers based on platinum sensors were installed in the invar beam to allow corrections due to temperature changes. Their results are shown in Figure 12. Displacements measured during one year are shown in Figure 13.

Figure 12: Location of the laser sensor (a) and temperatures measured at the invar beam (b).
