CRACKING BEHAVIOR AND DETERIORATION SUPPRESSION EFFECT OF PROTECTIVE SURFACE COATINGS ON ASR-AFFECTED STRUCTURES

Koji Utsunomiya ^{1*}, Hiroaki Uenakada¹, Kiyoshi Sakiya², Tsutomu Niina², Yukio Adachi²

¹Hanshin Expressway Engineering Company Limited, Osaka, Japan

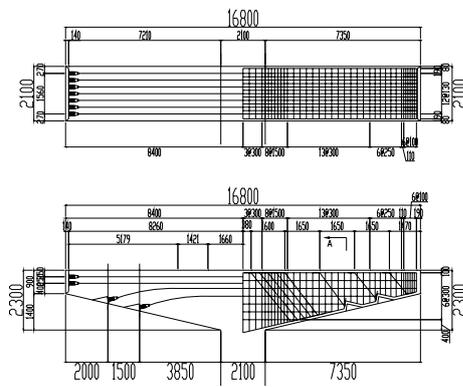
FIGURE 1: Structural drawings of Pier I

A T-shaped prestressed concrete (PC) pier shown in Figure 1 (hereinafter referred to as “Pier I”) and a T-shaped reinforced concrete (RC) pier shown in Figure 2 (hereinafter referred to as “Pier II”) were examined in the present investigation. Piers I and II were built in the same age, completed in 1969 and 1972, respectively. In-house manual of the Hanshin Expressway defines ASR-affected piers as those with a beam containing gel and showing a total crack extension (crack width: 0.3 mm or above for RC piers or 0.2 mm or above for PC piers) of over 100 m [2]. Piers I and II were found to meet this definition and have been handled as ASR-affected piers in maintenance management.
