Deterioration processes of dams affected by concrete swelling reactions. The Portuguese experience in monitoring and rehabilitation

António Lopes Batista (1)

(1) National Laboratory for Civil Engineering (LNEC), Lisbon, Portugal, albatista@lnec.pt

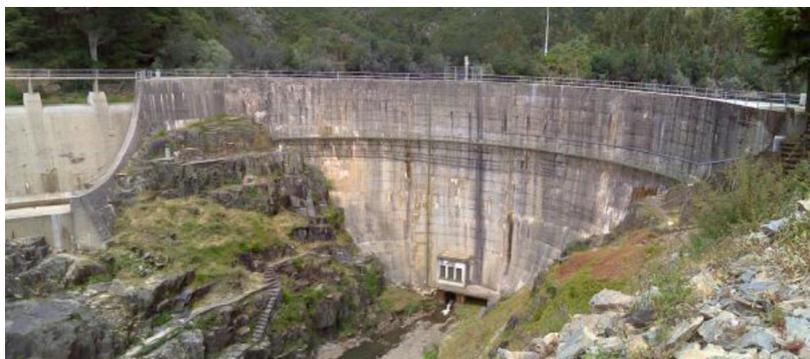
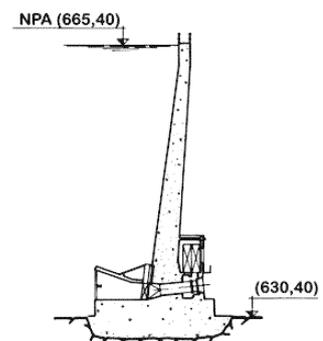
Alto Ceira dam, built in 1949 and deactivated in 2013 (through demolition of its central section), was a slender arch with a height of 36 m (Figure 2.1). The dam was founded on a schistose rock mass. In its construction, concrete produced with quartzite aggregates was used. Since the 1960s, the behavior observed of the dam has been characterized by progressive displacements, vertically upwards and radially towards upstream. The concrete cracking became more accentuated over time, reaching a very advanced stage at the beginning of this century, with leakage through the cracks mainly located in the bearing zones, at mid-height (Figure 2.2).

Figure 2.1: Alto Ceira dam. Downstream view and central cantilever cross-section

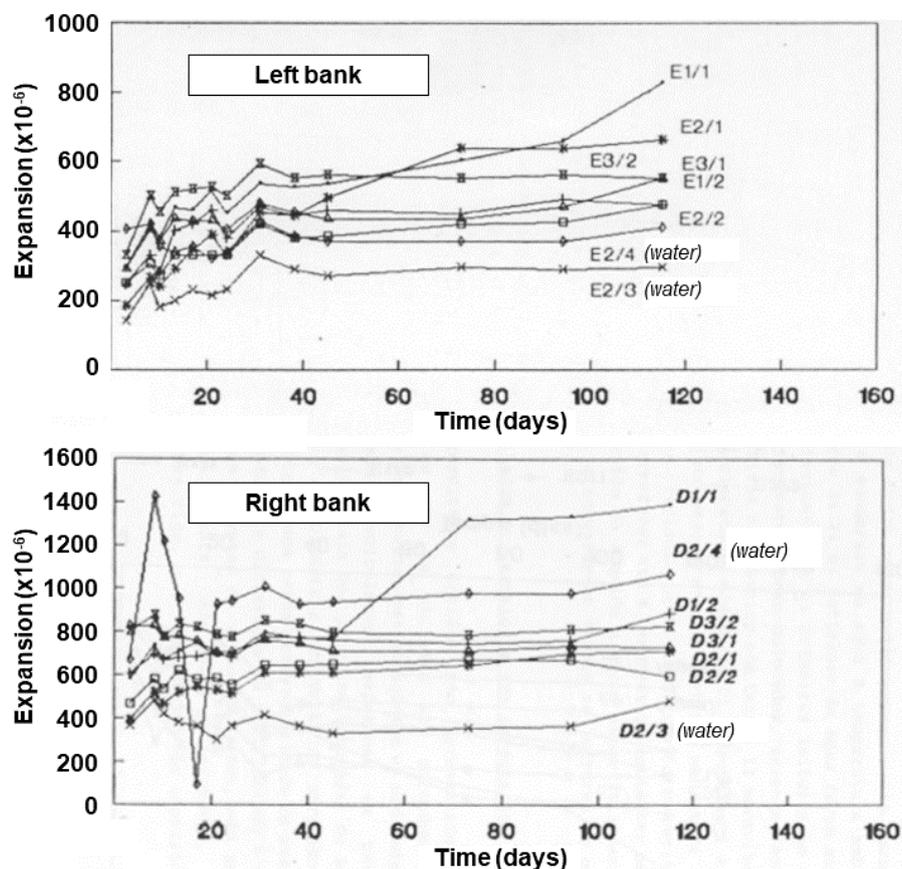
The first laboratory, physical and chemical tests, carried out on concrete samples extracted from the dam's body in 1986 confirmed the seriousness of the deterioration of the concrete and its high remaining potential for expansion [3]. In 1990, a new campaign of sampling and testing of the dam's concrete was carried out. The results of the accelerated expansion tests, carried out by immersing the concrete specimens in a saturated solution of sodium chloride and in distilled water, in an oven at 50°C, are shown in Figure 2.3 [4]. In specimens produced from samples extracted from the left bank, maximum remaining expansions of about 1400×10^{-6} were then obtained.

Figure 2.3: Alto Ceira dam. Main results of the accelerated expansion tests of concrete specimens (extracted in 1990) immersed in a saturated solution of sodium chloride and in distilled water, in an oven at 50°C (adapted from [4])

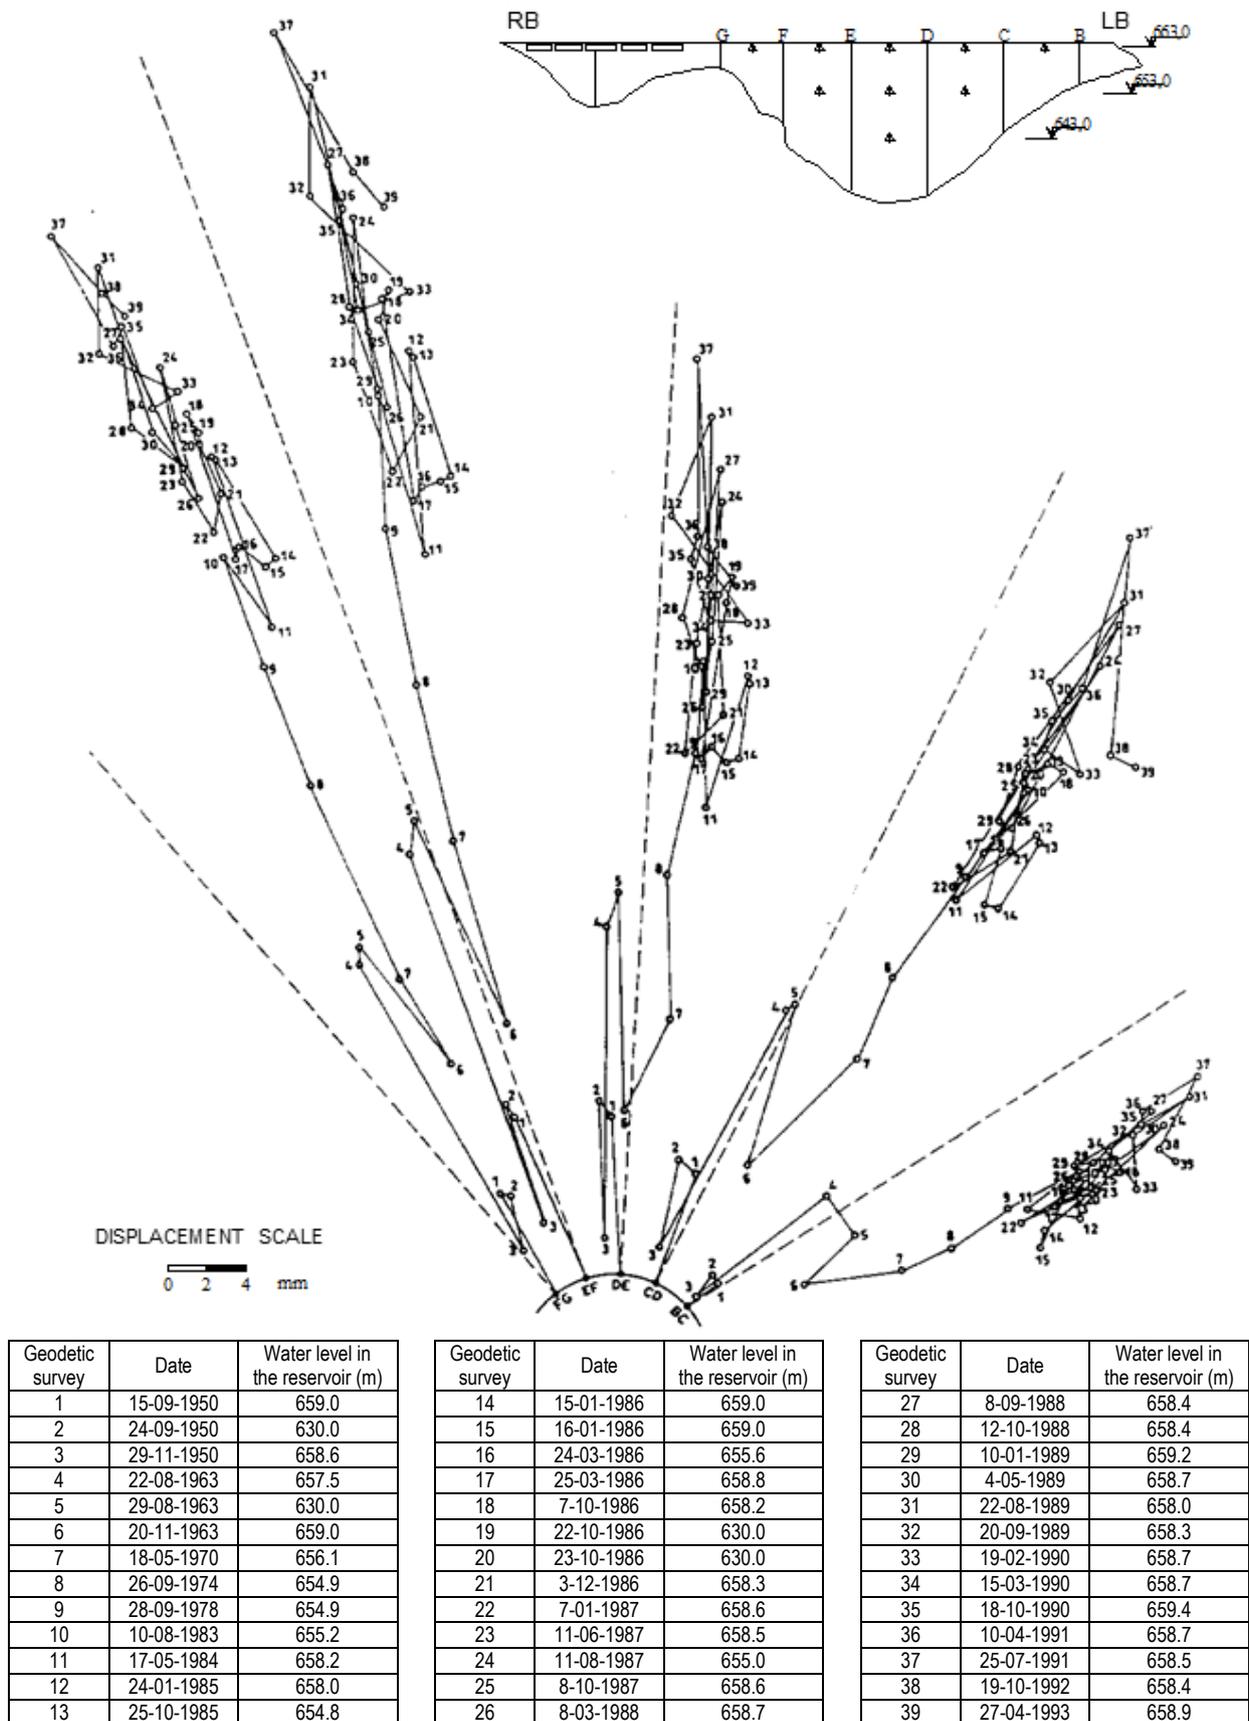
The absolute displacements of the dam were monitored by geodesic methods since the first filling of the reservoir, in 1950. The radial displacements showed, over time, a great progressivity towards upstream. Figure 2.4 shows the evolution of horizontal displacements observed by geodesic methods in the upper targets of the arch (elevation 663.00 m), between 1950 and 1993. Figure 2.5 presents the evolution of these displacements at the point where they had the greatest values (next to the crest of EF block), including a function adjusted to the values observed between 1984 and 2011. The irreversible value of the radial displacement at this point reached, in this period, about 50 mm.

Figure 2.4: Alto Ceira dam. Evolution of the horizontal displacements monitored by geodesic methods in the upper targets of the arch (elevation 663.00 m), between 1950 and 1993 (adapted from [5])

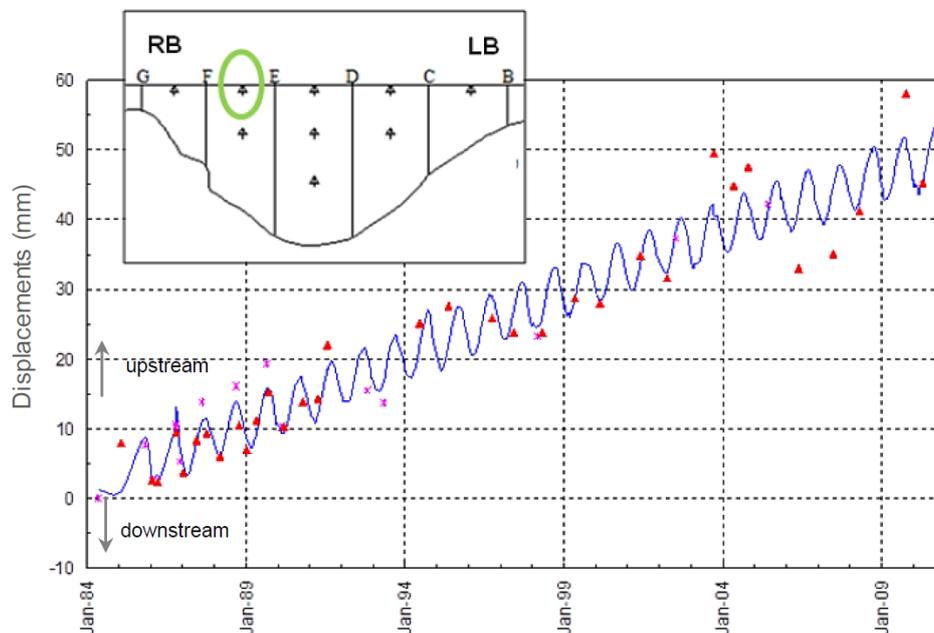
Figure 2.5: Alto Ceira dam. Function adjusted to the radial displacements monitored by geodetic methods in the upper target of the EF block, located near the crest, from 1984 to 2011

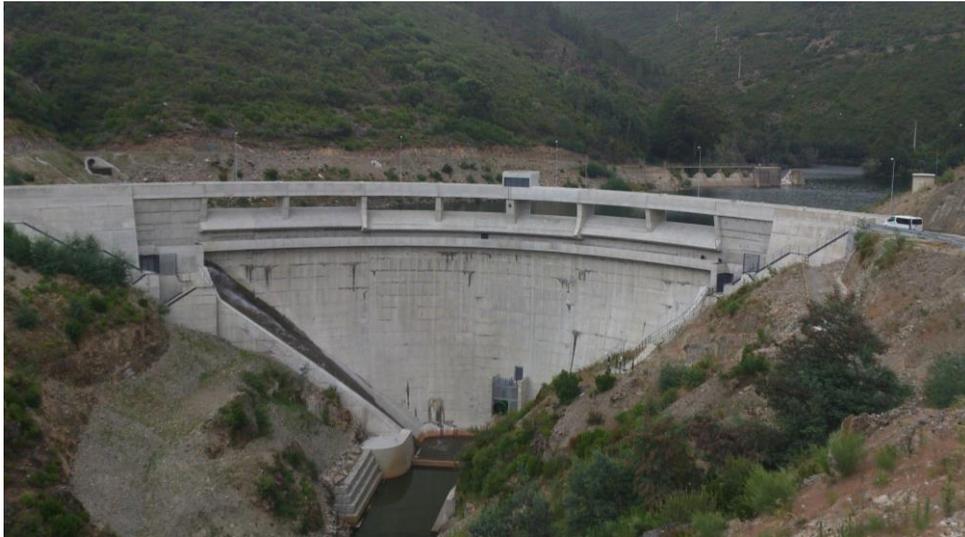
The behavior modelling and structural safety assessment studies of the dam, performed in 1994 [5], based on the finite element method, were supported by a mesh of three-dimensional finite elements of the dam and its mass rock foundation. In 2004, these studies were updated [9] confirming the magnitude of the evolution of the structural degradation predicted about a decade earlier. Given the depth of the main cracks and the progressive evolution of the water leakages in the bearing zones at mid-height, it was recommended to the dam's owner to carry out studies aiming the dam's rehabilitation or even its replacement. Subsequent studies by the owner concluded that the location and the characteristics of the dam, associated with the great magnitude of displacements and opening of cracks, made its rehabilitation impracticable [10]. The owner then proceeded with the design of the new dam, also of the arch type, which was built about 300 m downstream (Figure 2.10), between 2011 and 2013 [11]. The old dam was deactivated through the demolition of the central section of the structure. This is the only case of replacement of a concrete dam, in Portugal, due to structural deterioration.

Figure 2.10: Alto Ceira dam. View of the new dam (called Alto Ceira II dam) and of the old dam (partially demolished), after the first filling of the reservoir, in July 2014

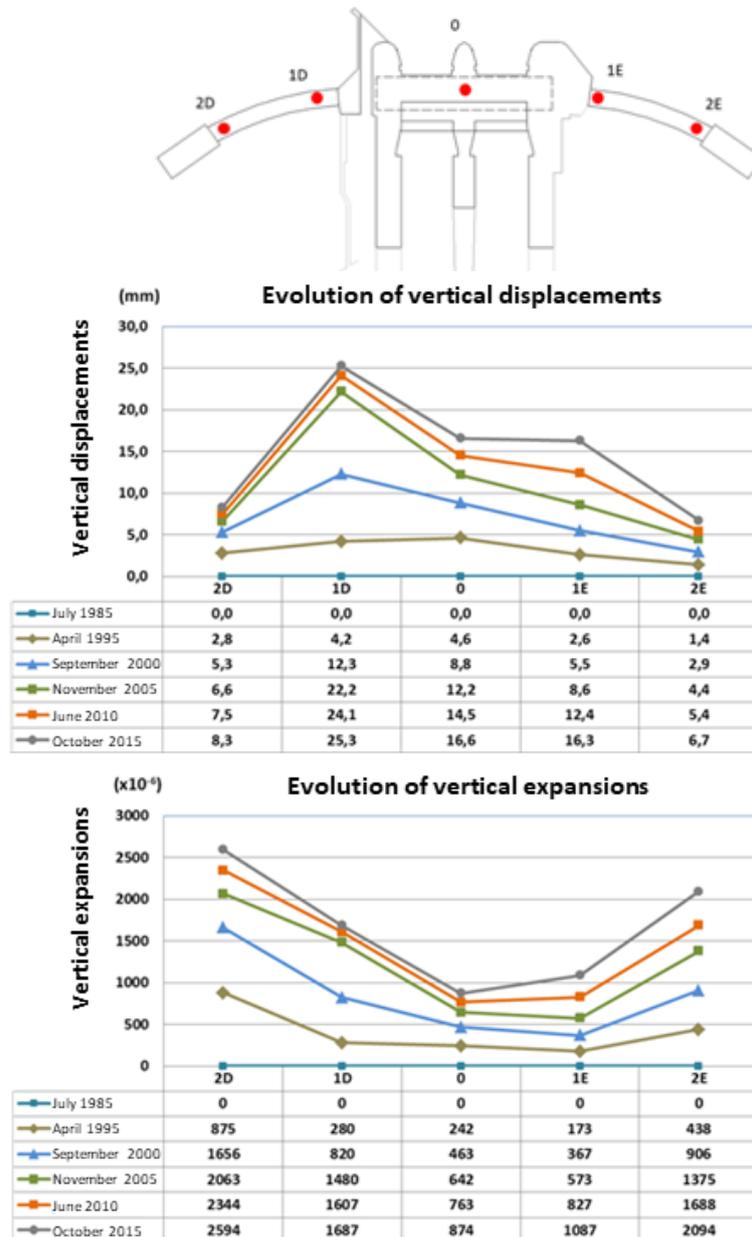
Figure 2.19 summarizes the results of the quantitative analysis of the vertical displacements monitored between 1985 and 2015, as well as the corresponding vertical strains [30]. Between 1985 and 2015 there were very high accumulated strains, on the order of 2140×10^{-6} in the right arch, 1590×10^{-6} in the left arch and 870×10^{-6} in the central buttress.

Figure 2.19: Fagilde dam. Results of the quantitative analysis of the vertical displacements observed at the crest by precision geometric levelling, until 2015, and estimation of the corresponding vertical expansions [30]

Given the concrete degradation, three alternative interventions have been pointed out, namely: i) waterproofing the upstream face and cement grouting of cracks in the arches; ii) the replacement of the two arches; and iii) the replacement of the dam itself. The first two alternatives would require detailed studies to be carried out on the dam's behavior in its new structural condition. However, due to the dam's limited capacity to supply water in the dry season, it is considered advantageous to replace the dam with a new one, located in a suitable section of the river a few hundred meters downstream.

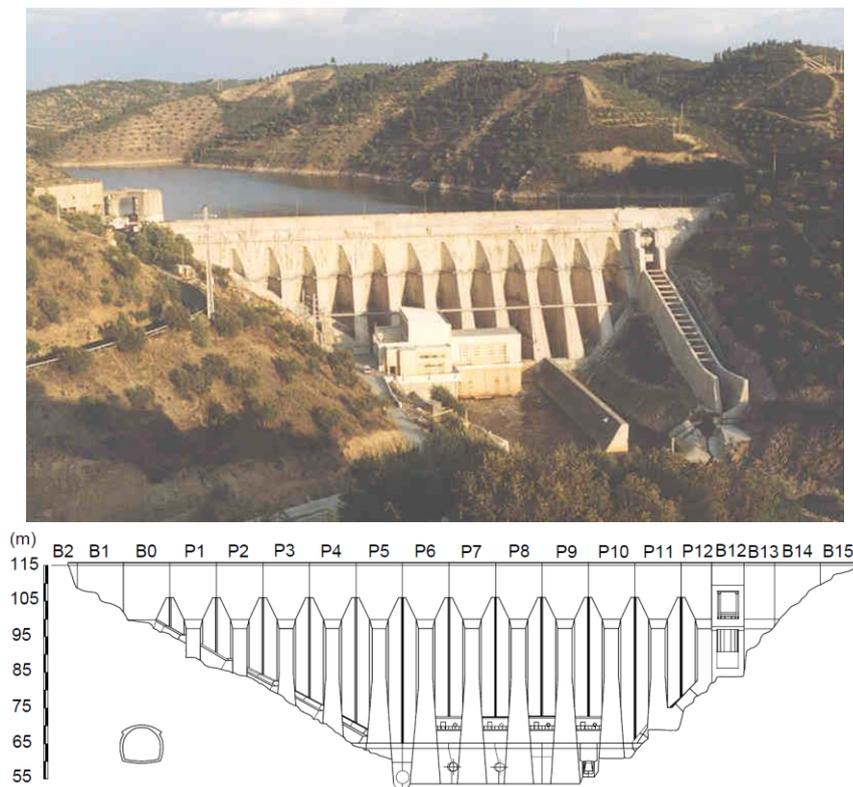
Figure 2.20: Pracana dam. Downstream view and elevation in 1992, after the rehabilitation works

The dam showed an abnormal behavior since it began operating, characterized by progressive displacements, in vertical and upstream-downstream directions, and rapid evolution of generalized cracking. There were significant water seepage through the dam body, essentially through horizontal cracks in concreting joints, with thick calcium carbonate deposits (Figure 2.21).

The interventions in the dam included: i) the general treatment of the concrete, for its regeneration, through the injection of cracks with epoxy resins and cement grout; ii) the installation of an impermeable membrane on the upstream face, including the construction of a foundation plinth at the upstream toe; iii) the construction of two concrete struts downstream, to lock the webs of the buttresses, one close to the downstream toe and the other in an intermediate position; iv) the consolidation of the foundation and the execution of new waterproofing and drainage curtains, the waterproofing curtain being done from the top of the new upstream plinth; and v) the recovery and reinforcement of the monitoring system. A frontal auxiliary spillway was also built on the left bank, to provide the dam with sufficient discharge capacity. The power plant was updated, which included the construction of the water intake for a new generation unit.

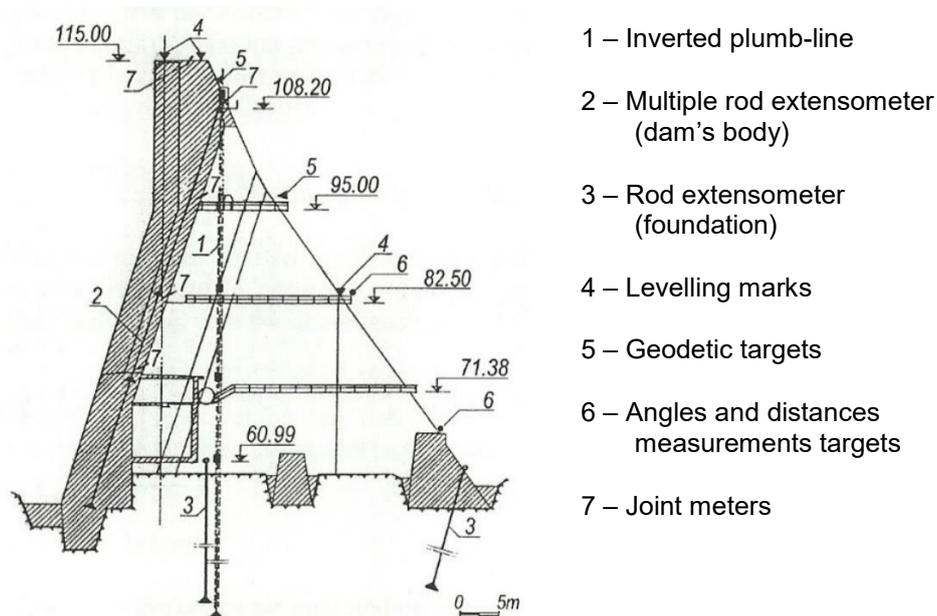
Figure 2.25: Pracana dam. General scheme of the new monitoring instruments installed in 1992 to measure displacements of the dam and its foundation [35]

The monitoring system was rehabilitated and reinforced, to better monitor the structural behavior and the evolution of the expansion process (Figure 2.25). The following new instruments were installed: i) multiple rod extensometers, along the head of five buttresses (P1, P4, P6, P9 and P12); ii) two rod extensometers at the foundation of each buttress, one near the head and one at the downstream toe; iii) inverted plumb-lines in five buttresses (P1, P4, P6, P9 and P12), with suspension close to the crest and deep fixation in the rock mass foundation; iv) thermometers in the body of two buttresses (P5 and P7); and v) new jointmeters to control the opening/closing movements between buttress heads. The geodetic monitoring system was also revised and improved.

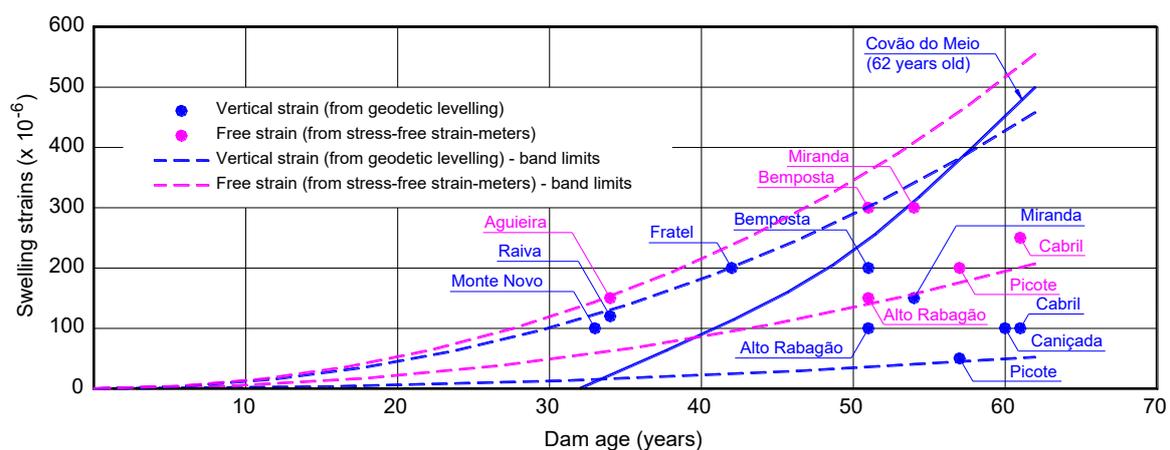
There are 14 dams affected by swelling reactions, usually of the ASR type, in which granitic aggregates, some highly deformed and containing subgrained quartz, were used in the concrete mix: Alto Rabagão, Caniçada and Penide, in the northwest of the country; Miranda, Picote and Bemposta (strained granite), in the international section of Douro river; Aguieira, Raiva, Cabril, Bouçã, Covão do Meio and Fratel, in the central part of the country; and Monte Novo and Caia, south of Tagus river. Those dams were built between 1942 and 1982, exhibiting a behavior characterized by very low expansion rates during the first 20 to 30 years, but then showing increasing rates over time. Table 3.3 shows the average values, in 2020, of the free strains observed in the stress-free strain-meters and the vertical strains estimated from the results of the crest levelling, as well as the respective evolution rates in the last 10 years. Figure 3.1 shows the evolution, up to 2015, of the aforementioned strains, for some of these dams [39]. This type of behavior is related to the slow reactivity of aggregates with undeformed crystalline silica [40], so those that were built with concrete produced with (strained) quartzite aggregates developed expansive reactions very early on, while in dams where granitic aggregates were used the initial dormant period of this phenomenon reached more than 20 to 30 years.

Figure 3.1: Portuguese dams built with granite aggregates and affected by the ASR. Evolution until 2015 of the average values of the monitored free strains by stress-free Carlson strain-meters and strains obtained from geodetic levelling, in terms of the dam age [39]
