Diagnosis and structural recuperation of foundation blocks under attack by AAR in a Brazilian building

Keywords: AAR; blocks; concrete; foundations; pathology

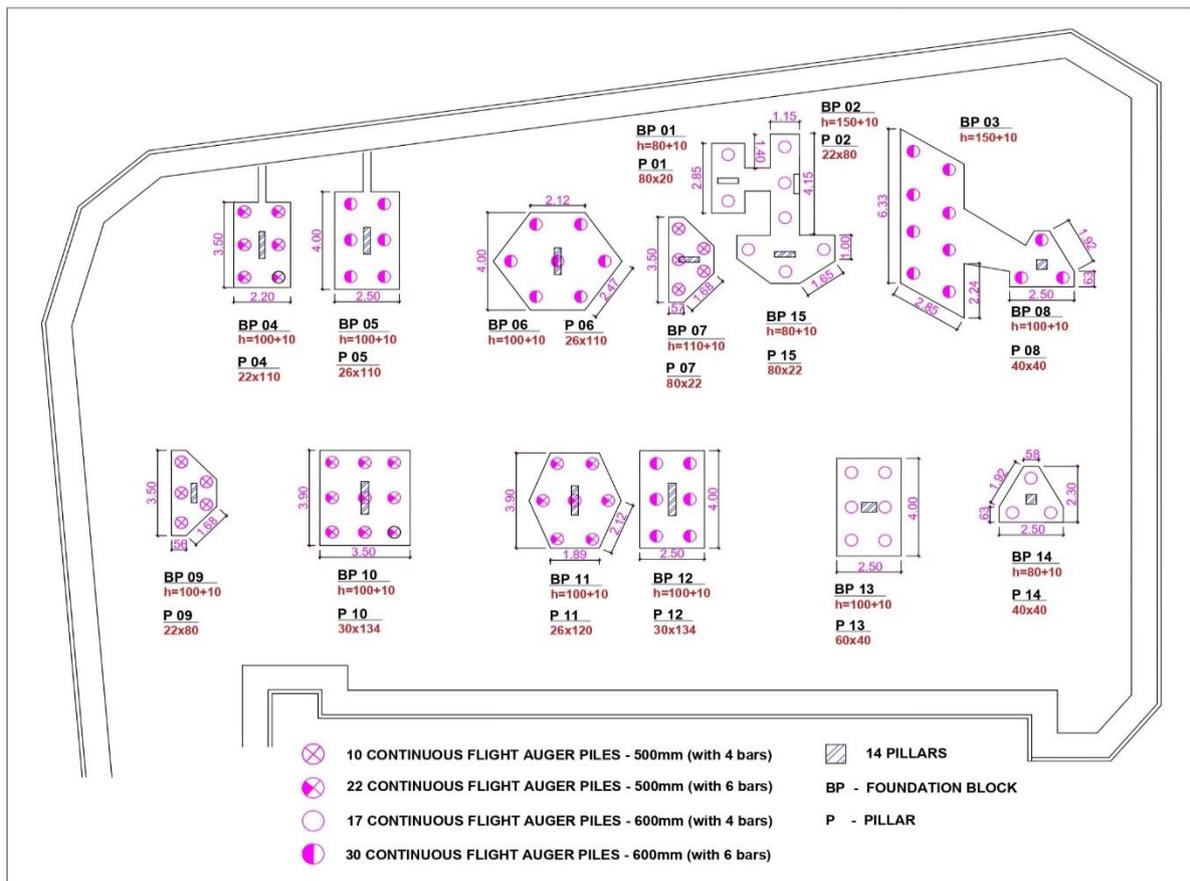
Figure 2.1: Outline of the building's 15 foundation blocks

The building described in this article was built in 2006. In 2018, it was diagnosed with AAR and the foundation blocks were recuperated. It is a class A residential building, with one apartment per floor and a total of 12 floors. It is located on the coast in the city of Recife, Pernambuco in an aggressive environment (class III), according to NBR 6118/2014 [3]. The building has 15 foundation blocks that are shown in Figure 2.1.
