Structural behavior of Pracana dam 30 years after rehabilitation due to severe ISR-ASR damage

Keywords: Pracana dam; ISR-ASR damage; rehabilitation; monitoring; structural condition

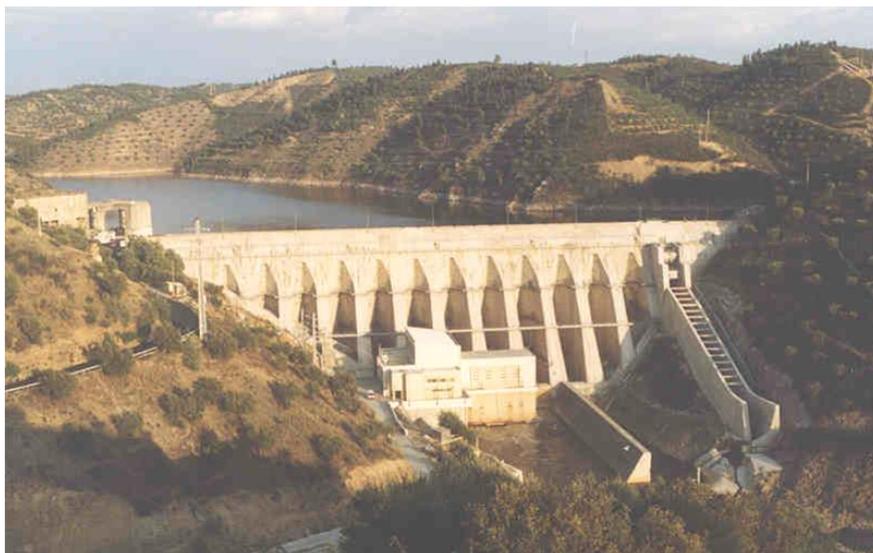
Figure 2.1: Downstream view of Pracana dam in 1992, after the rehabilitation works

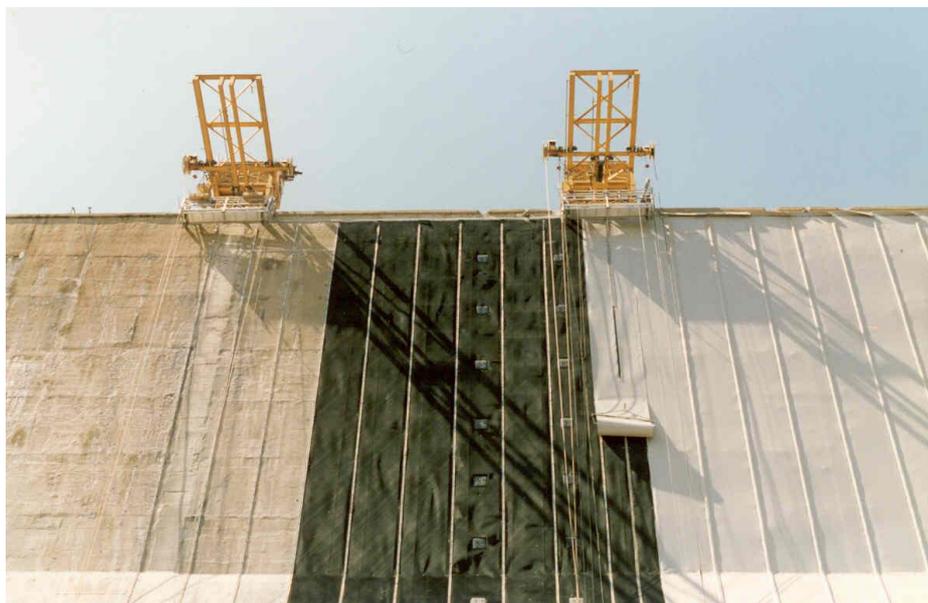
The waterproofing system of the upstream surface consists of a non-adherent synthetic membrane in order to prevent the contact of the reservoir water with the concrete and, thus, stop the water supply to the ASR and simultaneously prevent the uplift developing in existent cracks of the buttresses heads (Figure 2.2). The system selected by EDP is a Carpi patented system consisting of an impervious flexible PVC geomembrane 2.5 mm thick, heat-coupled during extrusion to a non-woven, needle-punched 500 g/m² geotextile. The PVC geomembrane, which was applied over a HDPE geonet with drainage purpose, fulfil many requirements, namely: i) low permeability ($k \approx 10^{-12}$ cm/s); ii) high flexibility, that enables installation also on not smooth faces; iii) resistance to punching, tearing and impact; iv) resistance to high temperature gradients and to freeze-thaw cycles; v) resistance to stresses induced by large relative movements, such as movements induced by earthquakes; and vi) expected long durability.

Figure 2.2: Stage of installation of the upstream impervious membrane

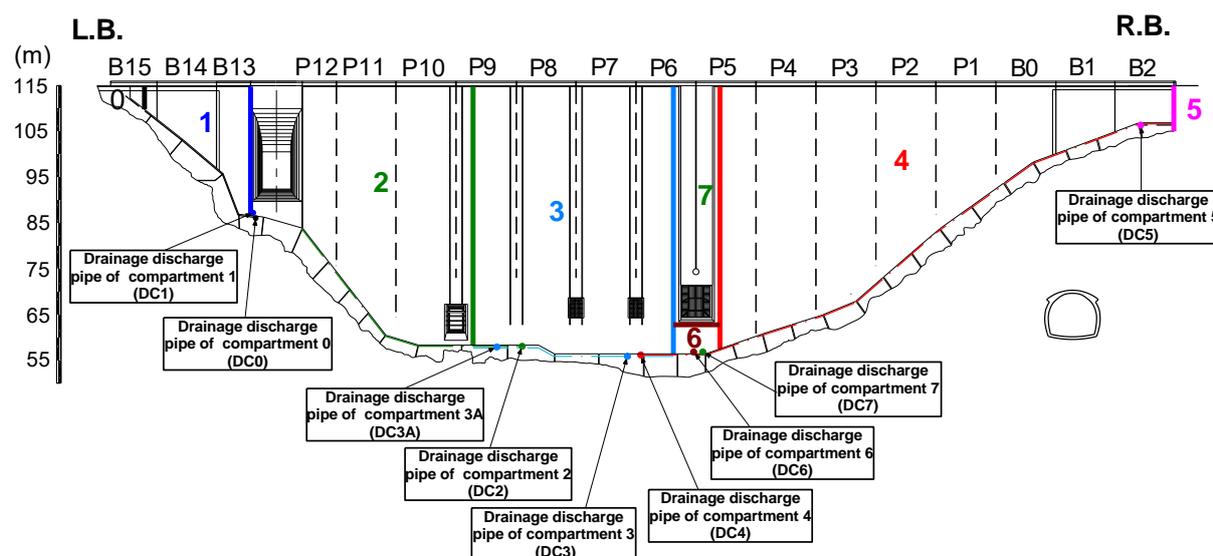
Figure 3.6: Drainage system of geomembrane from the eight independent compartments, with location of the drainage discharge pipes of each compartment.

Figure 3.7 shows the discharges evolution in the different geomembrane drainage compartments. As can be seen, in the compartments 1 and 4, where several membrane ruptures have occurred, the discharges were higher. In compartment 1, where the most significant ruptures occurred in 2011, 2018

and very recently (December 2019), the discharges have reached maximum values of about 75 l/min. The discharges from compartment 4 had a first increase between 2000 and 2003, with maximum values of about 65 l/min, but since 2011 to 2016 the increase was higher, reaching a maximum value of 209 l/min in April 2016. In November 2016 there was a geomembrane repair intervention that drastically reduced those discharges. However, in 2019 new rips appear to have occurred.

It should be noted that the measured values of the water level in the compartments have been systematically zero, which indicates there is no accumulated water between the geomembrane and the upstream surface of the dam, and that the compartment drains have an appropriate discharge capacity. Nevertheless, preventive actions must be taken to remove the solid material that floats in the reservoir, particularly in flooding periods, to avoid its impact on the geomembrane, which has been the cause of the rips that have occurred.

Mitigation of the swelling process proportionate by the rehabilitation works is undoubtedly a positive result to which the geomembrane installation on the upstream surface has given an important contribution. However, the long period with the reservoir emptied and the dam weather conditions, relatively warm and dry, may have also contributed to reduce the speed of the swelling process. In view of the results obtained, it is considered that the geomembrane continues to exhibit a good performance and functionality, preventing the upstream water access to the dam body. After 28 years of natural exposure, the evaluation of its physical condition must be checked frequently, which is done by carrying out visual inspections, in order to detect rips usually caused by floating woody material, especially after the occurrence of important floods. These rips are usually repaired in the following dry season.
