ALKALI-AGGREGATE REACTION IN SOUTHERN NORWAY

V.Jensen & S.W.Danielsen

SINTEF FCB the Cement and Concrete Research Institute, Trondheim Norway

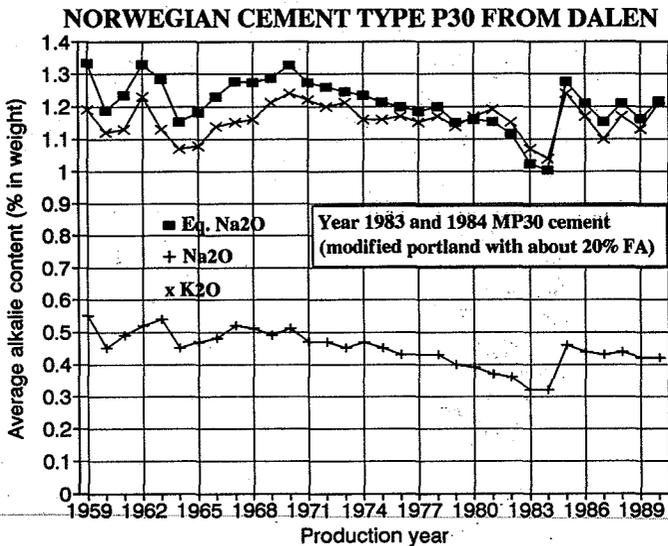
Figure 1 Annual average alkali content in P30 cements produced at Dalen cement factory in the period 1959-1990 - Sjøler (4)

Figure 1 shows the annual average alkali content in P30 cements produced at Dalen cement factory in the period 1959-1990 - Søpler (4). Figure 1 depicts the average alkali content (% in weight) of K_2O , Na₂O and eq. Na₂O. The analysis results from 1983 and 1984 are reported as MP30 cement. Note the high alkali content in P30 cements produced in Dalen cement factory.
