Assessment of Severely ASR Damaged Bridges: From Diagnosis to Structural Effects

This paper presents an overview and discussion of the Danish experiences with assessment of the residual load carrying capacity of severely non-shear reinforced ASR damaged bridges. The discussion is supported by experimental data acquired from large scale in-situ tests of three severely ASR deteriorated bridges. The influence of ASR cracking on the mechanical properties of concrete and the pre-stress effect on the reinforcement due to ASR expansion are discussed.

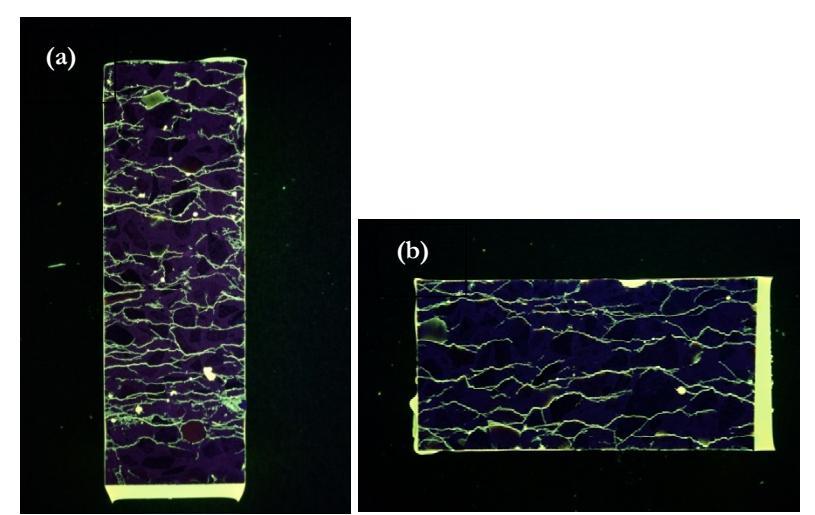
FIGURE 1: Fluorescent impregnated concrete cores drilled vertically (a) and horizontally (b) from bridge no. 3. The crack pattern is typical for all the three severe ASR damaged bridge decks. However the amount of cracks varies between the bridge decks and areas within the same bridge deck. The ASR induced cracks are orientated parallel to the reinforcement bars. The ASR expansion is not restricted in the vertical direction, since the bridge slabs are not provided with vertical reinforcement.

From 2012 to date three severely ASR deteriorated bridge decks were examined and full-scale tested. The bridge decks in all the investigated bridges were only provided with two layers of horizontal reinforcement but not provided with vertical reinforcement. It is well-known that crack formation due to ASR strongly depends on the boundary conditions and on reinforcement configuration of the structures. Since all the bridge decks were not provided with vertical reinforcement, the cracks were mainly orientated parallel to the horizontal reinforcement. Figure 1 shows the typical crack formation in the bridge decks. The fluorescent impregnated concrete cores in Figure 1 are drilled both vertically and horizontally from the bridge deck in bridge no. 3.

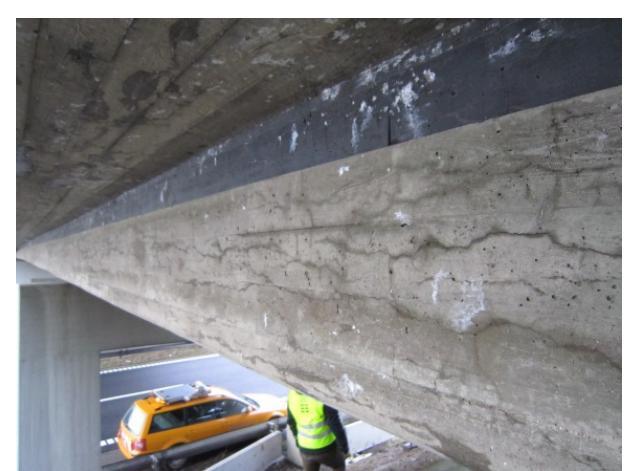
FIGURE 2: Bridge no. 1 - Fine longitudinal wet cracks with white precipitations in the bridge deck and in the prestressed main beam.

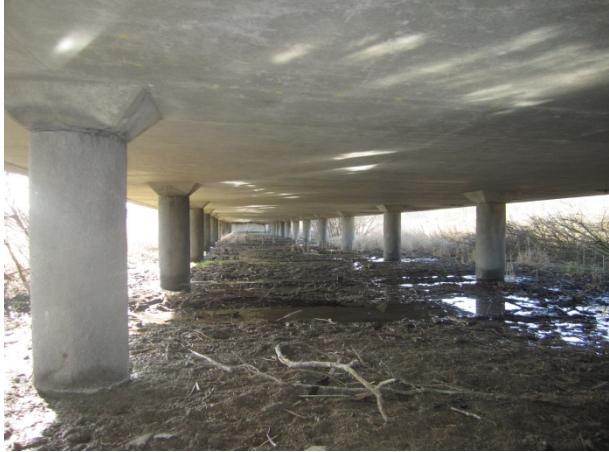
FIGURE 3: Bridge no. 3 – Overview from beneath of the pile supported reinforced bridge deck.

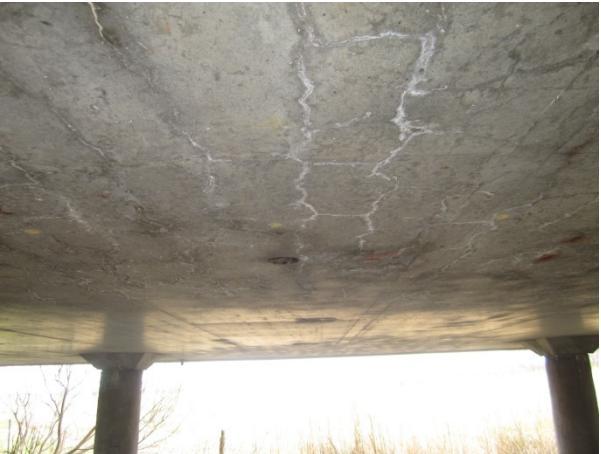
FIGURE 4: Bridge no. 3 – Longitudinal and transverse ASR induced cracks with white precipitations from beneath the bridge deck. Locally there is sign of reinforcement corrosion.

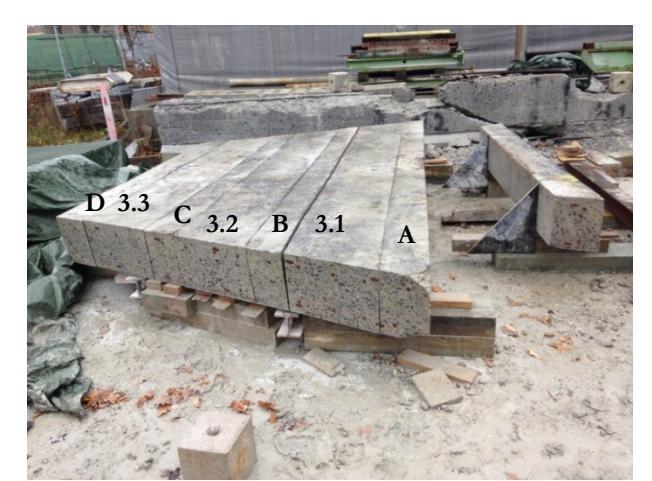
FIGURE 5: Bridge no. 3 - Trapezoidal slabs cut into beams at the Technical University of Denmark. Beam no. 3.1, 3.2 and 3.3 were loaded until failure in a three point bending test setup. Concrete cores were drilled from beam A, B, C and D after strain gage measurements of the ASR induced tensile strain in the reinforcement bars.

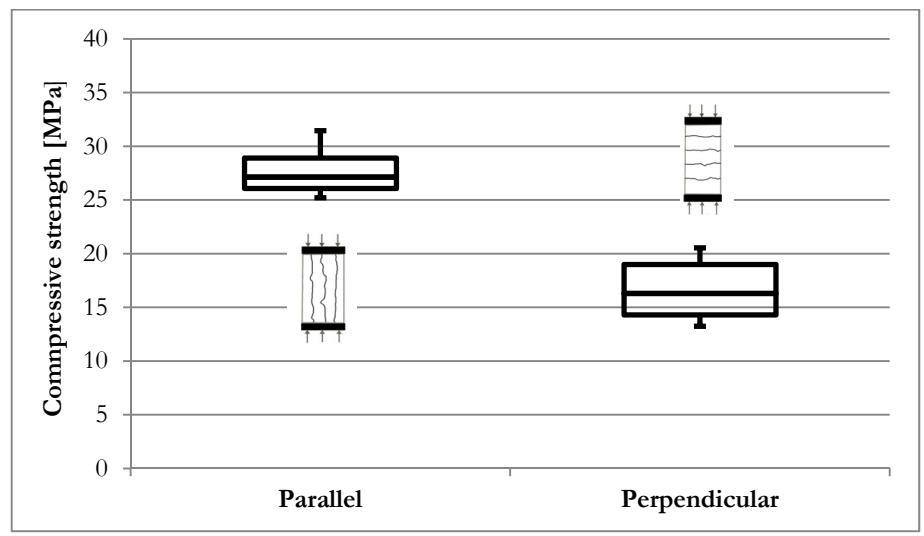
FIGURE 6: Measured compressive strength of concrete cores with cracks parallel and perpendicular to the load direction. The results are presented graphically as a box and whisker plot. The bottom and top of the boxes represents the first and third quartiles and the line inside the boxes represents the second quartile (the median). The top and bottom of the whiskers represents the measured maximum and minimum compressive strengths, respectively.

Figure 6 shows the influence of crack orientation on the converted compressive concrete strength of concrete cores drilled from bridge no. 3. The concrete cores are all drilled from the same trapezoidal slab in the same area. The converted compressive concrete strengths are represented graphically as a boxplot. Figure 6 shows clearly that the strength of the concrete cores with ASR cracks primarily orientated parallel (horizontally drilled) to the load direction are considerably higher than the strength of concrete cores with ASR cracks perpendicular (vertically drilled) to the load

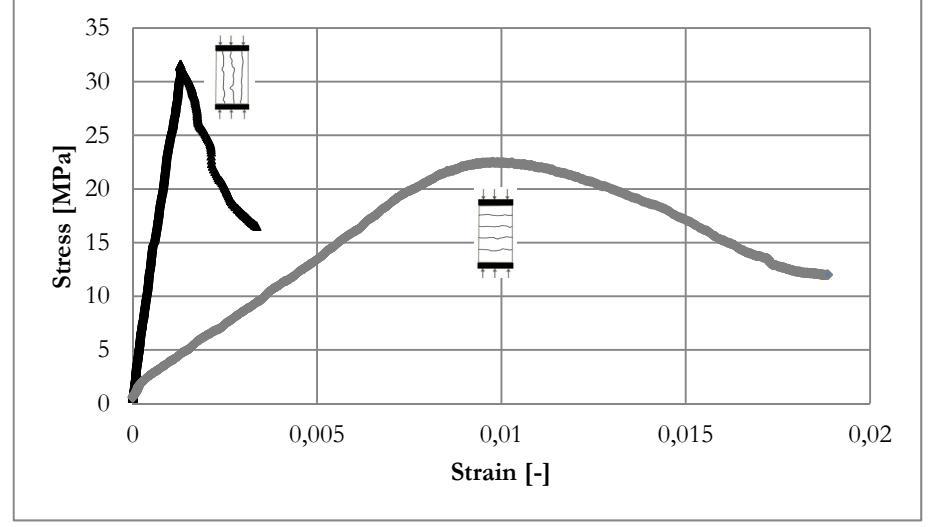
FIGURE 7: Stress-strain relationship for drilled concrete cores with ASR cracks orientated parallel and perpendicular to the load direction. The shapes of the curves are representative for the concrete cores tested from all three examined bridge slabs.

The modulus of elasticity, Young's modulus, for the ASR deteriorated concrete cores also depends on the crack orientation within the tested concrete cores. Figure 7 shows the stress-strain relationship for concrete cores with ASR cracks parallel and perpendicular to the load direction. The Figure shows that the modulus of elasticity of the concrete core with ASR cracks parallel to the load direction is 26.1 GPa and of the concrete core with ASR cracks perpendicular to the load direction is 2.5 GPa. The reduction in modulus of elasticity is significant for concrete cores with ASR cracks perpendicular to the load direction, which can be attributed to the compaction of the ASR cracks. To the authors' experience the considerable reduction in elastic modulus of concrete cores cannot directly be related to the possible reduction in the bending stiffness of ASR cracked cores and the bending stiffness of ASR cracked reinforced concrete beams may be attributed to restraint conditions of concrete in the reinforced beams and the ASR induced pre-stress in the reinforcement.

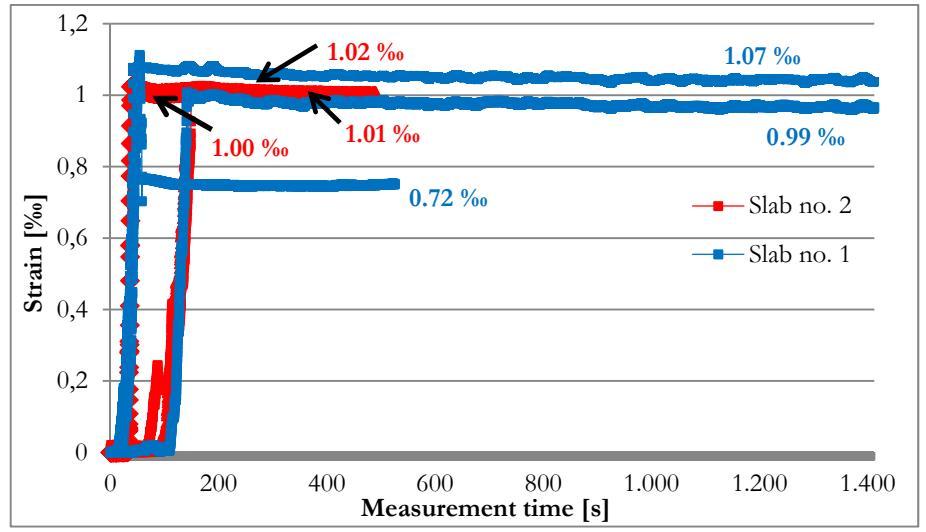
FIGURE 8: Measured ASR induced tensile strain in reinforcement bars as function of time. 3 strain gage measurements are performed on the longitudinal reinforcement bars on beams cut from slab no. 1 and slab no. 2, respectively.

Figure 8 shows 6 strain gage measurements attained from beams cut from two different trapezoidal slabs from bridge no. 3. The Figure shows a rapid increment from zero strain when the reinforcement bar was cut, where after increases in the slope are seen and then a stabilization of the curves. This steep increasing part of the curves corresponds to the cutting of the reinforcement bars and thereby the contraction of them. The stabilized parts of the curves correspond to the measured tensile strain, i.e. pre-stress action, in the reinforcement bars. Figure 8 shows that the measured strains in the reinforcement bars are similar on approximately 1.0 % in beams from both trapezoidal slabs. The value of 0.72 % is lower than the other measurements which is explained by a much lower anchorage length (0.3 m) of the reinforcement bar compared to the anchorage length of the other reinforcement bars (>1.0 m).

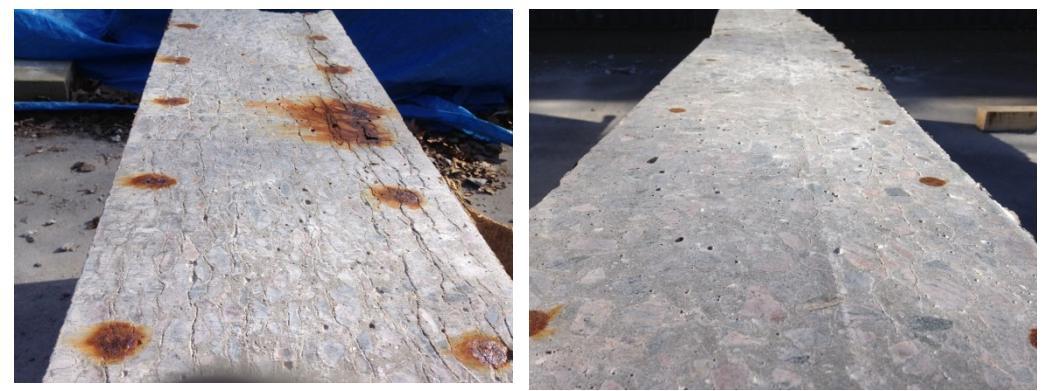
FIGURE 9: Surface condition of concrete beam in slab no. 1 (left) and slab no. 2 (right). Slab no. 1 has considerably more ASR induced cracks than slab no. 2. There are locally signs of surface corrosion on transverse reinforcement bars in slab no. 1, but no sign of corrosion in the longitudinal reinforcement bars where the strain gage measurements are conducted.

A detailed visual inspection has been conducted on all beams and elements cut from the three ASR damaged bridge decks. Moreover several examinations of thin sections have been conducted. From these examinations and inspections the authors can in general neglect the possibilities for other contributing factors to cause cracking. The contributing factors could be fatigue of concrete slab by repeated active loading by traffic, freezing and thawing and steel corrosion due to chloride intrusion. However, locally in some of the beams cut from bridge no. 3 signs of steel corrosion due to chloride intrusion have been observed, see Figure 9.

Figure 9 shows the visual condition and crack formation on beams cut from the two trapezoidal slabs. The Figure shows that the beams cut from slab no. 2 contain remarkable fewer ASR cracks than beams cut from slab no. 1. The compressive strength of cores drilled from the two slabs is also different. In average the compressive strength is 15 MPa lower for slab no. 1 compared to slab no. 2 for both crack orientations. These results question how the pre-stress in the reinforcement develops as a function of ASR expansion and crack formation. Apparently, the above mentioned results show that the ASR induced pre-stress in the reinforcement may be achieved just as the first ASR cracks and expansion develops in the concrete. The ASR induced pre-stress action in the reinforcement may rapidly achieve a constant level even if further expansion and crack formation occur in the concrete.

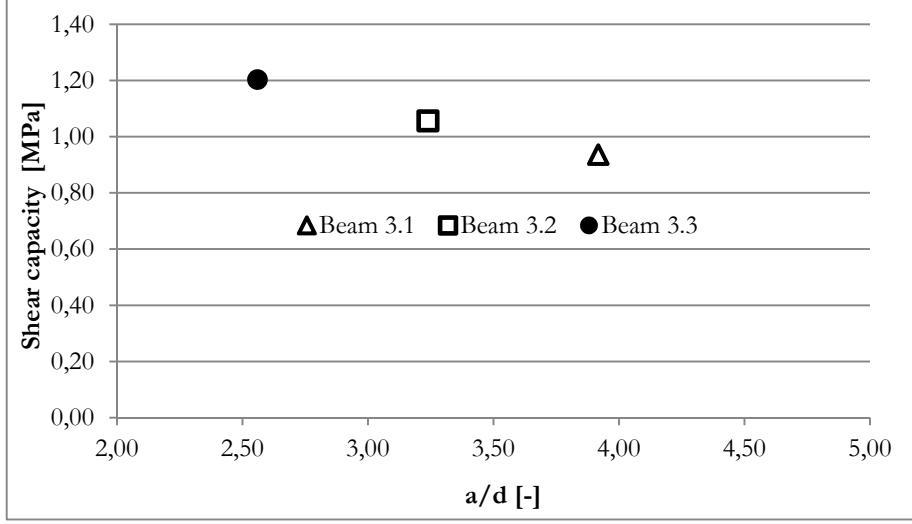
FIGURE 10: Tested shear capacity as function of shear span to effective depth ratio, a/d, from beam no. 3.1, 3.2 and 3.3. The presented beams are cut from the same trapezoidal slab.

The shear test results for the three beams 3.1, 3.2 and 3.3 are shown in Figure 10. The Figure shows a linearly decrease of the shear capacity as function of the shear span to effective depth ratio, a/d. The high shear capacity at a small shear span to effective depth ratio may by explained by the effect of arching action.
