ALKALI SILICA REACTION IN CONCRETE WITH GRANITE -LABORATORY TESTS AND REAL SERVICE CONDITIONS

Kai Fischer^{1*}, Liudvikas Urbonas, Detlef Heinz

¹Centre for Building Materials, Technische Universität München, Munich, <u>GERMANY</u>

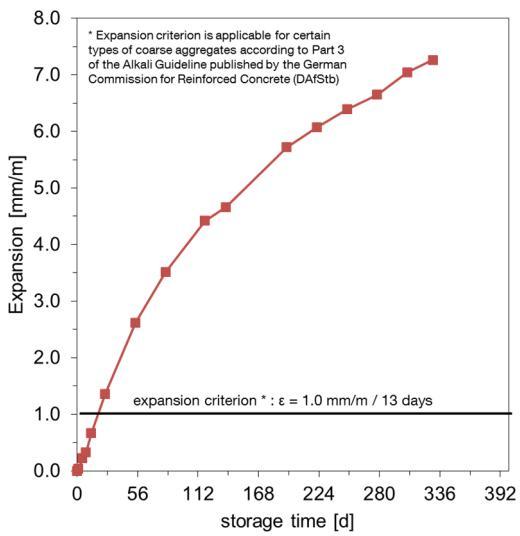
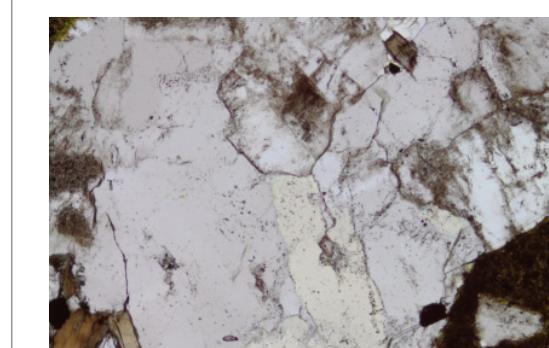
FIGURE 1: Expansion of the of the mortar prisms with granite after a storage of one year in 1 M NaOH solution at 80 °C (left); Photomicrograph of the microstructure of the granite in mortar before exposure to the NaOH solution; PPL (right).

The exposure of the mortar prisms with granite to 1 M NaOH solution at 80 °C resulted in an expansion of 7.26 mm/m after 330 days. The development of the mortar microstructure regarding ASR in the granite grains is described below. As expected, no signs of damage were found in the thin sections of the mortar prisms before solution storage (Figure 1). After 28 days storage in the 1 M NaOH solution, the specimens exhibited an average expansion of 1.36 mm/m. Pronounced changes were observed in the aggregate grains. As shown in Figure 2 there is a significant amount of microcracks within the granite grains which are systematically located along grain boundaries between single quartz crystals. It is well-known that grain boundaries are preferred pathways for the permeation of the pore solution into the grain [8, 6]. The examination with UV illumination illustrates that up to this period of exposure the microcracks are limited to the aggregate components and do not continue into the surrounding hardened cement paste matrix. Moreover, no alkali-silica gel was found in microcracks. A few air voids were filled with alkali-silica gel. After 330 days of exposure an intensive damage pattern caused by ASR was found in the specimens. Dissolution of quartz along the grain boundaries was observed. Figure 3 shows that dissolution structures and associated cracks are concentrated in the quartz. However, a small amount of cracking was also observed within feldspar (Figure 4). Furthermore, the mortar is characterized by a large amount of alkali-silica gel and cracks running through the aggregate and the cement paste matrix (Figure 4). Alkali-silica gel is typical

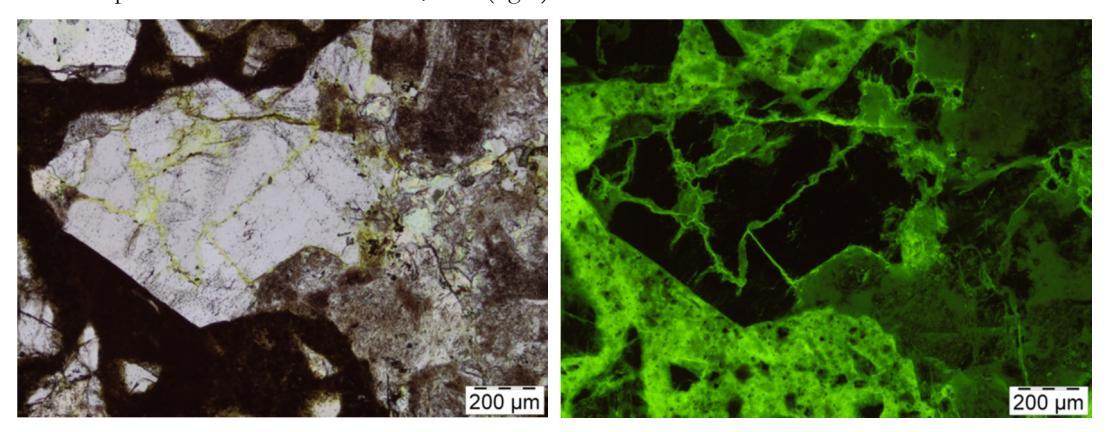
FIGURE 2: Photomicrograph of the microstructure of granite after 28 days in NaOH solution at 80 °C with a crack formation along crystal boundaries; PPL (left); UV light illumination (right).

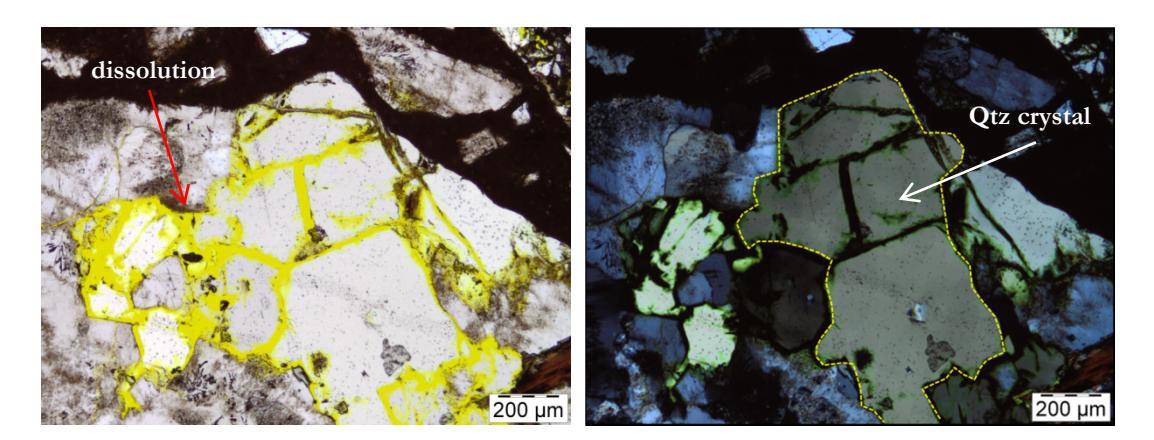
FIGURE 3: Photomicrograph of the microstructure of granite after one year in NaOH solution at 80 °C with a crack formation and dissolution along crystal boundaries and within single quartz crystals; PPL (left); XPL (right).

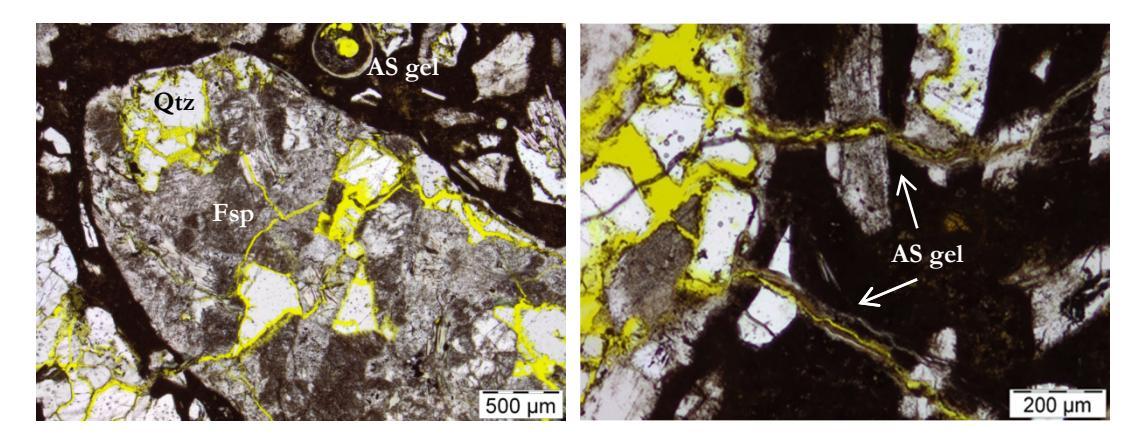
FIGURE 4: Photomicrograph of the microstructure of granite after one year in NaOH solution at 80 °C with dominated signs of damage in quartz crystals (left) and the formation alkali-silica gel (AS gel) in cracks right; PPL.

located in air voids and in cracks at the transition zone between grains and cement paste. A systematic formation of alkali-silica gel in the inner parts of granite grains, as for example observed by Velasco-Torres et al. [6] in real service concrete damaged by ASR, was not found.

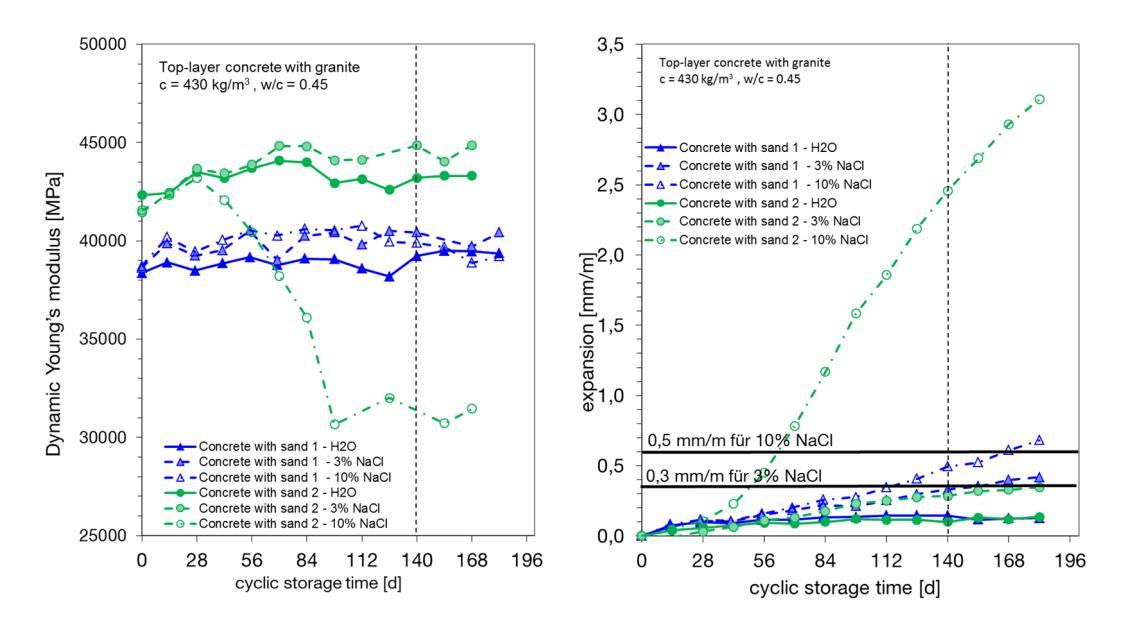
FIGURE 5: Development of the dynamic Young's modulus und expansion of concrete with sand 1 and sand 2 in the 60 °C concrete performance test with external supply of alkalis.

The results of the 60 °C concrete performance test with external supply of alkalis for the granite concretes with different sands are summarized in Figure 5 below. It is obvious that the storage in deionized water caused no significant expansion and changes to the dynamic Young's modulus. The exposure to a 3 % NaCl solution led in both concretes to similar expansion values after 140 days, 0.28 and 0.33 mm/m for the concrete with sand 2 and the concrete with sand 1, respectively. Accordingly, the concrete expansions are in the range of the 0.30 mm/m threshold after 10 cycles of exposure. A distinctive discrepancy of the expansion behaviour was observed for the 10 % NaCl solution. While the concrete with sand 1 showed a final expansion of 0.49 mm/m after 140 days, the expansion of the concrete with sand 2 reached a value of 2.46 m/mm. The specimens with sand 2 exhibited a high expansion increase after only 42 days. The simultaneous decrease of the dynamic Young's modulus indicates the beginning of a damaging ASR at this storage time. The different development of expansion and the dynamic Young's modulus for the two concretes agrees with the results of polarization microscopy. This is mainly due to the different sands. Numerous reactive components especially siliceous limestone, chert and microcrystalline quartz - of the concrete with sand 2 are characterized by ASR (Figure 6). Originating in the sand grains, the cracks systematically run into the surrounded cement paste matrix sometimes reaching the concrete surface. In contrast, the specimens with sand 1 show slight indications of ASR caused by components of the sand. In both concretes, granitic grains show an occasional and not systematic crack orientation. The formation of alkali-silica gel was not observed in these cracks. Accordingly, the association with ASR caused by granitic components was not detectable after 10 cycles of exposure. Further exposure of the concretes to the 60 °C concrete performance test with external supply of alkalis should provide more precise conclusions on the crack development in granitic aggregate related to ASR.

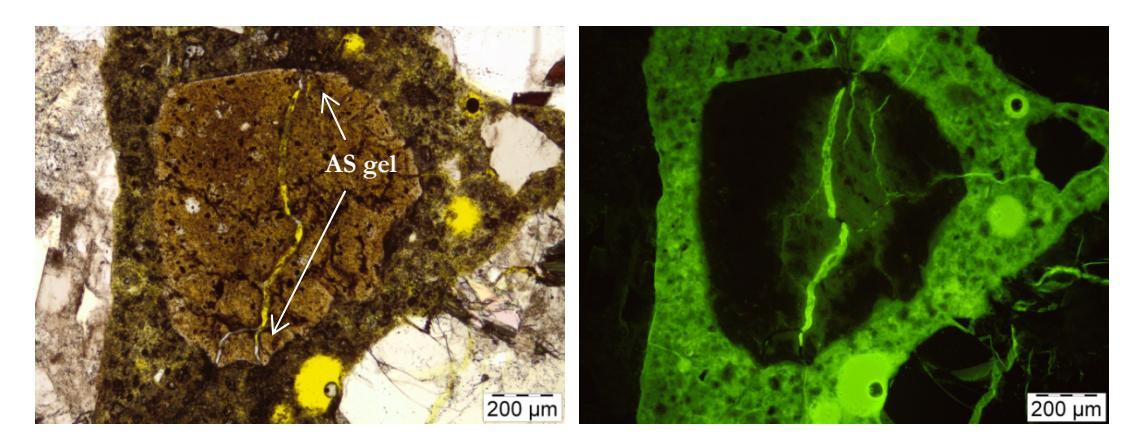
FIGURE 6: Cracked chert grain with the formation of alkali-silica gel at the transition zone between grain and the surrounded hardened cement paste in the concrete with granite and sand after 10 cycles of exposure in the concrete performance test with a 10 % NaCl solution; PPL (left); UV light illumination (right).

The specimens exposed to de-ionized water and a 3 % NaCl showed no microscopic indications of ASR. An effect of the NaCl concentration of the storage solution with regard to damage development is apparent in the concrete with sand 2. Obviously the increase from 3 wt. % to 10 wt. % NaCl in the storage solution leads to a significant increase in ASR in many of the reactive components of sand 2. Such a distinct effect in the 60 °C concrete performance test with external supply of alkalis shows that an ASR in the sand fraction can contribute to the expansion and thus also to the assessment of the concrete composition with regard to its ASR potential. The behaviour of the sand was unexpected especially because the performance test was developed with focus on the coarse aggregate because they cause ASR damage in real service. Even previous publications about the investigation of the 60 °C concrete performance test with external supply of alkalis on concrete with greywacke and rhyolite (most common slow reactive aggregates in Germany) did not mentioned such contribution of sand on the test results [1, 9]. Moreover, in Germany, ASR damage in real service concrete caused by sand is unknown.
