COMBINED ATTACK FROM AAR AND DEF IN THE FOUNDATION BLOCKS OF A BUILDING

This paper will describe a real case of associated attack (AAR+DEF), presenting some lab supplementary tests and analyses that had led to a correct diagnosis of those pathologies in the foundation blocks of a residential building, in Brazil. Repair and rehabilitation through crack grouting and use of reinforced and prestressed concrete were performed and will also be presented.

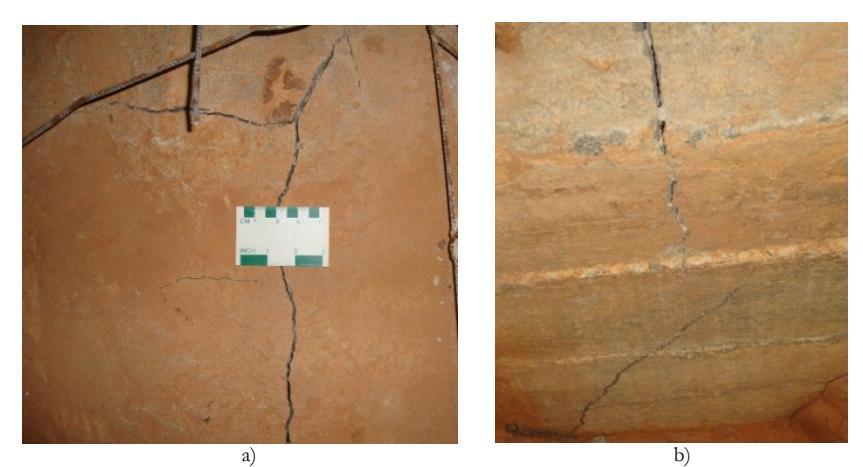
Having as a base the intense cracking in foundations blocks of a building in Brazil (Figure 1), aiming to diagnose the problem and to investigate its possible causes, investigations in field as from a thorough visual inspection, along with a program of laboratory studies were carried out in one block. It is worth stressing that the block in question has a compressive characteristic strength at 28 days of 35 MPa, is cage-like reinforced, that is, there is lower, upper and lateral reinforcement steel and its dimensions are: length 4.6 m, width 2.6 m and height 2 m. Cores about 40 cm in length were extracted from near the top surface of the concrete block for petrographic analysis.

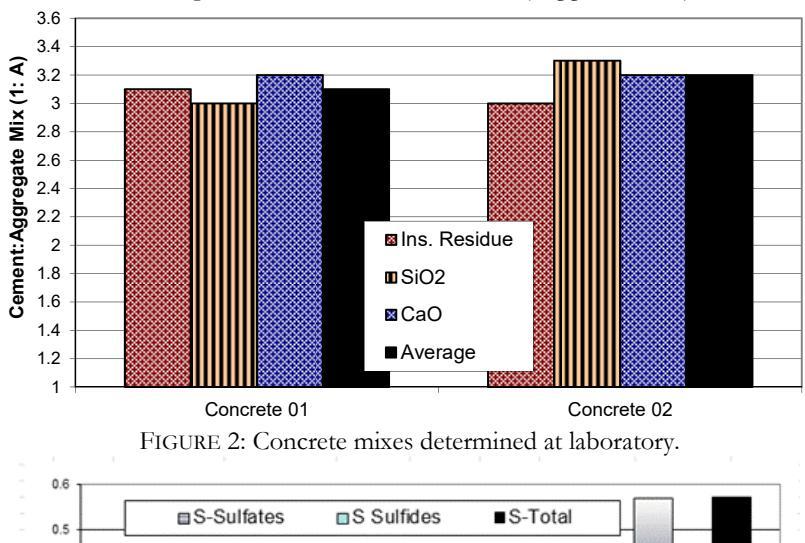
The mix design reconstitution data obtained from the chemical analyses and from the proportioning of paste and aggregate fractions can be observed in Figure 2.

Having as a reference the mixes determined from the "insoluble residue", "siliceous anhydride" and "calcium oxide", no great variation was observed between the determinations for each sample and, on average, the mixes obtained were 1:3.1 and 1:3.2 for concretes 1 and 2, respectively, which were concretes of the same proportioning. By estimating the cement content in these concretes, from some generic parameters such as specific mass of the concrete constituents, chemical analysis of the reference cement and a probable w/c ratio of 0.5, values of 438 kg/m³ and 433 kg/m³ are reached for concretes 1 and 2, respectively.

These mix reconstitution studies were important to aid the diagnosis of the blocks problem even with the limitations presented by the technique. The estimated cement content represents, on average, 435 kg/m³ (considering a characteristic strength of 35 MPa). There is no data related to the adiabatic temperature rise of the concrete used in this specific construction. Thus, the estimated temperature for the present study was based on an internal data base of Desek Company. This contains several Brazilian civil works that have used the same cement type. Considering this data and a

probable temperature increase of 0.12°C for each kg/m³ of cement for the type of concrete under study, the adiabatic rise is of the order of 52°C. As this concrete was not precooled or postcooled, its casting temperature may have reached about 30°C, thus allowing an adiabatic temperature rise in the block to reach values close to 82°C.

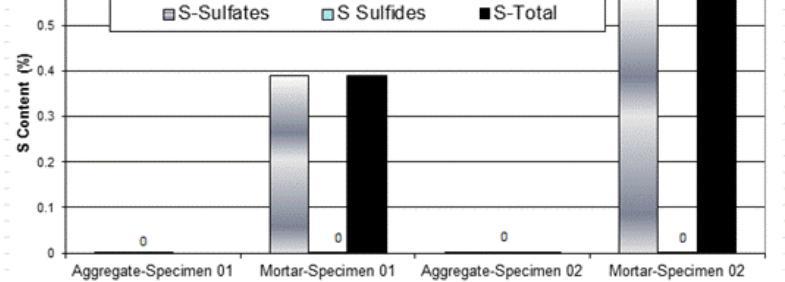
FIGURE 3: Sulfur contents from sulfate and sulfide in aggregates and mortars (expressed in weight percentage).

The sulfur analyses results, expressed in weight percentage, determined in the aggregate and mortar fractions of the concretes are depicted in the graph of Figure 3.

The study conducted by chemical analysis allows observing that the aggregates do not show to be a source of sulfur, be it by some sulfate or sulfide, indicating phases present solely in the mortar fraction of concretes, and in these, only as sulfates origin.

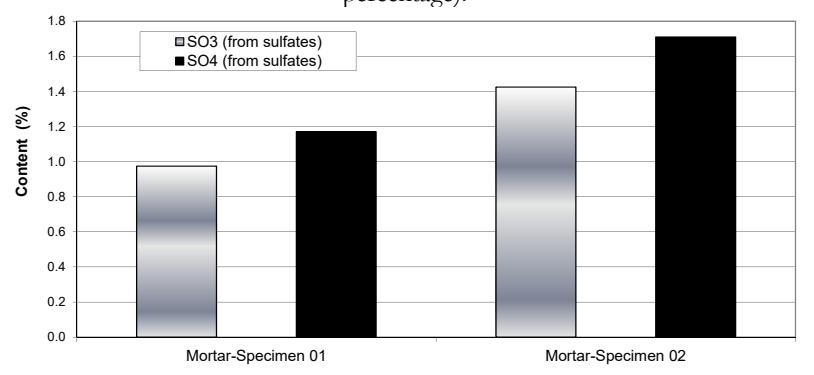
FIGURE 4: SO3 and SO4 contents in concrete mortars (expressed in weight percentage).

Calculating sulfur in terms of sulfurous anhydride (SO₃) and sulfates (SO₄) in the mortars, considering stoichiometric parameters commonly used, the data presented in Figure 4 are obtained. The SO₃ data reach values close to 1.0% and 1.4%; the SO₄ ones, approximately 1.2% and 1.7% for concretes 1 and 2, respectively.

Analyzing the average cement content of concretes (435 kg/m^3) obtained by mix reconstitution, estimating the mix employed in the concretes, and calculating the SO₃ content in relation to the cement mass, values close to 3% and 4.5% are obtained for concretes 1 and 2, respectively, showing a certain variation between the concretes. Anyway, the data obtained showed to be relatively high as regards cement-base composite, which indicates a favorable sulfate attack. According to the Brazilian cement specification standards, the maximum value admissible for sulfur trioxide in the cement is 4%. The concretes placed in the foundation blocks were known to have been made with cement without supplementary cementing materials such as those with pozzolanic characteristics.

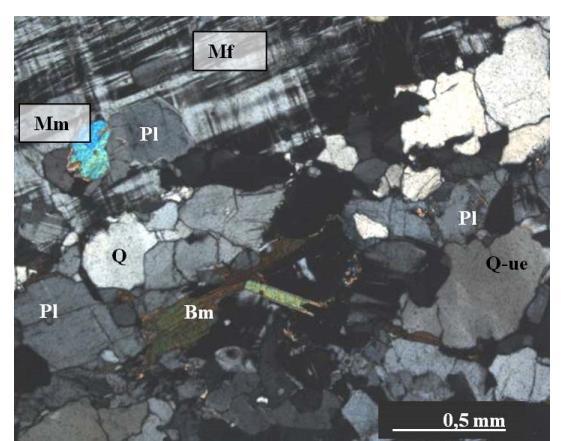
FIGURE 5: Optical micrograph of main minerals from concrete aggregate. Legend: Q: quartz; Q-ue: quartz with undulatory extinction angle; Mf: microcline feldspar; Pl: plagioclase feldspar; Bm: biotite mica; Mm: muscovite mica.

The aggregates mainly consist of feldspars (microcline and plagioclase) and quartz, also containing micas (biotite and muscovite), but in a restricted way, besides some opaques and accessories in smaller proportion. It is important to stress that the mineralogical potentiality of the aggregates as regards alkali-aggregate reaction, taking as a reference [16, 22], show characteristics of reactive potentiality such as deformed quartz with undulatory extinction (varying from 15° to 35°). Potassium feldspars (microcline) were identified, which may also contribute to the expansive reaction. Figure 5 shows some of the major mineralogical characteristics of the aggregates constituting the concretes.

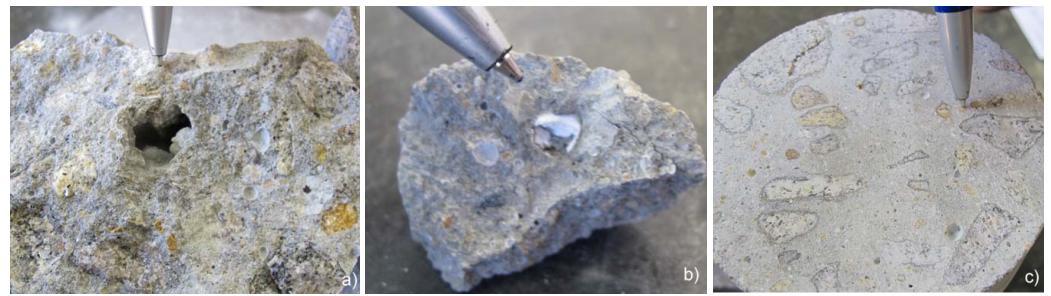
FIGURE 6: a) White deposits inside a pore (C1); b) White materials in the pores (C2); c) External surface of drilled core indicating several rims (C2).

The petrographic analyses of the concretes initially involving visual inspections, which precede the scanning electron microscope (SEM/EDS) analyses and followed the preparation of samples for SEM indicated characteristics not commonly found in normal concretes, be it on the surface of the concretes, be it within them, with their pores partially or totally filled with white material. Dark rims were also identified around some aggregates, suggesting alkali-aggregate reaction. Note that the two samples analyzed (Concrete 01 and 02) seemed similar in the visual inspection. Figures 6 (a, b and c) illustrates the major characteristics observed during the visual inspection of concretes.

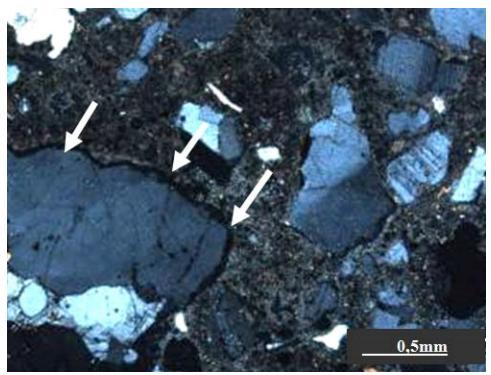
FIGURE 7: Fragment of an aggregate presenting rim (C1)

Using optical microscopy, besides the important mineralogical characteristics observed in the aggregates during the petrographic analyses, characteristics indicating chemical reaction could also be verified in the plates prepared for the concretes, such as rims around the aggregates and pores containing deposition of material (Figures 7 and 8).

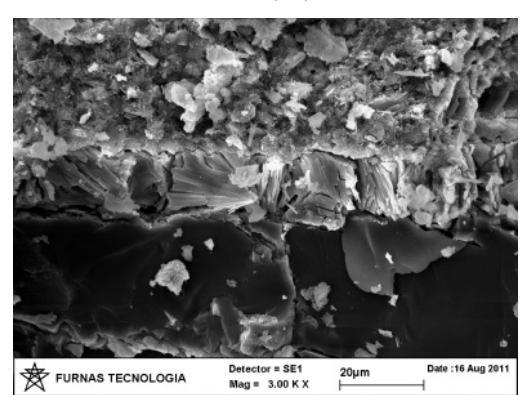
FIGURE 9: Massive crystals of ettringite in the transition zone (Concrete 01).

In the analyses involving scanning electron microscopy (SEM), the two concrete samples analyzed also showed to be very similar, and among the main characteristics observed are the pores (which in the visual inspection presented white depositions), independently of their size, containing acicular products mostly suggesting sulfate phases, besides massive formations. Some of the regions also showed some cracks following the pores, when filled with the neoformed products. Some other pores also contained silica alkaline cracked massive material characteristic of the gel, and among them some incidence of botryoidal formation as well as some crystallized rosette-like and lacy products, all of them characteristic of AAR [23]. The concentration of the two neoformed phases mentioned was also simultaneously observed at some points of the samples analyzed.

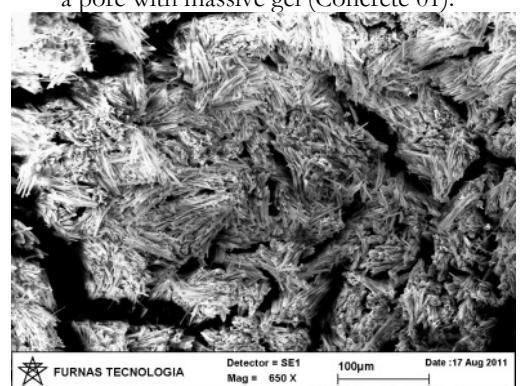
FIGURE 13: Agglomerates of sulfate phases in the paste (Concrete 02).

Acicular depositions on the aggregate were also visualized, suggesting reaction with the aggregate. The rims observed in the visual inspection indicate a reaction of the paste with the aggregate; this reaction can involve sulfate phases (from sulfides) or even alkali-aggregate reaction. In some localized regions, the aggregate was also fragmented; moreover, powdery material was verified, along with the punctual incidence of some cracks in the paste.
