CAN LIGHT WEIGHT AGGREGATE (LWA) LEAD TO HARMFUL ASR IN THE FIELD?

Harald Justnes1*, Jan Lindgård1, Marit Haugen1, Eva Rodum3, Bård Pedersen3, Shon, Myung-soo4

¹SINTEF Building and Infrastructure, Trondheim, NORWAY

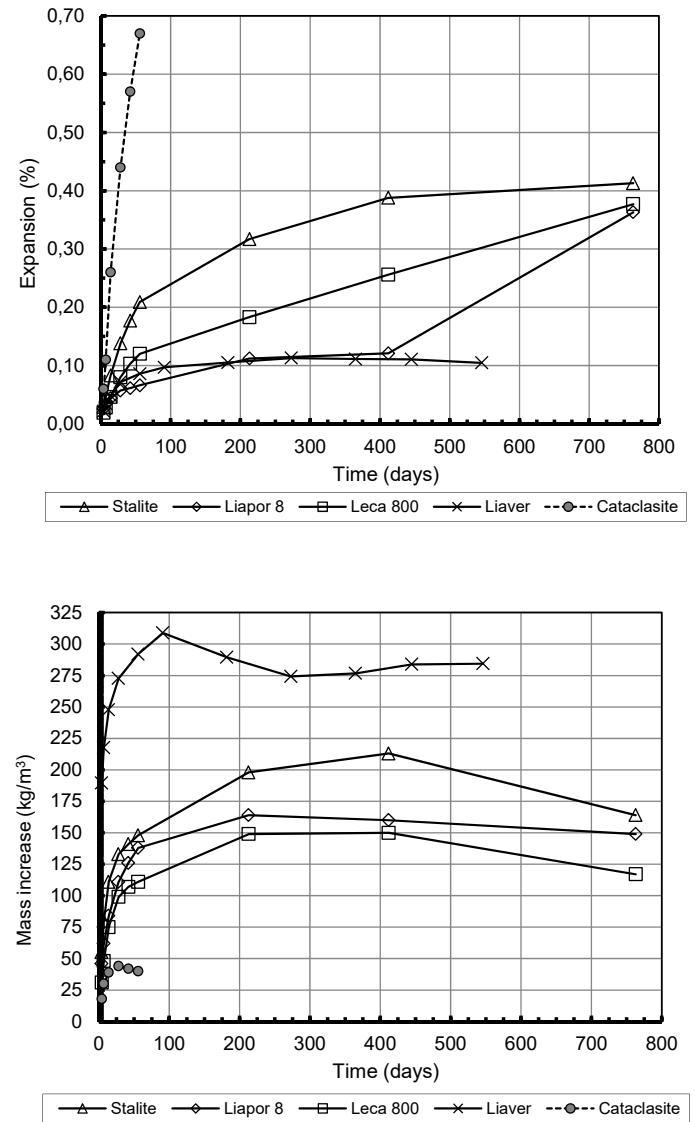
FIGURE 1: Linear expansion (upper) and mass increase (lower) of mortar bars submerged in 1N NaOH at 80°C. The four LWAs are compared with the normal density alkali-reactive cataclasite aggregate.

The Liaver LWA was treated and tested similarly as the other three LWAs. For all the four LWAs the length and mass change of the prisms as function of time are plotted in Figure 1, where their behavior is compared with a mortar with the normal density alkali-reactive cataclasite aggregate.

The huge weight increase of the mortar bars with the various LWAs is clearly shown in Figure 1, ranging from 150-300 kg/m³. In particular the mortar bars with the Liaver aggregate has an extreme weight increase. If one assumes that the solid part of the LWAs (without pores) has a density of about 2.6 kg/l, the LWAs (except Liaver) after crushing and fractionation contained 44-48 volume% porosity. Prior to mixing into mortar, about half of this porosity was filled with water. The remaining non-filled LWA porosity can then be estimated to 0.18 l per liter mortar, leading to a mass increase of 180 kg/m³ mortar if filled with water or another medium of similar density. As can be seen from Figure 1, only Stalite reached such a mass increase within the test period of 800 days.

(Comment: When testing Stalite, Liapor and Leca the original plan was to end the tests after about 7 months. Of this reason, the level of liquid was not controlled sufficiently after this period. As a consequence, the mortar bars have periodically in the period 210 to 760 days of exposure not been totally submerged in the NaOH liquid. Thus, the measured expansion and weight gain should most likely have been somewhat higher at the two last measuring points in time than shown in Figure 1).

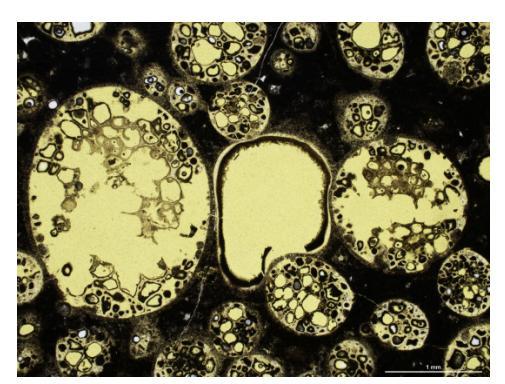
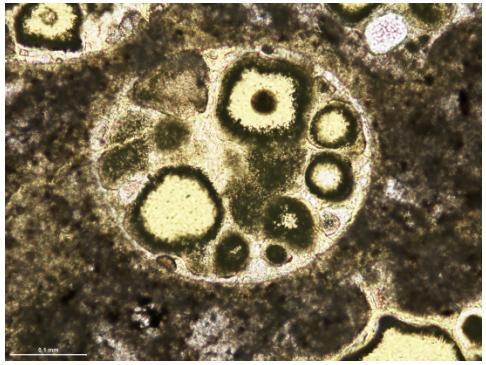
FIGURE 2: Mortar prism with Liaver LWA exposed for 1N NaOH at 80°C for 15 months. The left picture shows disintegration of coarser Liaver LWA particles during the exposure. Some cracking is observed in the cement paste, and the air voids contain reaction products. Reaction products are observed inside the Liaver particles, as well (right picture).

The thin section (TS) analysis of the mortar with Liaver after 15 months of exposure to 1N NaOH at 80°C (Figure 2) showed disintegration of coarser LWA particles. Some cracking was observed in the cement paste, and the air voids contained reaction products. Reaction products were also observed inside the Liaver particles. No SEM analysis has been performed for this sample.

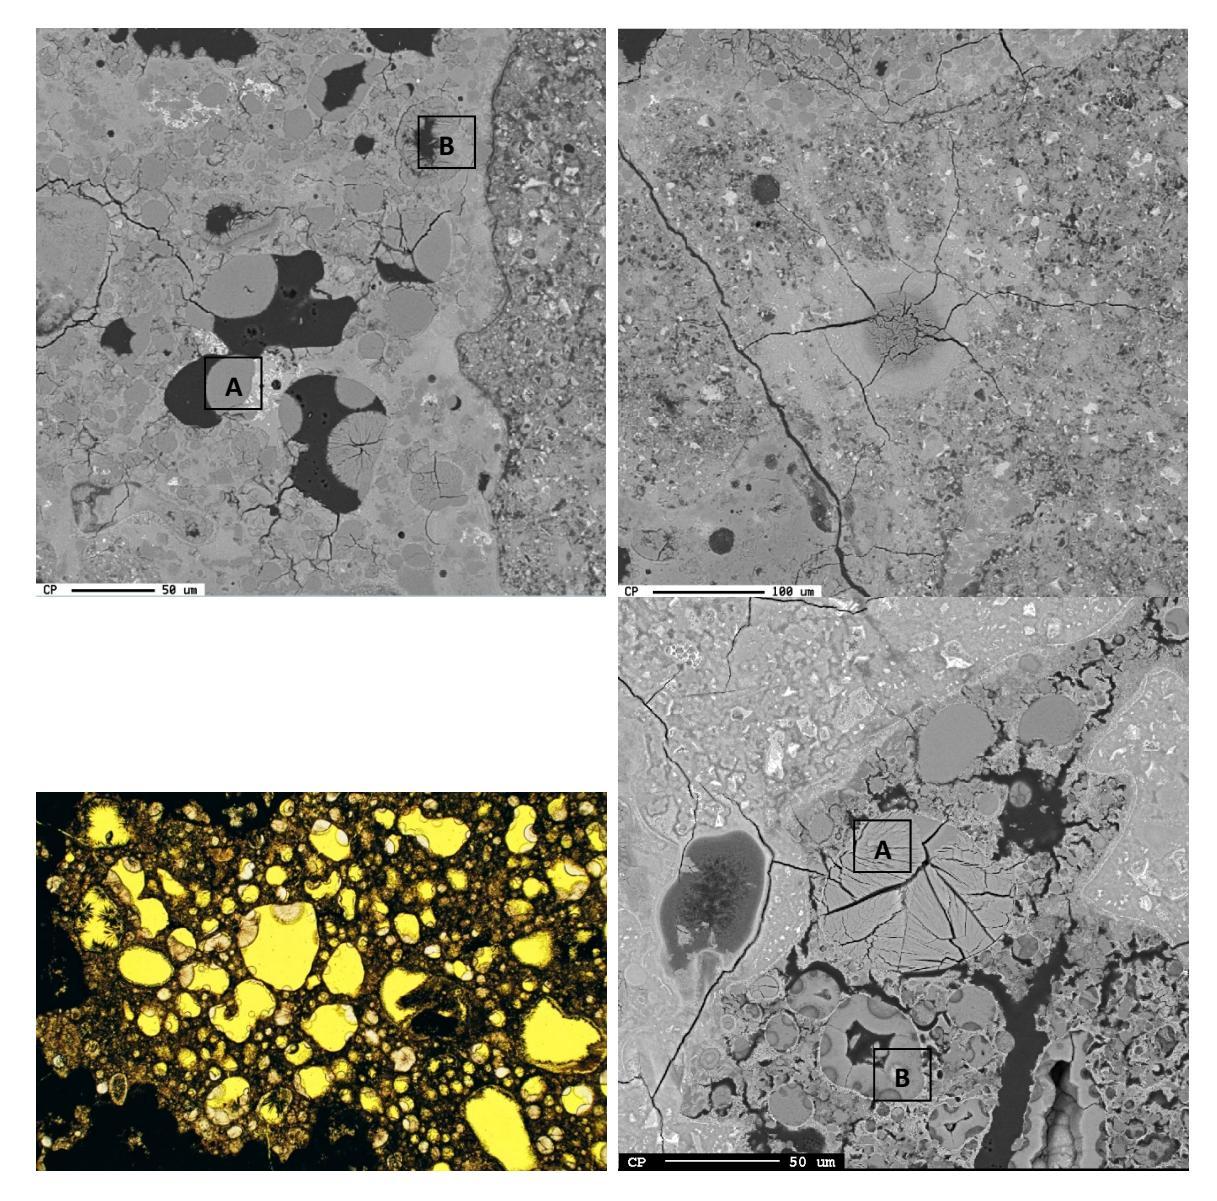
FIGURE 3: The two upper SEM pictures show mortar with Stalite LWA exposed for 56 days. The upper left picture shows the borderline between LWA (left) and paste (right) running from top to bottom of the image. Reaction products (marked A and B) are observed in air voids inside the Stalite particles. The relative atomic composition of the gel marked A was 42 Si, 15 Al, 4 K, 1 Na and 1 Ca, while the composition of the fibre like point B was 38 S, 13 Al, 10 K, 1 Ca and 1 Na. The upper right picture shows a circular air void in the paste that is filled to the rim with reaction product. In the upper part of the image a LWA particle is visible and some denser grey lines seem to connect the LWA particle to the air void. Microcracks are radiating out of the filled air void.

The two lower pictures show mortar with Stalite LWA exposed for 13.5 months. The left picture is taken in a polarization microscope (TS analysis), and shows alkali-silica gel in voids inside a Stalite particle. The SEM picture to the right shows a reacted Stalite particle with crystalline gel with minor alkalis (marked A) and amorphous gel with a high content of alkalis (marked B).

After 13.5 months of exposure, the TS analyses (Figures 3-5) showed that the porosity of the cement paste in the mortar bars with Stalite and Leca 800 appeared to be very low. This is valid also for the mortar with Liapor 8, but smaller areas of this thin section had very high porosity. For the three LWA mortars the cracking was now significantly more pronounced compared with the TS analysis after 56 days of exposure. The extent of cracking was ranged as follows: Stalite > Leca 800 > Liapor 8. The amount of ASR-gel in air voids in the cement paste has also increased significantly for all the three LWAs. For the mortars with Stalite and Liapor 8, a corresponding increase of ASR gel was also observed in air voids inside the LWAs.

SEM analyses performed after 56 days of exposure revealed that all three LWA types developed ASR and detailed images are shown in Figures 3, 4 and 5 for Stalite, Liapor 8 and Leca 800, respectively, with explanatory text. Crystals and gel grow in the voids inside the LWAs as well as in air voids in the paste as rims. When the crystals grow inside the voids of the LWAs there can be mass increase without too much expansion for a while. However, when more ASR products are produced inside the LWAs and in air voids in the paste, as documented after 13.5 months of exposure (see Figures 3-5), the expansion of the mortar bars increases as shown in Figure 1.

The commented SEM images with EDS analyses in Figures 3-5 show that ASR products within the LWA are dominated by the elements Si, Al and K with some Na, but poor in calcium (Ca). ASR products near the interface with binder are richer in Ca. The solid material of the LWA is composed of a glassy aluminosilicate (sometimes with inclusions of quartz) and the glassy phase may react with potassium hydroxide as indicated in Eq. 1 (a similar reaction may occur in the sodium hydroxide solution):

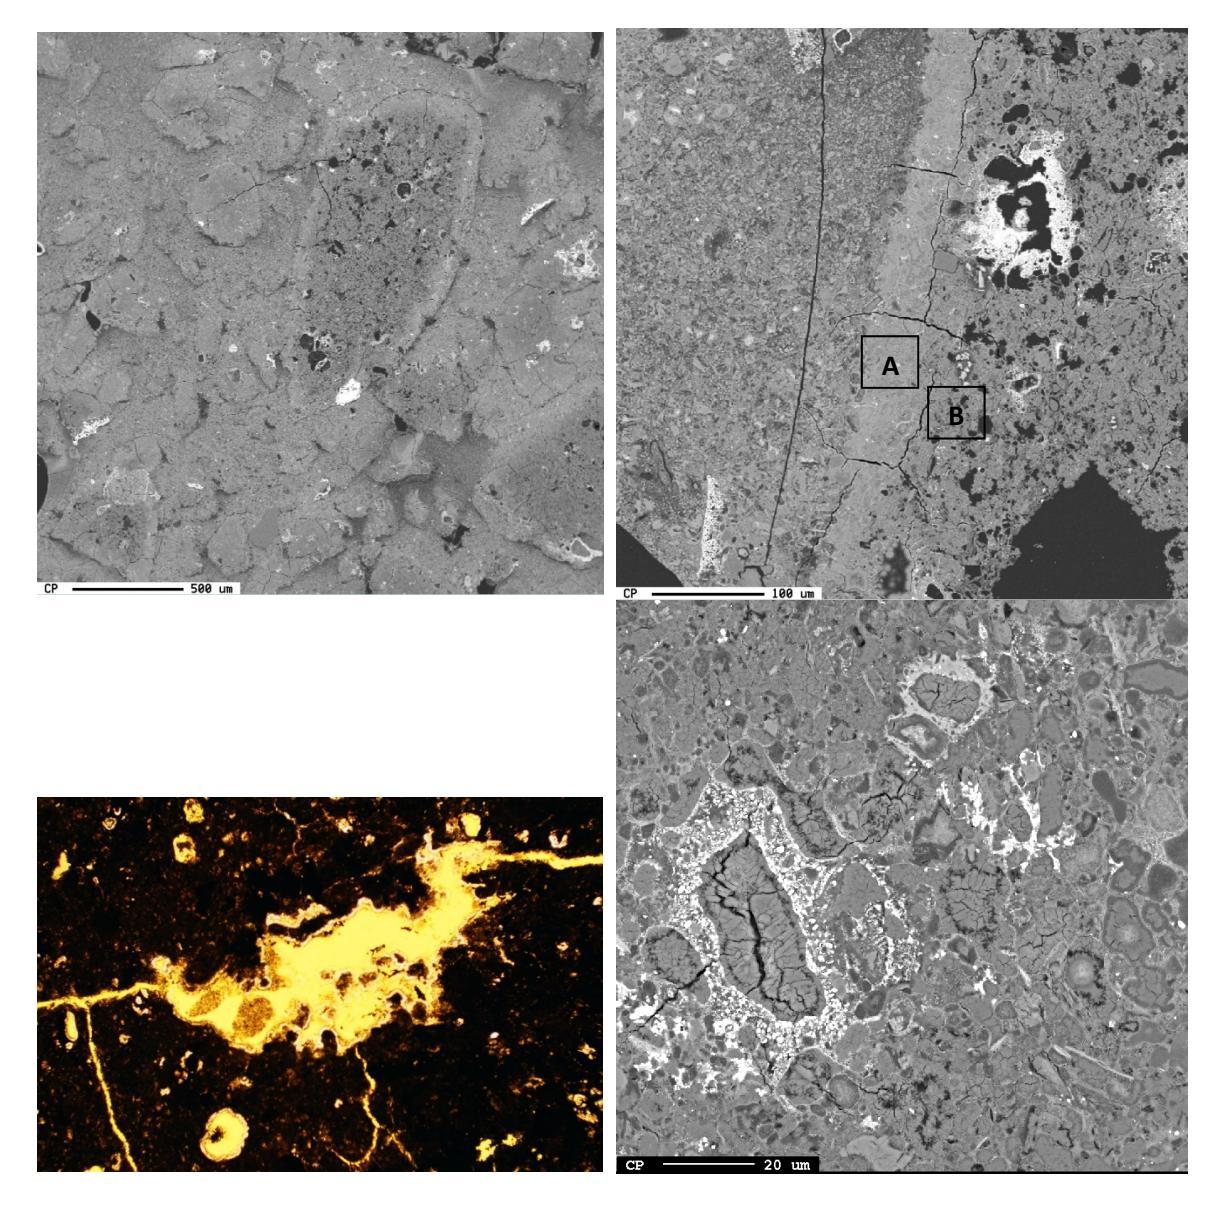
FIGURE 4: The two upper SEM pictures show mortar with Liapor 8 LWA exposed for 56 days. The upper left image serve as an overview. The apparent topography is likely to be density differences between cement paste depleted in calcium hydroxide used to react through some of the smaller LWA particles. A Liapor particle with a reaction rim in visible in the middle. The particle is less affected inside. The upper right picture shows the reacted interface zone (marked A) between a Liapor particle (right) and the cement paste. When analyzing point A by EDS in a defocused circular area of 10 μm diameter, the following relative atomic composition was found: 31 Si, 18 Ca, 10 Al, 5 K and 2 Na, while a similar analysis in point B inside the LWA gives 32 Si, 6 Ca, 15 Al, 7 K and 2 Na.

The two lower pictures show mortar with Liapor 8 LWA exposed for 13.5 months. The left picture is taken in a polarization microscope (TS analysis), and shows alkali-silica gel in air voids in the cement paste. The SEM picture to the right shows different reaction products inside a LWA particle, in which the chemical composition is dominated by Si and Al, with some Ca, K and Na. The white areas are iron compositions, a possibly consequence of alkali-silica reactions.

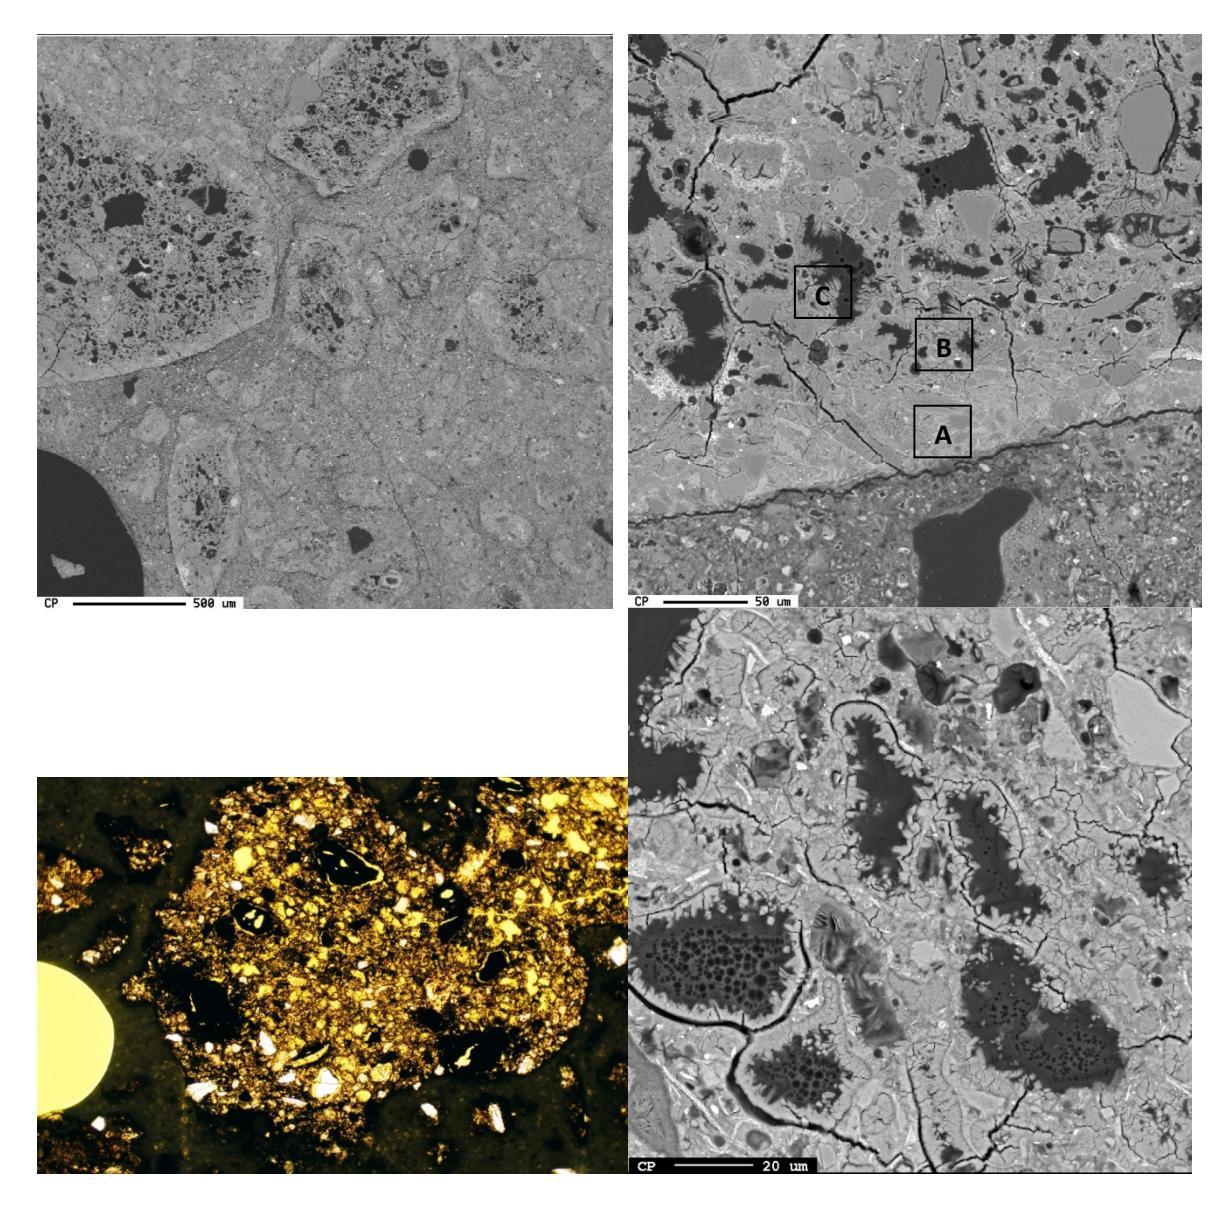
FIGURE 5: The two upper SEM pictures show mortar with Leca 800 LWA exposed for 56 days. The upper left picture shows reaction rims around coarser LWA particles, while the smaller LWA particles seem dense and have reacted through. The right picture (upper part) shows a Leca particle with a reaction rim. EDS of a circular are of 10 µm diameter in the area marked A indicates a relative atomic content of 34 Si, 13 Ca, 8 Al, 2 Na and 3 K. The composition of the area marked B inside the reaction rim indicates a composition of 36 Si, 3 Ca, 14 Al, 4 Na and 9 K. The analysis of the fringed products marked C in the void corresponds to 36 Si, 23 Ca, 1 Na, 1 K.

The two lower pictures show mortar with Leca 800 LWA exposed for 13.5 months. The left picture is taken in a polarization microscope (TS analysis), and shows possibly white alkali-silica gel in voids inside the LWA particle. The SEM picture to the right shows reaction products consisting of Si, Al and some K in air voids inside a Leca particle (small air voids are completely filled). The Leca 800 particle is cracked.
