EVALUATION OF THE DELETERIOUS CHARACTER OF SILICEOUS AGGREGATES INCORPORATING SULFIDE MINERALS

Andreia Rodrigues¹, Josée Duchesne^{1*}, Benoit Fournier¹

¹UNIVERSITÉ LAVAL, Centre de recherche sur les infrastructures en béton (CRIB) Québec, QC, <u>CANADA</u>

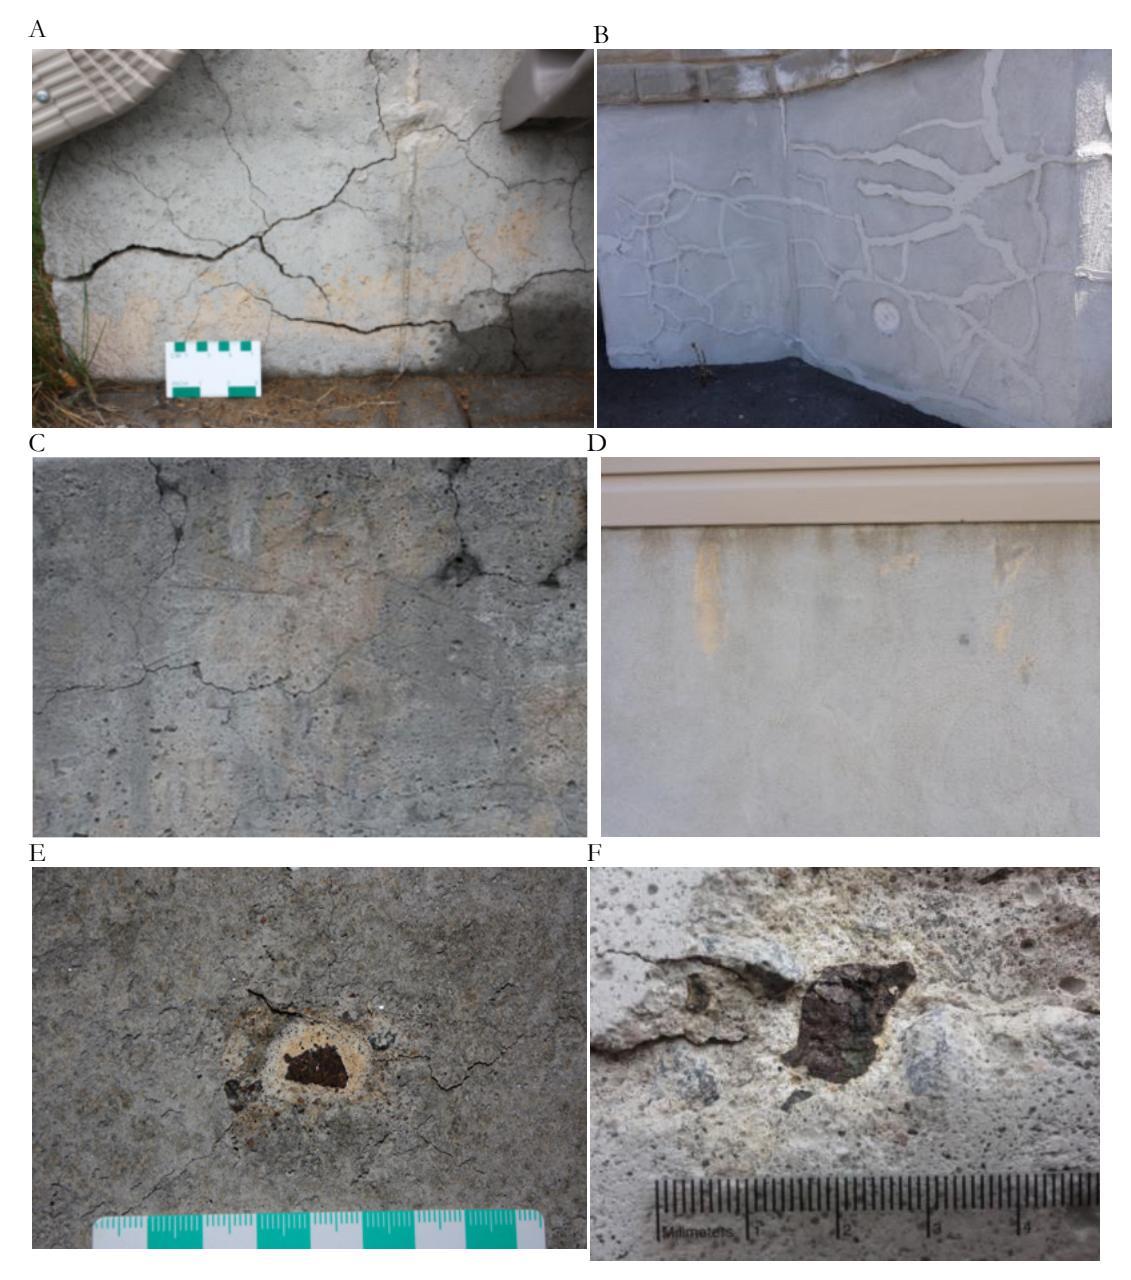
FIGURE 1: Concrete foundations showing map-cracking and yellowish/brownish discoloration. B: Cracks filled with caulking material to prevent moisture ingress. C and D: Yellowish and brownish discoloration surrounding the cracks. E and F: Pop-outs showing the presence of oxidized and rusted aggregate particles, as well as whitish/yellowish secondary reaction products.

Figure 1 shows typical signs of concrete deterioration observed in the foundations, which mainly consist of map-cracking, with some crack openings reaching more than 40 mm. Sometimes, those cracks were filled up with sealer to prevent the moisture to penetrate into the damaged concrete and in an attempt to delay the progress of deterioration. Yellowish and brownish discoloration is often observed surrounding these cracks. Pop-outs can be observed on the walls showing the presence of oxidized and rusted aggregate particles. It is also possible to observe small bumps/blisters that can be easily detached from the surface thus showing oxidized and rusted aggregate particles.

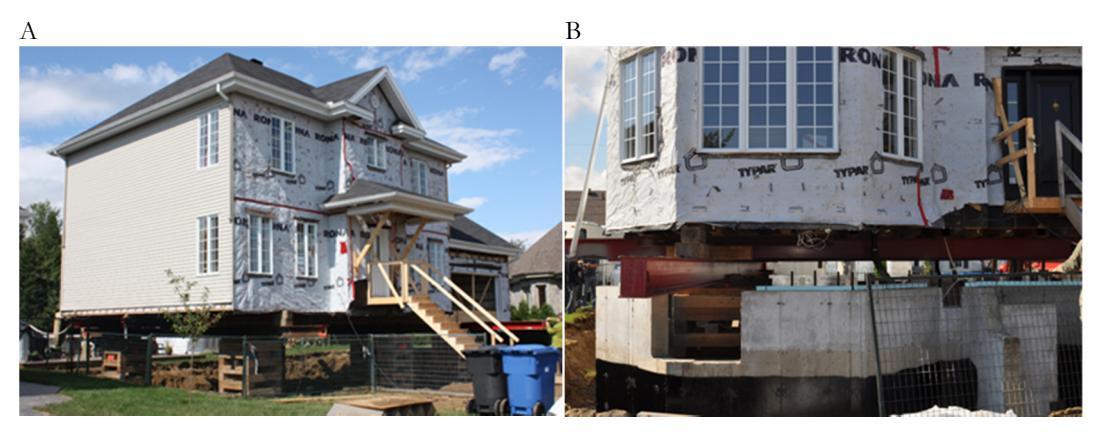
FIGURE 2: Replacement of the concrete house foundations walls. A: lifted house with all the brick work removed. B: New foundations being placed.

The deterioration problems are related to the coarse aggregate used in the concrete. The coarse aggregate is a gabbro, an intrusive igneous rock, containing various proportions of sulfide minerals, including pyrite (FeS₂), pyrrhotite, pentlandite and chalcopyrite, disseminated or in veins [1]. Iron sulfides have the tendency to be unstable in the presence of oxygen and water. The chain of reactions generated after the iron sulfides oxidation in the concrete can thus lead to a deleterious internal sulfate attack [2]. The problematic concrete has a porous and friable paste and, in many cases, it is possible to observe the breakdown and disintegration of concrete. In some cases, the deterioration is such that the concrete foundation has to be replaced (Figure 2).

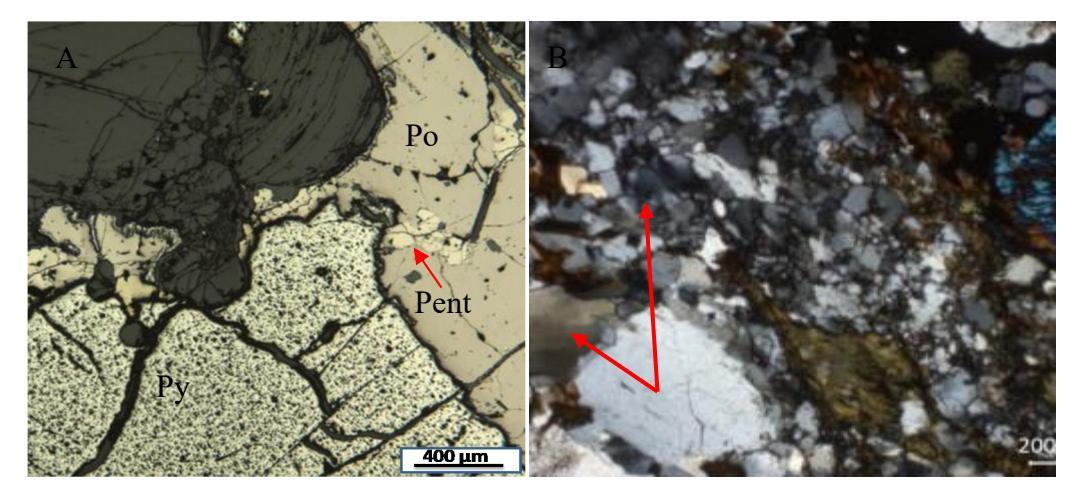
FIGURE 3: Example of mineralogy responsible for concrete damage. A: Reflected polarized light view of iron sulfide minerals responsible for oxidation (MSK aggregate) (Py = pyrite, Po = pyrrhotite, Pent: pentlandite). B: Potentially reactive silica (microcrystalline and stained quartz) viewed under crossed polarized light (GGP aggregate).

In addition to the aggregate responsible for the concrete deterioration in the Trois-Rivières area (MSK), three sulfide-bearing aggregates and two aggregates with no or only traces of iron sulfides (control) were selected for this study, including the well-known Spratt limestone. Table 1 presents the mineralogy of the aggregates tested along with their ASR potential according to ASTM C 1260 accelerated mortar bar test. Figure 3 shows examples of mineralogy responsible for concrete damage due to sulfide oxidation or alkali silica reaction.

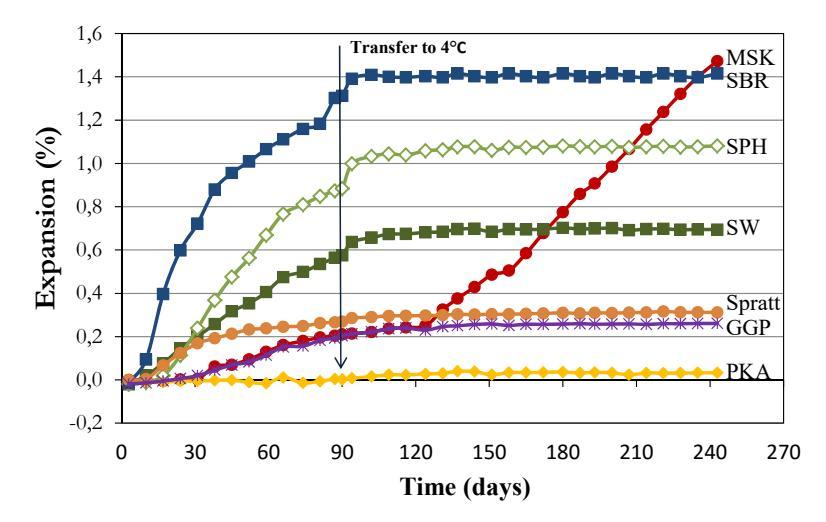
FIGURE 4: Expansion of mortar bars subjected to two 3-hour wetting periods in bleach (6 vol%) per week, and kept at 80°C and 80% RH during 90 days. The bars are transferred after that period to 4°C and 100% RH and exposed to the two 3-hour soaking periods in bleach per week.

Figure 4 presents the expansion results for the two-phases accelerated mortar bar test to assess the deleterious effect due to the oxidation of sulfide-bearing aggregates.

As illustrated in Figure 4, different behaviors were observed based on aggregates mineralogy (Table 1). The mortar bars incorporating the control aggregate PKA did not suffer from significant expansion during both phases of the program. This confirms that the somewhat harsh conditions used in the proposed mortar bar method do not in themselves induce excessive expansion in mortars incorporating sulfide-free aggregate materials. Figure 5 shows the condition of the PKA control samples at the end of the experiment. The very low expansion observed for these samples is confirmed by the good condition of the test specimens during the entire test.

In the case of the MSK aggregate, the specimens transferred to low-temperature conditions showed a slowed down of the expansion following 4°C transfer (at 90 days), but then increased dramatically after 150 days to reach about 1.5% ℓ/ℓ at 300 days. At 300 days, one of the bars transferred to 4°C was so deteriorated that it broke in pieces. Figure 6 shows the condition of the MSK aggregate at the end of the test. It is important to note that the MSK aggregate is the problematic aggregate used in the Trois-Rivières area.

In the present test, the sulfide-bearing and alkali-silica reactive aggregates SBR, SPH and SW, present a different expansion pattern, characterised by a rapid onset of expansion that stopped shortly after the transfer of the bars at 4°C (Figure 4). It is interesting to note that the mortar bars incorporating the highly alkali-silica reactive Spratt limestone also showed a quick onset of expansion in the particular storage conditions used for testing; however, the expansion level reached at 90 days was much lower than that measured for the SBR, SPH and SW aggregates. The rapid onset of expansion is suspected to result from the development of ASR in the above mortar specimens; however, additional testing and the detailed petrographic examination of the mortar bars will be required to confirm this hypothesis. The absence of expansion following transfer of the bars at 4°C, suggests that thaumasite formation did not occur in the above alkali-silica reactive mortar specimens. This result is not surprising in the case of the Spratt aggregate since it contains limited sulfide minerals (some disseminated pyrite grains) capable of forming sulfate ions necessary for the precipitation of thaumasite.

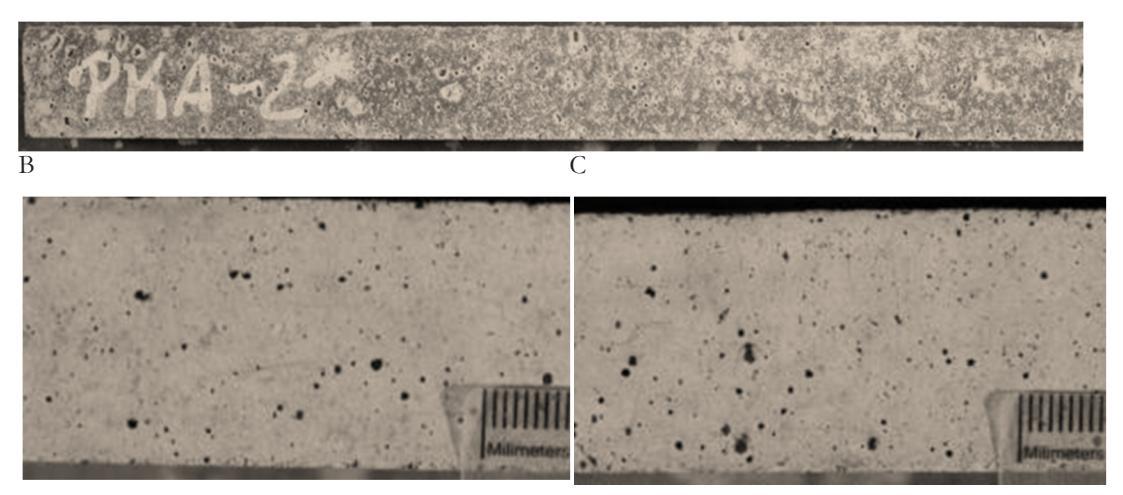
FIGURE 5: Mortar bar made with PKA aggregate at 90 days, showing no signs of deterioration for the entire duration of the test. B and C: Deterioration details of mortar bars at 180 days.

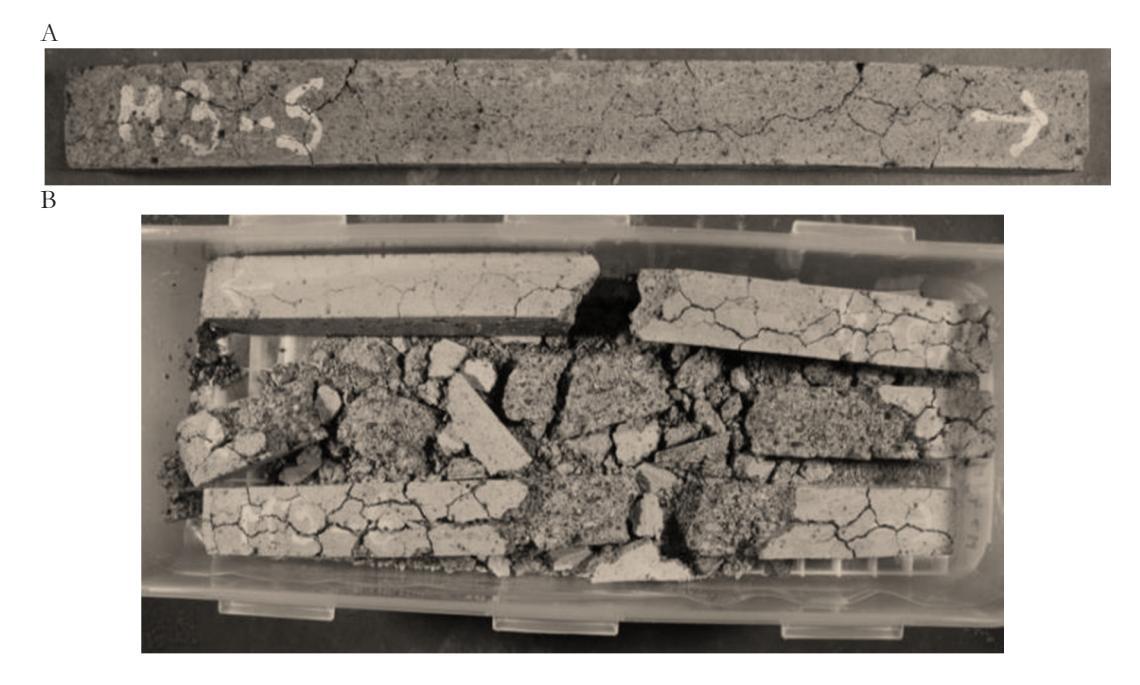
FIGURE 6: A: MSK mortar bars kept at 80°C and 80% relative humidity and then transferred at 4°C and 80% relative humidity immediately after rupture at 118 days. B: The same mortar bar series left at 4°C and 80% relative humidity for 7 months; the M3-5 bar illustrated in A is the one in the middle of the container.

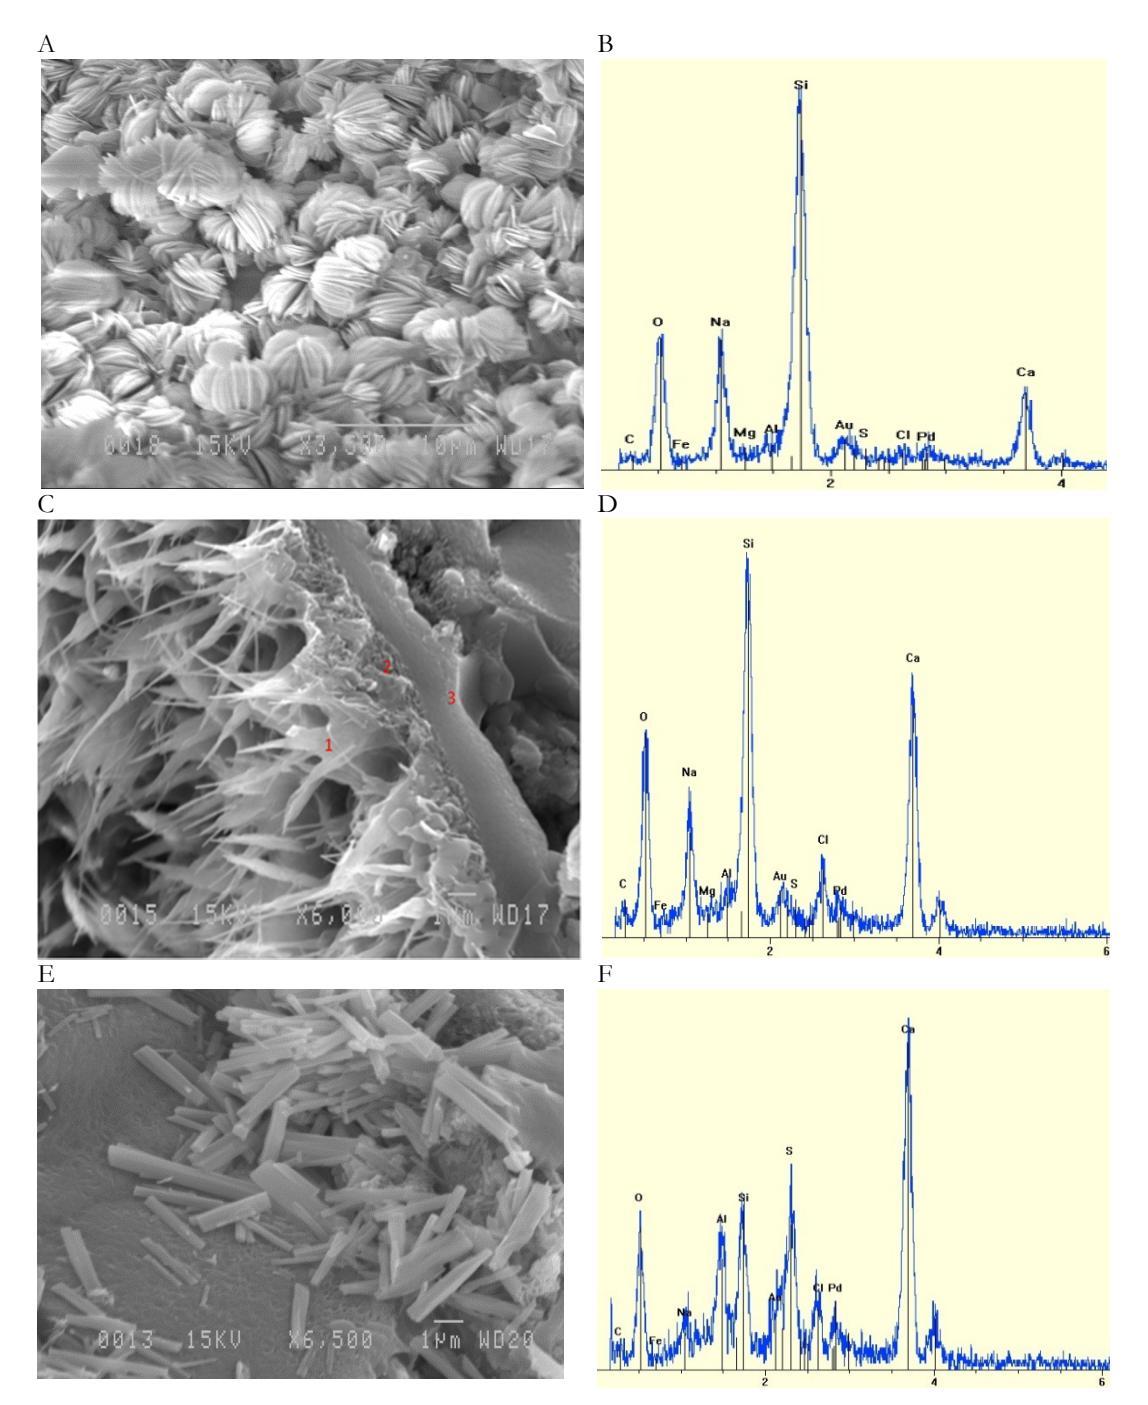
FIGURE 7: Secondary electron images of reaction products examined under SEM after testing with corresponding EDS spectrum. A and B: Rosette-like crystalline product typical from ASR (mortar bar incorporating GGP aggregate). C and D: ASR gel product (EDS spectrum corresponding to zone 3 on the micrograph) (mortar bar incorporating GGP aggregate). E and F: Ettringite-thaumasite crystals from sulfide oxidation and sulfate attack of cement paste (mortar bar incorporating MSK aggregate).

Figure 7 presents examples of reaction products observed by scanning electron microscopy (SEM) after the completion of expansion testing. Figures 7A to 7D show typical alkali silica reaction products (mortar bars incorporating GGP aggregate), while Figures 7E and 7F present ettringite/ thaumasite crystals formed at low temperature from sulfate ions generated by sulfide oxidation (mortar bars incorporating MSK aggregate).

Microstructural analyses suggest that the GGP aggregate is alkali-silica reactive (Figures 7A and 7B). However, mortar bars incorporating that aggregate did not show the rapid onset of expansion but rather a progressive expansion similar to that of mortar bars made with the sulfide-bearing MSK aggregate up to about 130 days. The potential alkali-reactivity of granitic/gneiss aggregates (i.e. GGP rock type) is often not adequately assessed through mortar bar testing [9].
