REACTION BETWEEN CEMENT AND ARTIFICIAL GLASS IN CONCRETE

by J W Figg*

SYNOPSIS

Conference on alkali-aggregate reaction in concrete Cape Town - South Africa March 30 - April 3, 1981

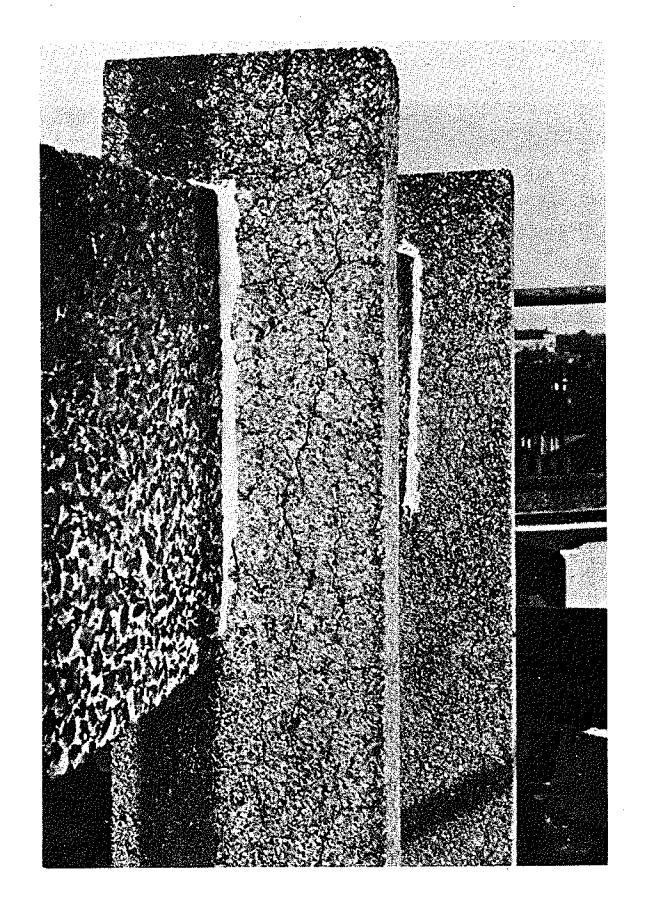
Inspection revealed that numerous cracks were present in the precast concrete units. Within the mullion/rib units these cracks tended to be more or less vertical and the same general direction applied to the chevron corner units. With the flat panels the cracks had a random orientation and this was particularly pronounced towards the top of the structure where the cracks had an appearance of 'map cracking' (Figures 1 and 2).

FIGURE 1: Top section of mullion/rib units of Case Study structure, showing cracking and distortion of precast concrete elements.

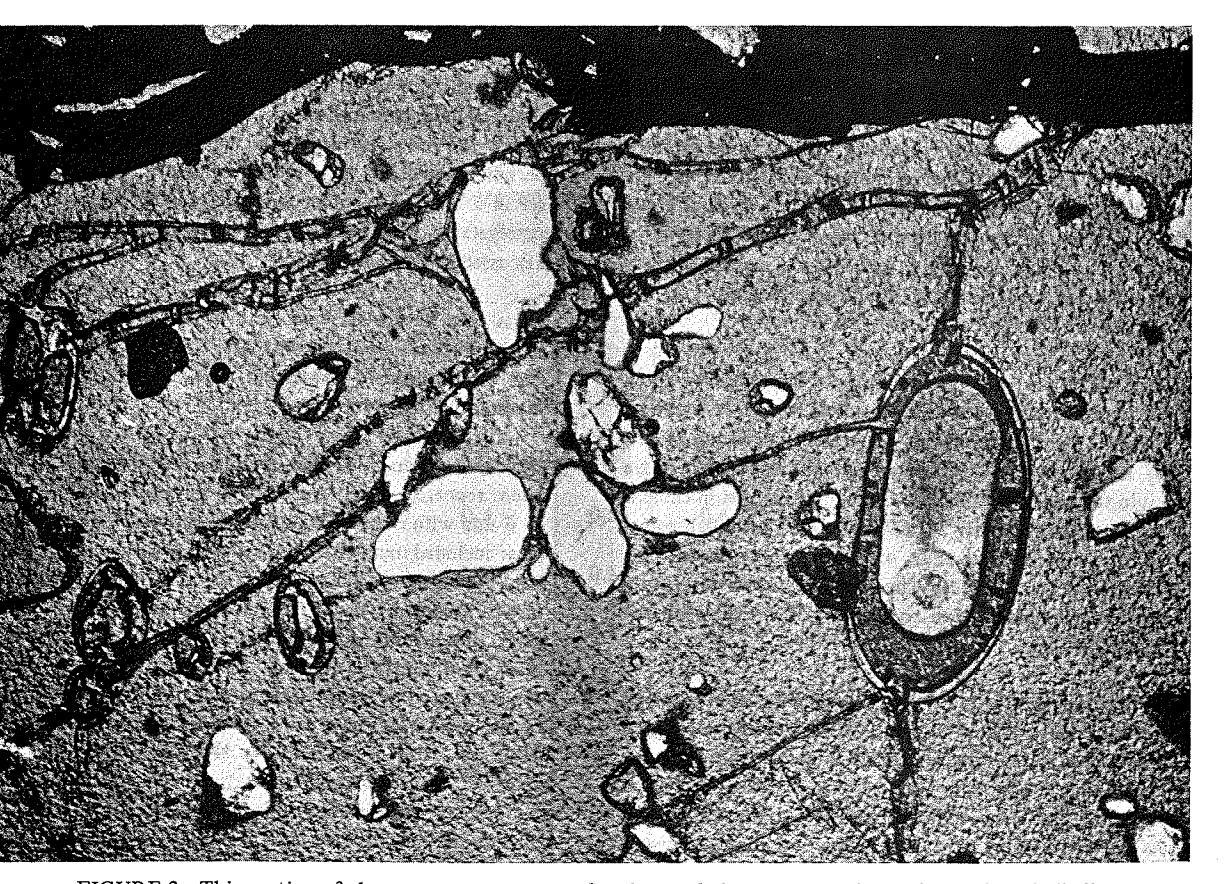
Numerous cracks were present in the aggregate particles sometimes sub-parallel to the edges, sometimes linking voids and sometimes traversing the aggregate to continue into the cement paste. In many instances the cracks and voids were seen to contain isotropic gel or a microcrystalline birefringent material, apparently secondary reaction products (Figure 3).

The gel showed typical shrinkage phenomena with often a gap between the gel and the edges of the crack or void and more or less regularly spaced fissures within the material.

FIGURE 3 : Thin-section of glass-aggregate concrete, showing eroded quartz crystals, cracks, voids and alkalisilicate gel in an aggregate particle. (Partially crossed polars, X50).

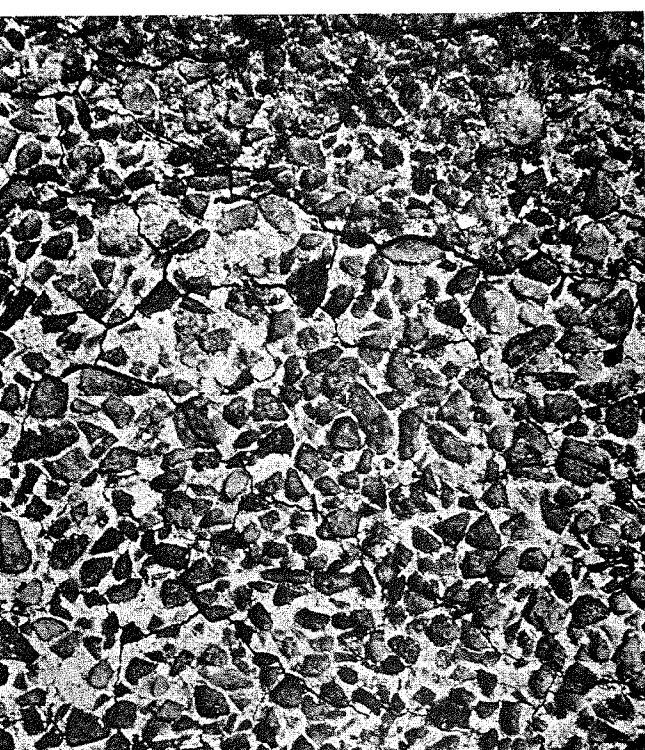
FIGURE 2 : Map-cracking of glass-aggregate precast concrete panel

Extensive random cracking (map-cracking) was present on all surfaces and this was most easily seen on the reverse side of the units which had been protected from the weather and where the original moulded face could be observed.

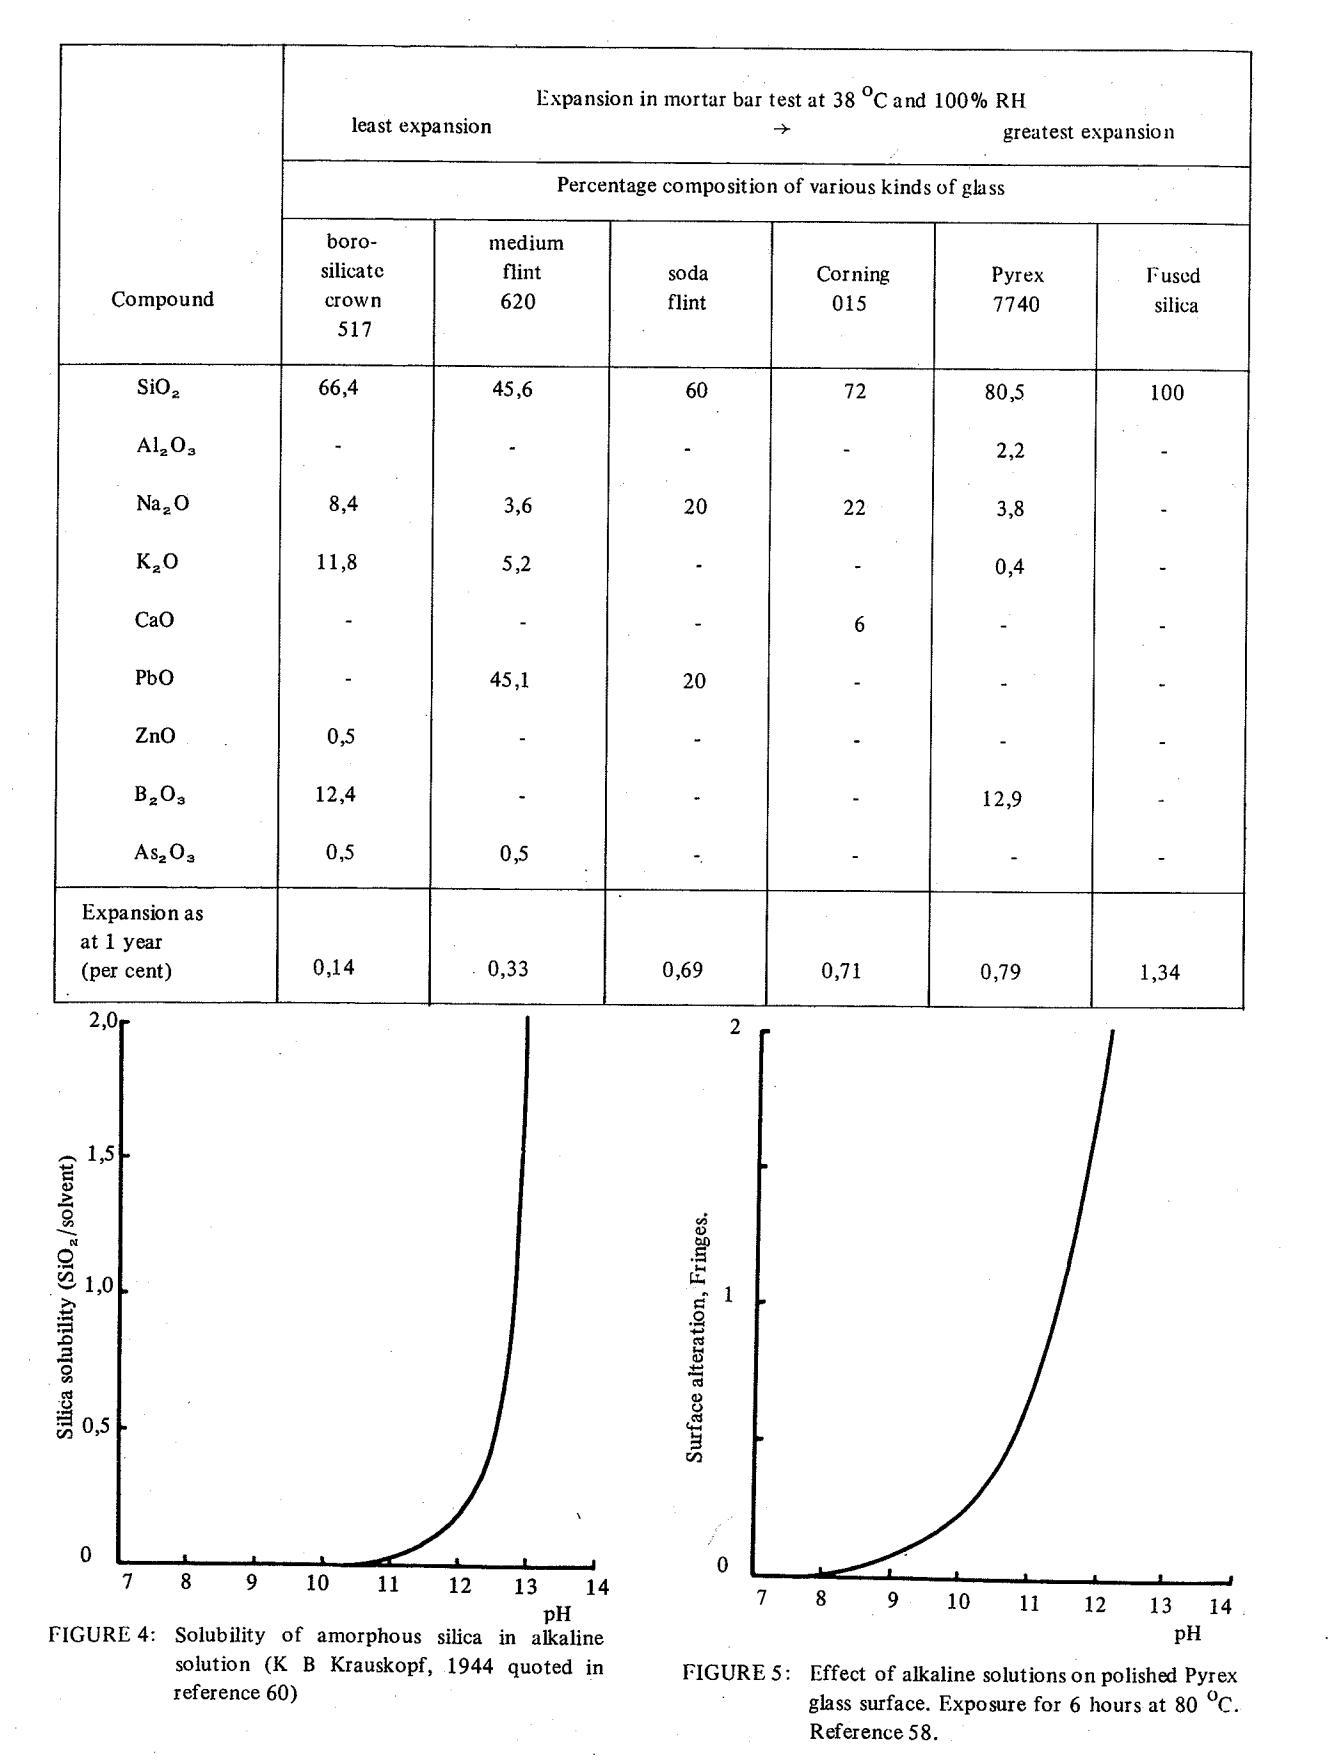
TABLE 5 : Composition of glass and comparison of linear expansion obtained in mortar bar test s⁵⁰

A number of commercial glass compositions were tested as 6 per cent replacement in an inert aggregate (Ottawa sand) to determine the linear expansions produced in the mortar bar expansion test58. The glass compositions and alkali expansivity are given in Table 5. These tests show that except for the fused silica the Pyrex glass gave the highest expansion.

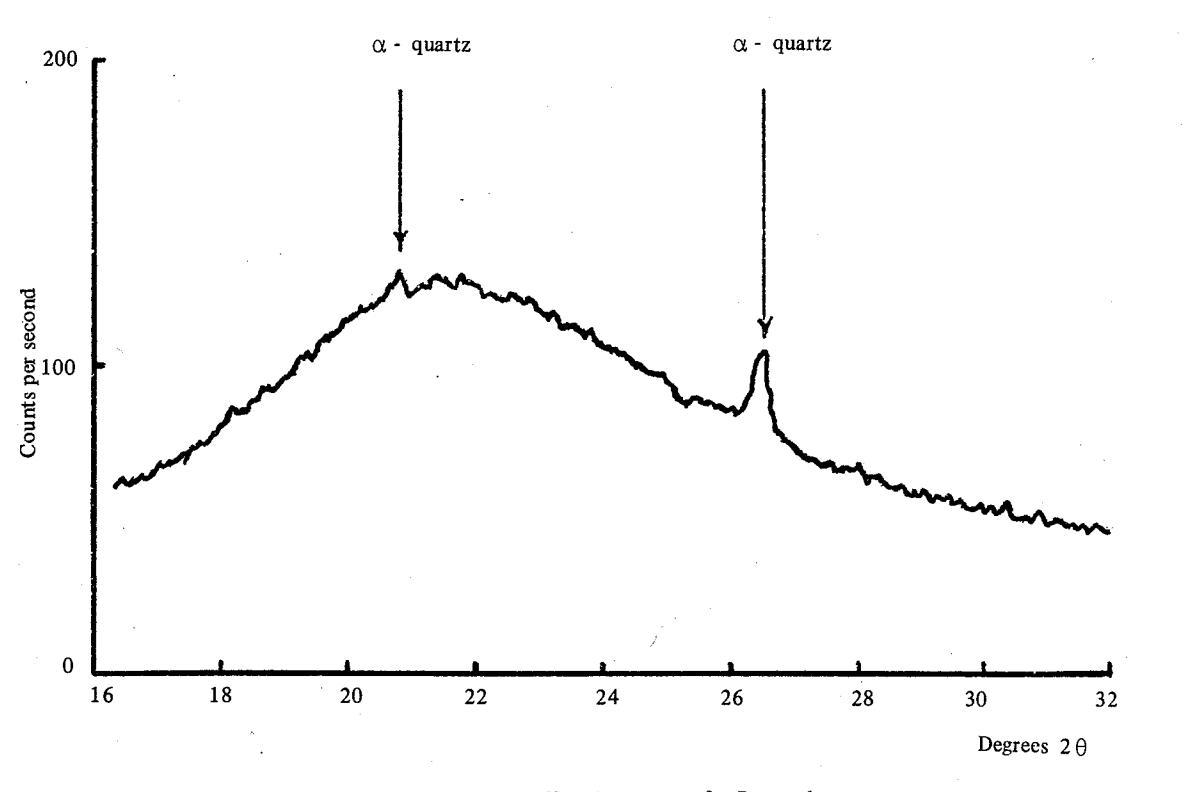
FIGURE 9 : X-ray diffraction pattern for Pyrex glass (W A Gutteridge, C & CA)

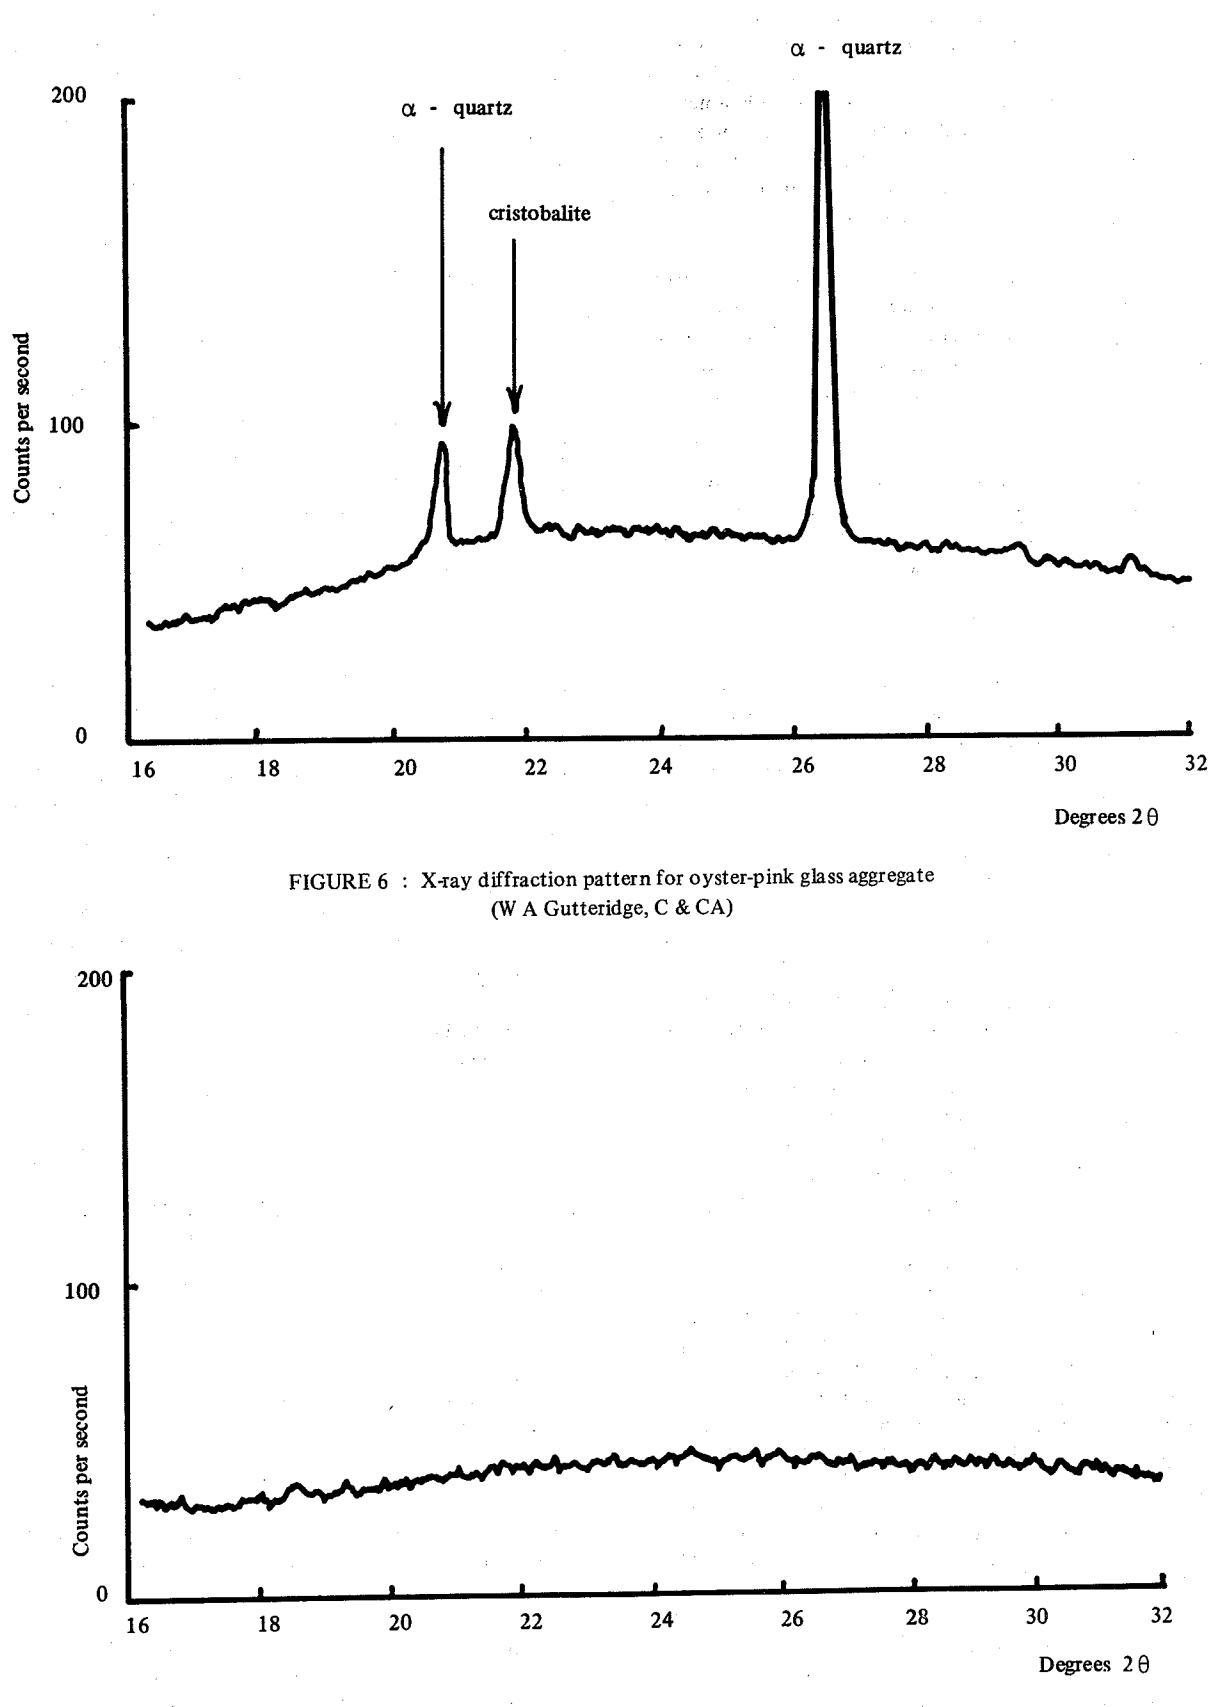
(ii) Green glass (Minehead). This sample gave virtually no diffraction pattern with only a slight increase in the baseline response due to the glass matrix. Despite the quartz crystals observed by optical microscopy no quartz response was obtained by X-ray diffraction.

FIGURE 7 : X-ray diffraction pattern for green glass aggregate (Minehead) (W A Gutteridge, C & CA)
