CASE STUDIES OF TREATING ASR-AFFECTED STRUCTURES WITH LITHIUM NITRATE

Kevin J. Folliard ¹^{*}, Michael D.A. Thomas², Jason H. Ideker¹, Bradley East¹, and Benoit Fournier³

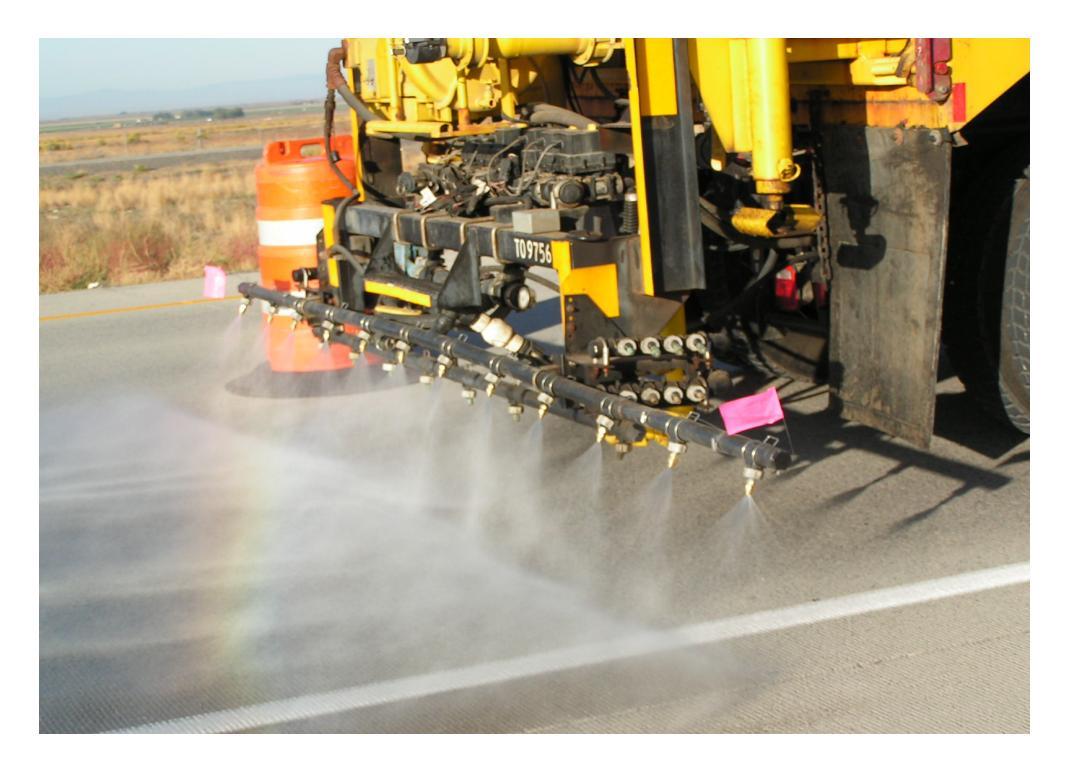
Figure 1: Topical application of lithium nitrate to pavement in Idaho

This section of I-84 is the most heavily instrumented and monitored section of pavement treated with lithium in the United States. This research is vital to the growing database for lithium used as a post-treatment for ASR-affected concrete. The site under investigation in Idaho is located just outside of Boise in Mountain Home. The Idaho Department of Transportation noticed that a significant stretch of highway on Interstate 84 exhibited cracking in certain areas after only a few years of service, mainly attributable to ASR. In 2004, a 4.8 km section of this deteriorating pavement was selected as a test section for topically-applied lithium nitrate (Figure 1).

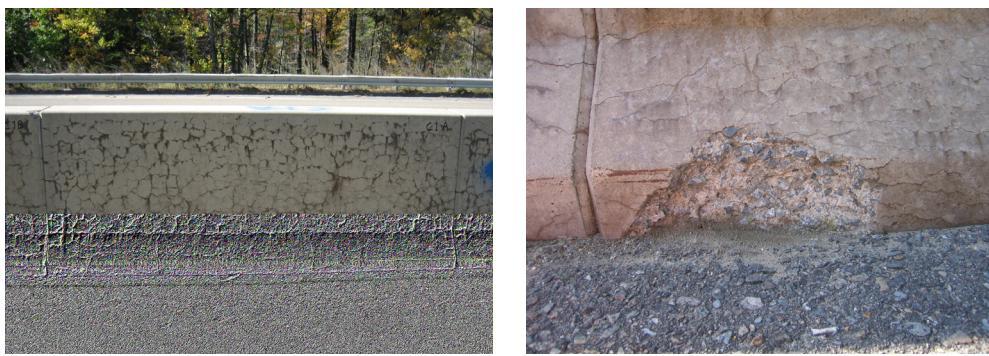
(a) General condition of ASR-affected barriers

ral condition of ASR-affected barriers (b) Close-up of damage at bottom of barrier due to ASR and subsequent freeze/thaw and scaling distress Figure 2: ASR-affected highway barriers near Leominster, Massachusetts

Highway barriers near Leominster, Massachusetts (just outside of Boston) have exhibited significant ASR-related distress after only a few years in service. Figure 2a shows the general condition of the barriers, with obvious signs of ASR-induced map cracking (note ASR has been confirmed as prime cause of deterioration. Figure 2b shows the frost damage and salt scaling distress evident in bottom of selected barriers exhibiting severe ASR. In 2004, the authors initiated field evaluation of a subsection of the damaged barriers, as described in detail by East [8].

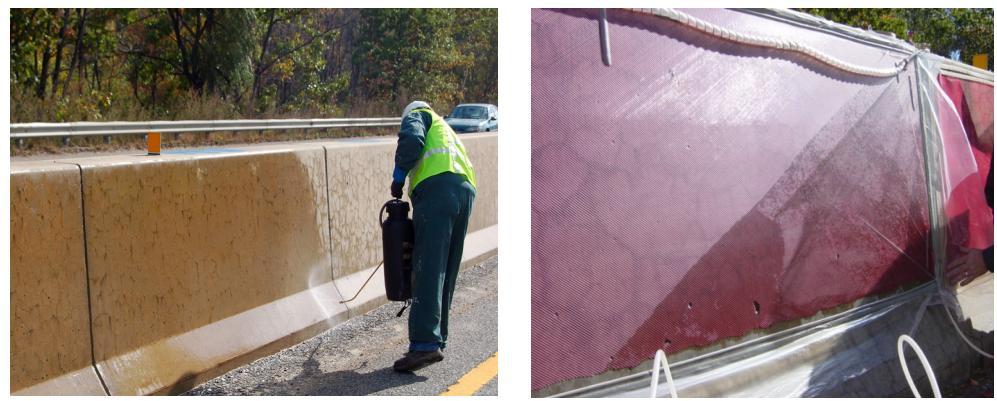
(a) Topical application of lithium nitrate (b) Vacuum treatment of barriers with lithium nitrate Figure 3: Topical and vacuum application of lithium nitrate to highway barriers

A total of 24 barriers (about 3 m long each) were topically treated by a contractor with various products, including 30% lithium nitrate solution, two silane-based products (40% silane content with remainder being either water or solvent), and a lithium silicate product. These coatings/sealers were applied manually (see Figure 3a) anywhere from one to four times over a 24-hour period as shown in Figure 3, with each treatment consisting of an application rate of 0.1 L/m². Lithium nitrate was also applied by vacuum to selected barriers (see Figure 3b), with vacuum pressure maintained for either 0.25 hour or 7.25 hours. A subset of these barriers that were treated by vacuum impregnation was subsequently treated with 40% silane (solvent-based) at a rate of 0.2 L/m². East [8] provides a detailed summary of this field test and monitoring program and parallel laboratory testing of cores extracted from the various barrier sections.

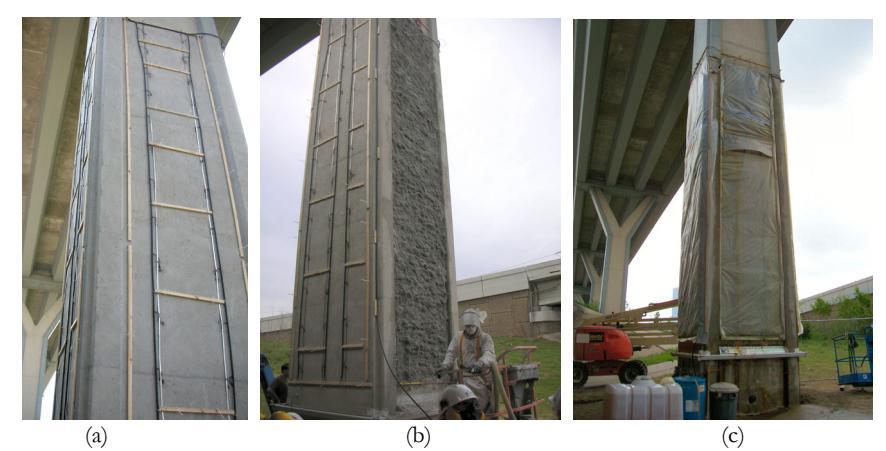
Figure 4: Summary of electrochemical treatment of Houston columns -- (a) Irrigation tubes, wood splices and metal strips are placed on the column. The metal strips are attached to titanium mesh that runs inside holes drilled into the side s of the column; (b) A cellulose layer is being applied to the side of the column; (c) Plastic sheeting is placed on all sides of the column. The gutters under the sheeting collect excess lithium to be reused.

and electrochemical methods), but also on application of silane-based products aimed at reducing internal relative humidity (see Table 1 for details of field test and Figure 4 for photo of electrochemical set-up for lithium application). More details of the electrochemical impregnation method, which involved connecting an anode (a 30%-lithium nitrate solution ponded at the surface of the concrete) to the imbedded reinforcing steel, which acts as a cathode, and driving lithium nitrate solution into the columns using 40V over the course of six to eight weeks, can be found in East [8]. The approach was to use essentially the same materials and methods for both sets of columns (moderately- and highly-damaged), and by doing so, one could evaluate the effects of the various treatments on future expansion and cracking, as a function of degree of distress at the time of treatment. All treatments to the columns were performed by contractors with significant experience in such techniques.

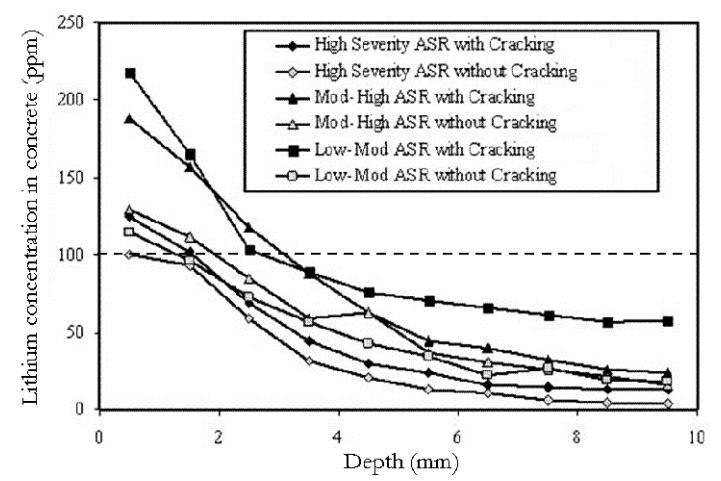
Figure 5: Depth of lithium penetration for Idaho pavement section. Dashed line (100 ppm) indicates concentration of lithium estimated to suppress ASR-induced expansion.

Long-term monitoring of the test pavement section in Idaho is in progress, with the results of approximately three years of monitoring described by East [8]. It is too premature to make firm conclusions about the effects of topical lithium treatments on the expansion and cracking of this pavement section. However, significant data have been generated on depths of lithium penetration, only a small portion of which are presented herein. Lithium profiles have been measured on cores extracted from various portions of the test section, capturing a range of levels of deterioration (i.e, surface cracking) and number of lithium treatments. Some cores were intentionally extracted directly above cracks, whereas others were taken away from cracks. The penetration data from the various cores were quite similar, regardless of the above variations in pavement condition or lithium treatment details – the depths of lithium penetration were very limited in all cases, with lithium penetrating only into the upper few millimetres. Figure 5 shows typical lithium penetration data for sections of pavement that received three topical treatments of lithium (the most lithium applied for any of the test section). Using the aforementioned 100 ppm lithium concentration as a threshold index (above which lithium would be expected to suppress expansion), it is clear that only the upper few millimeters (less than 4 mm for all samples) have received enough lithium to effectively suppress ASR. Even when

looking beyond this threshold value of lithium concentration, it clear that very little lithium has penetrated much beyond this upper layer, which certainly raises doubt about the potential benefits of topical applications of lithium for this pavement section. The depths of penetration shown in Figure 5 are consistent with other data generated on full-depth pavement sections that were removed from service in Idaho and subsequently treated topically in the laboratory. Although long-term field monitoring will continue for this pavement test section in Idaho, the general lack of lithium penetration will almost certainly ensure that the topical application of lithium to this pavement section will have no effect on future ASR-induced expansion and cracking.

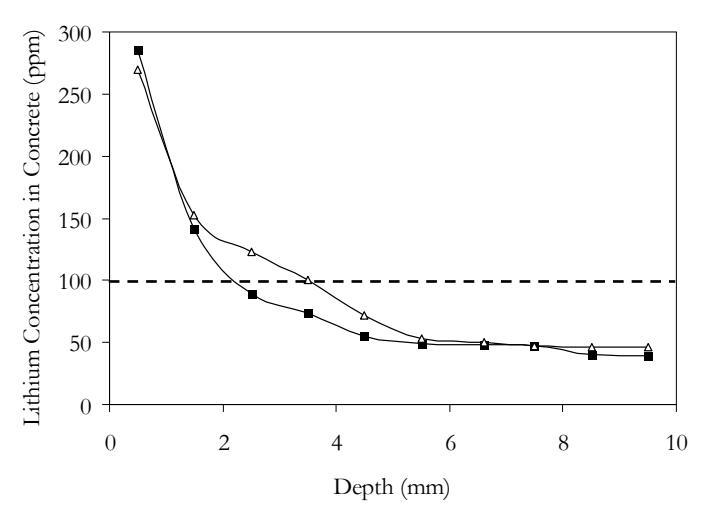
Figure 6: Depth of lithium penetration for Massachusetts highway barrier (vacuum impregnated with lithium nitrate). Plots are duplicate samples extracted from barrier that had been vacuum impregnated with lithium nitrate for 7.25 hours). Dashed line (100 ppm) indicates concentration of lithium estimated required to suppress ASR-induced expansion.

Figure 6 shows the lithium profile data for the ASR-affected barrier that was impregnated with lithium via vacuum (7.25 hours under pressure). As described earlier, the samples extracted for lithium profiling were removed from the barrier without the use of water as a lubricant, ensuring that any lithium contained in the sample would not be diluted. As can be seen in Figure 6, the depth of lithium penetration was limited to only the outer few millimetres, with duplicate samples containing lithium at the "threshold" concentration only in the first 2 to 4 mm from the treated surface. As with the field trial in Idaho, this pronounced lack of lithium penetration will, in all likelihood, yield little, if any, positive benefits in terms of reduced expansion and cracking. However, the barriers will continue to be monitored (expansion, cracking, internal relative humidity, etc.), with the results reported on the lithium and silane treatments in future publications.

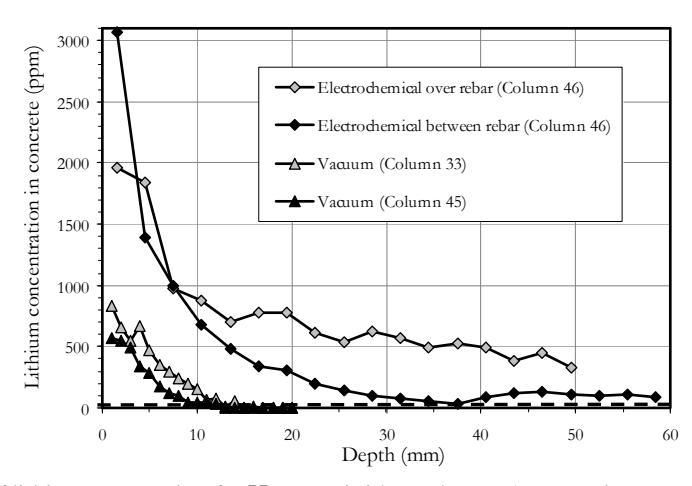
Figure 7: Depth of lithium penetration for Houston bridge columns (vacuum impregnated or treated electrochemically with lithium nitrate). Dashed line (100 ppm) indicates concentration of lithium estimated to suppress ASR-induced expansion.

Figure 7 shows the lithium profile data for bridge columns treated with 30% lithium nitrate solution, either by vacuum or electrochemical impregnation. The depth of penetration to which the "threshold" concentration of lithium (100 ppm) was attained for the vacuum-treated column was approximately 8 to 10 mm, which was higher than the penetration achieved in previous topical and vacuum applications (Sections 3.1 and 3.2). However, given the added cost and complexity of the vacuum impregnation apparatus, it remains to be seen whether this increased depth of penetration can be justified. It is too premature to determine whether these vacuum treatments have reduced expansion and cracking of these large elements (approximately 2×2 m in cross section), but continued monitoring will ultimately quantify the benefits of vacuum treatment on these two columns.

The lithium profile data shown in Figure 7 are quite encouraging for the electrochemically treated columns. Lithium was driven all the way to the reinforcing steel (depth of 50 mm) in a concentration estimated to be sufficient enough to suppress ASR-induced expansion. This is the most encouraging lithium penetration data generated under these FHWA-funded efforts and certainly suggests that electrochemical methods hold promise for treating ASR-affected structures with lithium compounds. However, one "side effect" of this process must be addressed. Figure 8 shows the sodium and potassium profiles, alongside the lithium profiles. Lithium ions were clearly driven to the reinforcing steel, as was the intention, but because the steel serves as a cathode in the electrochemical process, hydroxyl ions are produced at the surface of the reinforcing steel. To maintain charge neutrality and to offset the production of hydroxyl ions at the reinforcing steel surface, sodium and potassium ions from within the concrete migrated towards the steel surface. This increase in the hydroxyl ion concentration and subsequent increase in alkali (sodium and potassium) concentration near the surface of the reinforcing steel may exacerbate ASR-induced expansion and cracking in this region. Future monitoring of these columns (expansion, cracking, microstructural evaluations aimed at regions near the concrete/steel interface) should help to determine if the potentially detrimental side effects of electrochemical impregnation outweigh the benefits of the significant lithium penetration, as shown in Figure 8. Future publications will present the long-term data generated on these electrochemically-treated bridge columns.

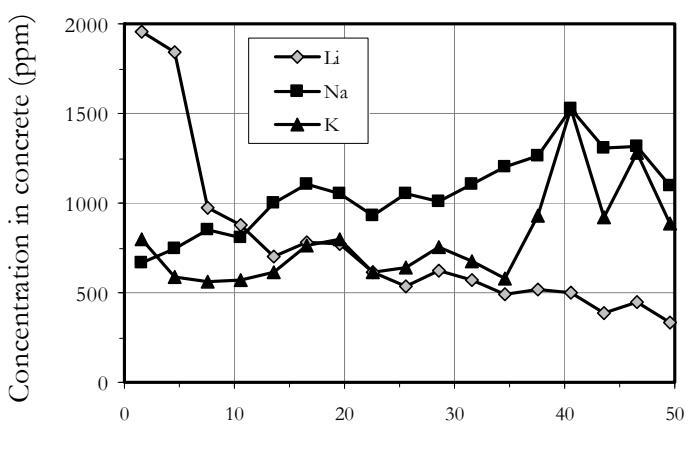
Figure 8: Lithium, sodium, and potassium profiles for Column 46 (electrochemically impregnated with lithium nitrate solution). Note that the lithium profile shown here is the same as in Figure 7 (electrochemical over rebar). This figure shows clearly that lithium ions were driven all the way to the reinforcing steel (depth of 50 mm from concrete surface) and concentrations well exceed target concentration of 100 pm; however, Na⁺ and K⁺ from within the concrete migrated towards the steel surface as the steel acts as a cathode in the electrochemical impregnation process.

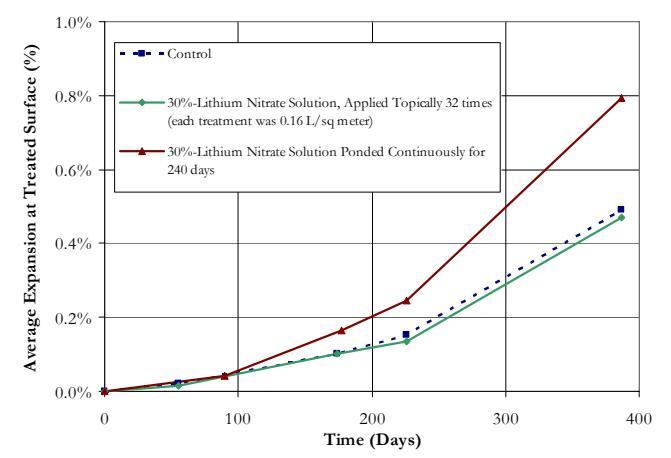
Figure 9: Effects of lithium treatment on outdoor exposure blocks. Values shown are average expansions at top of block. Topical applications of lithium (32 applications of 30%-lithium nitrate solution, each at application rate of 0.16 L/m^2) had little, if any, impact on expansion. Interestingly, the block that was ponded continuously with 30%-lithium nitrate solution for 240 days actually expanded significantly more than the control block.

As described in Section 2.4, a study was performed to quantify the effects of lithium treatments (topical or continuous ponding) on outdoor exposure blocks. Figure 9 shows the expansion results for three blocks cast from the same reactive concrete mixture: an untreated control block, a block topically treated with 30%-lithium nitrate solution 32 times over a 240-day period (each treatment consisting of an application rate of 0.16 L/m^2), and a block ponded continuously with 30%-lithium nitrate solution for 240 days. The aggregate contained in these blocks, a highly-reactive sand from El Paso, Texas, has been shown in previous studies to respond reasonably well to lithium when

As shown in Figure 9, the block topically treated 32 times over a 240-day exhibited essentially the same expansion as the control block. Interestingly, the block that was continuously ponded for 240 days with lithium nitrate solution has expanded considerably more than the control block. Additional work is in progress to study this in more detail, and the mechanisms responsible for this increased expansion are not fully understood. It may be possible that through continuous ponding, lithium nitrate was able to suppress expansion near the upper surface of the block that was in contact with the solution, while at the same time, the concrete below this upper portion continued to expand. It is possible that a more pronounced gradient between the highly expansive core of the block and the less expansive surface of the block resulted in more tensile stresses on the surface, resulting in more severe cracking and expansion. More research is needed to understand this behaviour. These blocks are still being monitored for expansion and cracking, and as such, cores have not yet been extracted for lithium profiling.
