ALKALI-AGGREGATE REACTION IN NORWAY AND SWITZERLAND. SURVEY INVESTIGATIONS AND STRUCTURAL DAMAGE

Viggo Jensen^{1,*} and Christine Merz²

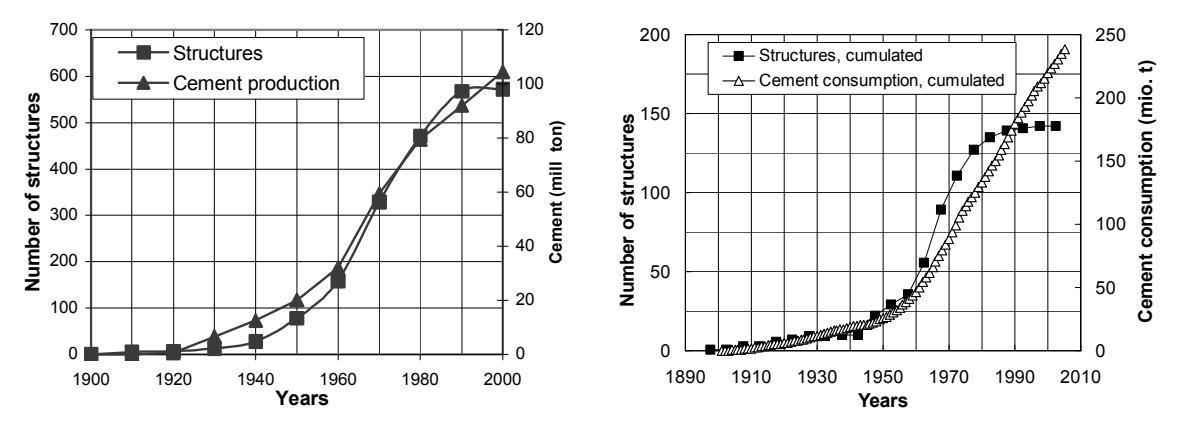
Figure 1: Left: Age distribution of all investigated structures with and without AAR damages and cement production relative to years in Norway. Right: Age distribution of investigated structures with AAR damages only and cement consumption relative to years in Switzerland.

In both countries investigated structures are dominated by examples with a construction age around 20-60 years but older and younger structures have also been investigated. Figure 1 shows the age distribution of structures (see section 3) and cement production/consumption relative to years in Norway and Switzerland. Left figure shows all investigated structures with and without signs of AAR in Norway, and right figure Swiss structures with AAR damage only. Note that the age distribution of structures more or less follows the production / consumption of cement in both countries. The close relationships to the cement production / consumption suggest that investigated structures in Norway and Switzerland are representatively selected. The Swiss results also indicate the existence of an incubation period on 10-20 years. The risk for AAR still is possible for new structures in case preventive measures are not applied in Switzerland.

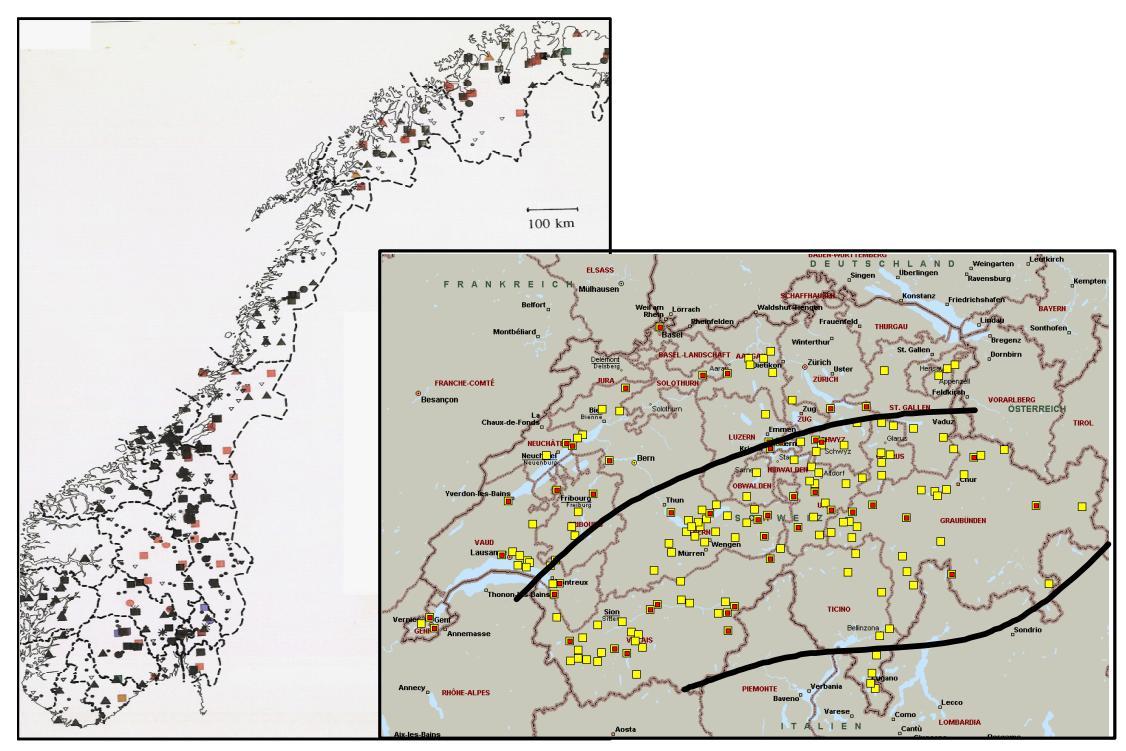
Figure 2: Geographical distribution of structures with signs of AAR in Norway (left) and Switzerland (right). Red points correspond to more detailed investigated structures by micro structural analysis [5, 18, 20].

Figure 2 left shows the geographical distribution of investigated structures in Norway. The field investigations in Norway revealed that 68% of investigated structures have varying signs of AAR, 17% with minor signs of AAR and 49 % with major signs of AAR (2% were investigated but not classified). All structures have been classified according to a classification system based on crack width and distribution in structural elements. Black points correspond to investigated structures and red points to structures where AAR in addition has been documented by micro structural analysis [5, 20]. Reacted aggregates in concrete structures have been "correlated" with reference bedrock samples and thereby given the basis for a bedrock map showing potentially alkali reactive aggregates. It has been shown that structures located within alkali reactive bedrock areas are more damaged relative to structures located outside such areas.

Figure 2 right shows the geographical distribution of 450 structures with signs of AAR in Switzerland. One point represents at least 1 to several structures on the same place. The alpine and prealpine region is delimited by the two lines. In Switzerland 80-90% of investigated structures showed minor to strong signs of AAR and a slow development of the damage and 10-20% strong and very strong signs of AAR and a fast development of the damage. Evidence for AAR has been observed everywhere, according to the fact that reactive aggregates are present in all parts of Switzerland [21]. Generally the alpine and prealpine region seems to be more concerned as other regions.

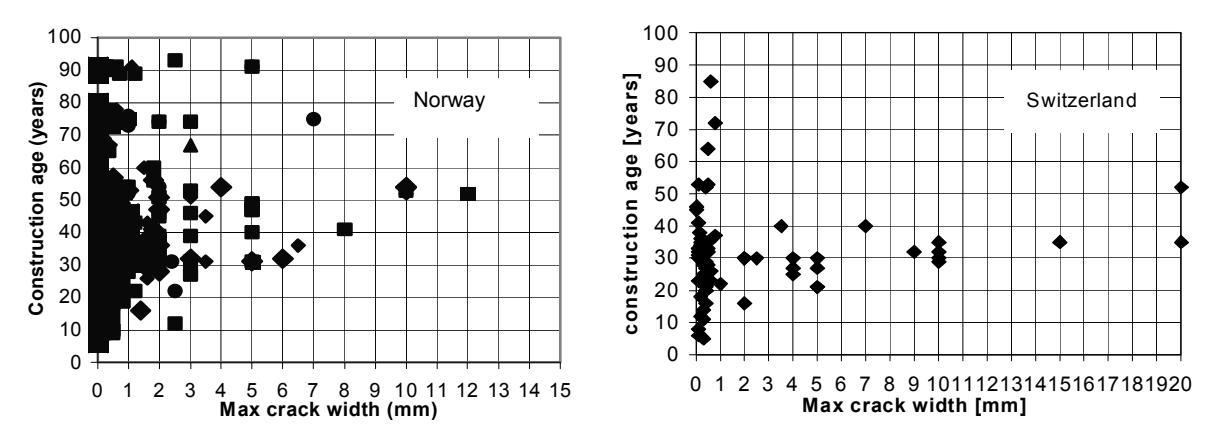
Figure 3: Distribution of maximum crack width relative to construction age in structures in Norway (left) and Switzerland.

Figure 3 shows the distribution of maximum crack width in 572 structures in Norway (left) and in 108 structures in Switzerland (right) relative to the construction age. Results from other investigated structures are not included because of unknown or uncertain construction age. Note the similar distribution in both countries.

In Norway and Switzerland investigated structures are dominated with construction ages around 20-60 years. Because in Figure 3 the graphical distribution of the maximum crack width is influenced by an increased number of structures in some periods relative to periods with fewer structures (false peak height) the average maximum crack widths in 323 Norwegian structures have been calculated for each decade as shown in figure 4. Structures without cracks and without measurable cracks are not included in the calculations. Note that the average crack width increases significantly from 0.25 mm after 10 years to 2.25 mm until 60 years (2 mm during 50 years) and that the number of structures in each decade from 20-60 years is sufficient for statistical analysis. Figure 4, right figure shows an exponential curve and equation which gives the best fit of the average expansion from 10 to 60 years in Norway. The number of structures older than 60 years is not sufficient for statistical analysis (blue bars).

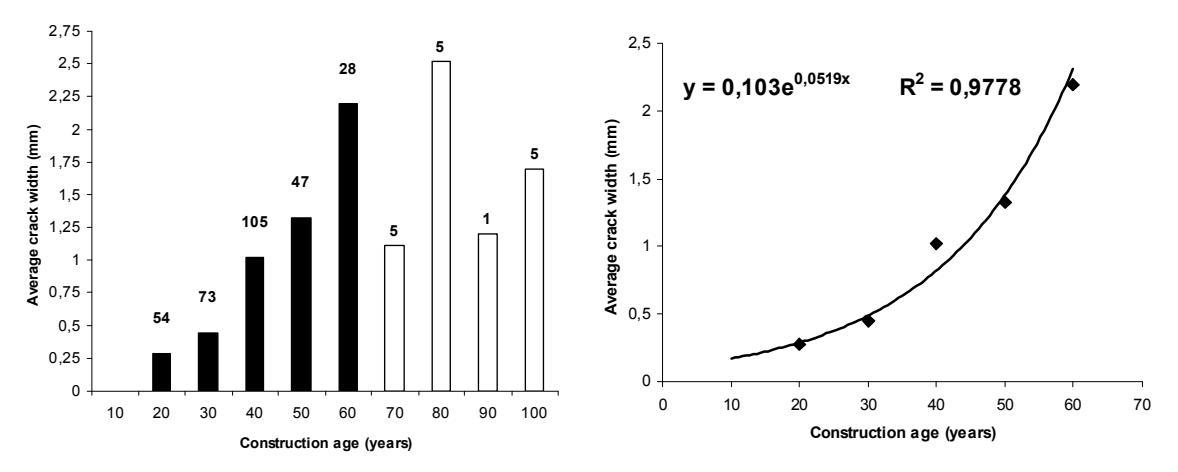
Figure 4: Histogram of average maximum crack width versus construction age in decades (left) and en exponential curve and equation of best fit (right). Number of structures on top of bars.

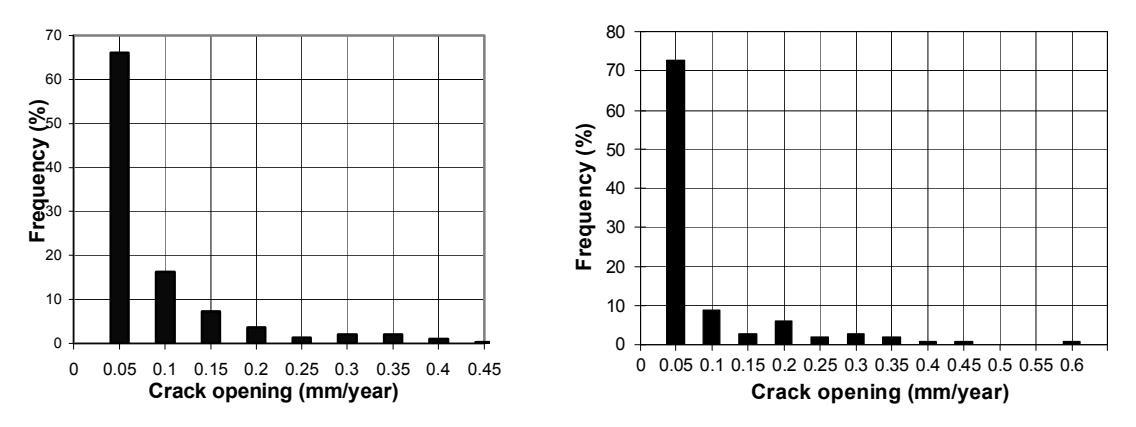
Figure 5: Frequency % of yearly crack width opening in Norway (left) and Switzerland (right).

Figure 5 shows the frequency distribution of yearly crack openings in 323 structures in Norway and 103 structures in Switzerland. The estimation of the yearly crack opening is based on the ratio actual crack width / age of structure. This is only a simple linear approximation which does not take into account the unknown incubation time until cracks appear. For the Norwegian structures an incubation period of 15 years has been subtracted from the structural age. Structures younger than 15 years (negative value) are not included in the graph (left). For the Swiss structures, the values are not corrected by a theoretical incubation time. Note the similar distributions of crack opening in Norway and Switzerland.

Based on data from the field investigations it can be calculated that the median value of crack opening in Norwegian structures is 0.027mm/year. The Swiss median value corrected for an incubation period of 15 years is 0.030mm/year, which is very similar to the Norwegian median value. The median value of crack opening without correction is 0.013mm/year in Norway and 0.015mm/year in Switzerland. The correction of 15 years incubation time gives values about twice as high.

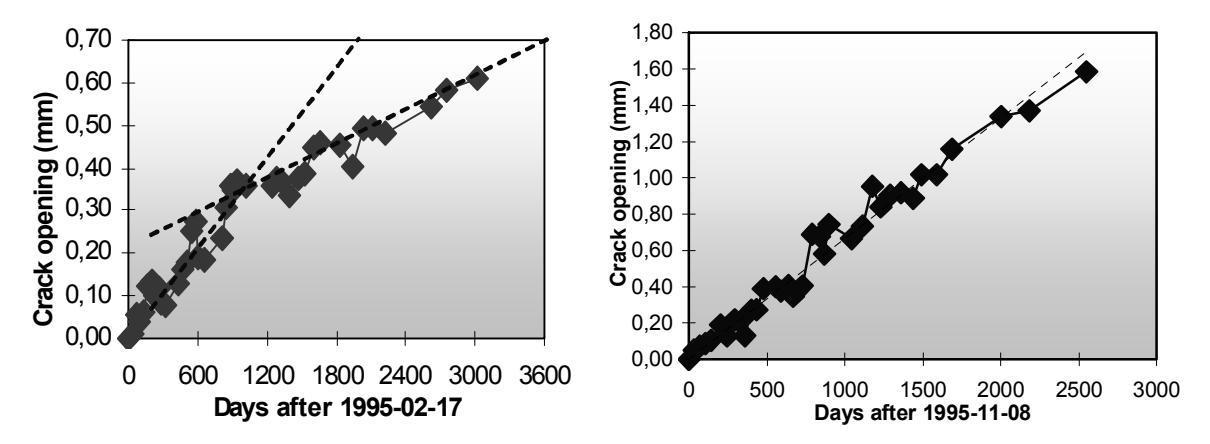
Figure 6: Increase of crack opening during 9 years measurements in Elgeseter bridge in Trondheim (left) and during 7 years on a dam structure in Southern Norway (right).

The variety of crack openings and crack widths are in good agreement with three point measurement of cracks by use of Demec gauge carried on several Norwegian structures [22, 23, 24, 25, 26, 27, 28]. Here most measurements vary between 0 and 0.1 mm. Variation or "change" in the crack openings over time has been observed in Elgester bridge in Trondheim, see figure 6 (left). Largest yearly crack opening has been measured on a dam structures during a period on 7 years to be 0.23 mm yearly, see figure 6 (right).

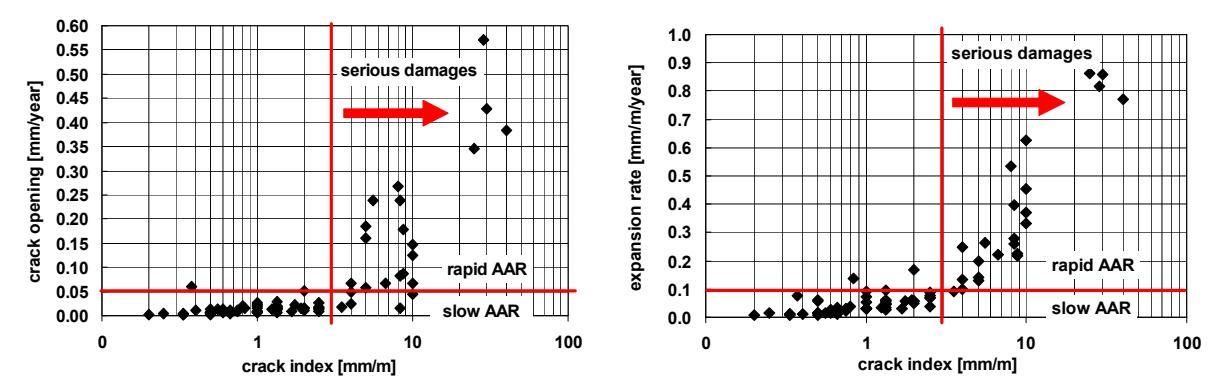
Figure 7: Calculated annual crack opening and expansion rates in function of the crack index of 103 structures (Switzerland).

In Switzerland the crack index after the French LCPC method [29] has been carried out on 103 structures and the expansion rate calculated. The results are presented in table 3 and figure 7. The crack development in a structural element is usually not homogeneous and influenced by different factors as discussed in [30]. The crack width measurements give not necessarily the real expansion rate of a structural element. Following [31, 32], the results are valid only if crack measurements are realised on the most exposed and cracked areas of the concrete surface. This kind of interpretation of the survey data represents only a general approach, giving some indications for a first rough evaluation of the significance of the damages. It cannot replace detailed measurements on a given structure.

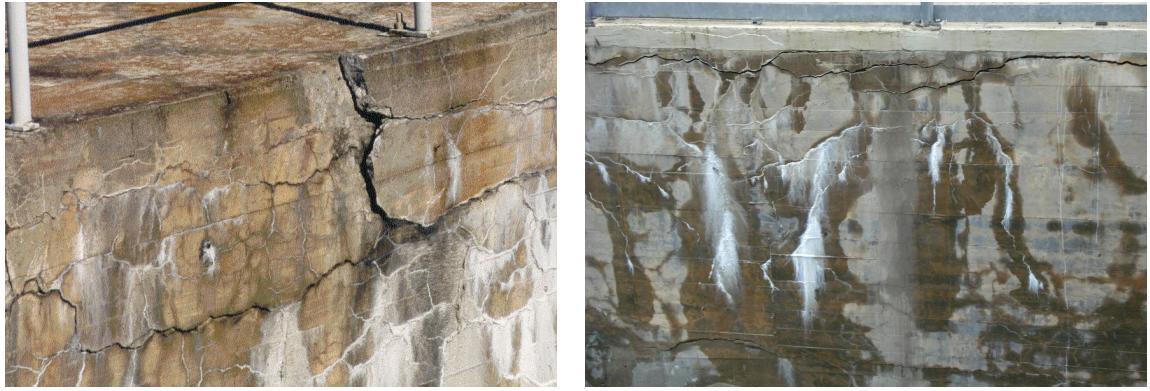
Figure 8. Extensive cracking due to AAR and freeze-thaw in a dam pier from Norway (left) and from .Switzerland (right).
