# STUDY OF REMEDIAL ACTIONS ON HIGHWAY STRUCTURES AFFECTED BY ASR

This paper presents information of the different demonstration projects undertaken under FHWA's *Alkali-Silica Reactivity (ASR) Development and Deployment Program*, with an aim at implementing in the field a number of techniques for mitigating the deleterious effects of ASR in highway structures.

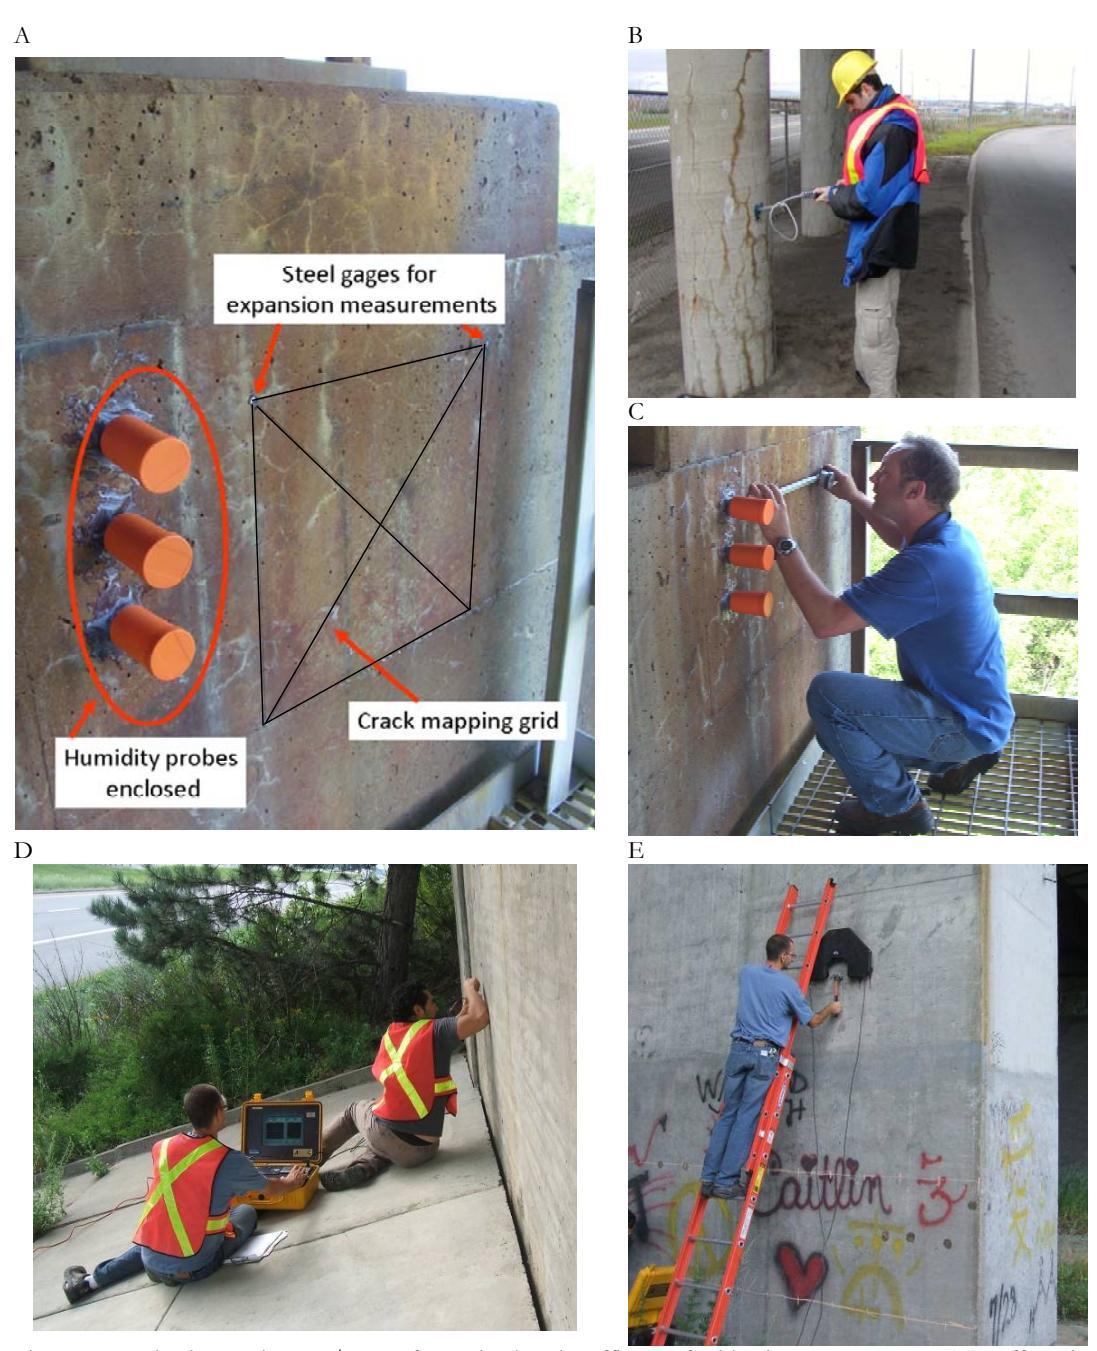
Figure 1: Monitoring equipment/set-up for evaluating the efficacy of mitigating treatments on ASR-affected concretes. A. Humidity probe and crack mapping grid. B. Temperature and humidity measurementsat different depths into the concrete elements. C. Expansion measurements. D. Impact-echo. E. Non-linear acoustic technique.

The project team also developed and implemented a monitoring program for treated and control sections, which included training of local State DOT personnel so they can continue to track the performance of the structures upon conclusion of the project. Monitoring activities include the following (Figure 1)[2]:

- Expansion measurements conducted by imbedding steel studs at different locations on the treated and control sections, and using a gage to regularly record changes of the nominal 500-mm gage lengths.
- Humidity/temperature measurements are done by drilling holes to different depths into the concrete. Probes are inserted into the holes and measurements taken upon equilibrium using a handheld reader.
- Severity of cracking on a 500-mm grid drawn on the surface of the treated/control elements. The number of cracks, along with crack widths, are recorded and used to create a Cracking Index (CI).
- Three non-destructive methods, i.e. impact echo, ultrasonic pulse velocity (UPV) and a non-linear acoustic technique [7-9], were applied to monitor internal damage in the concrete members evaluated.

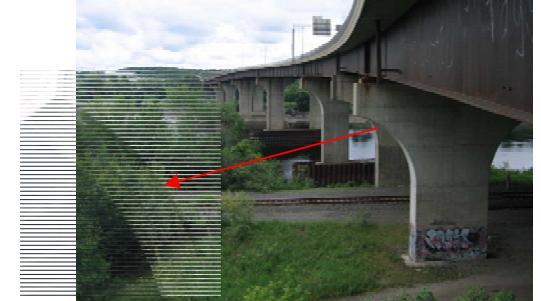
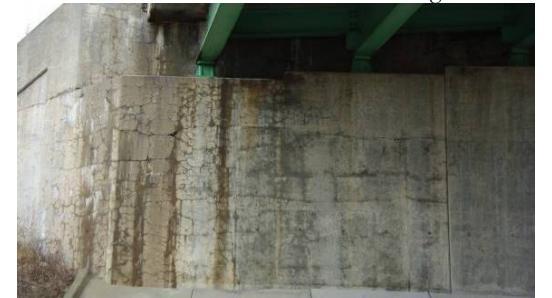
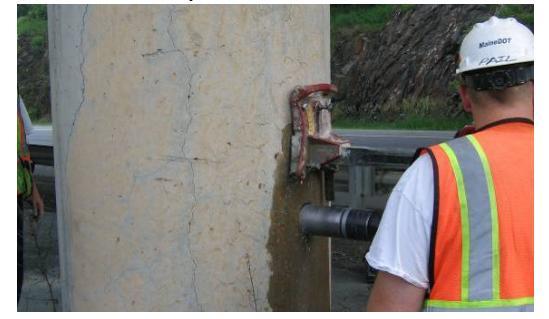
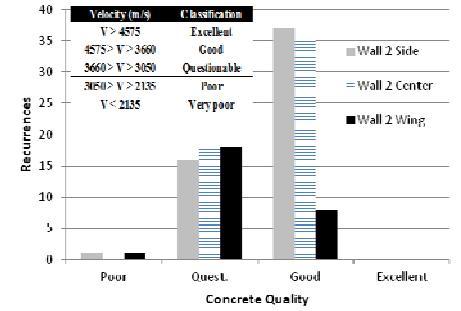
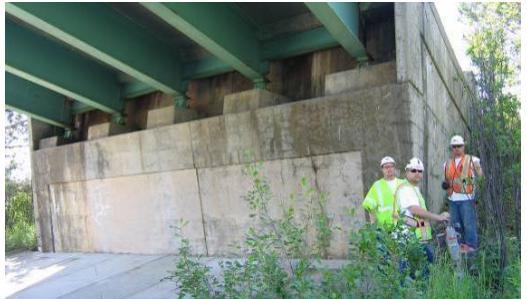
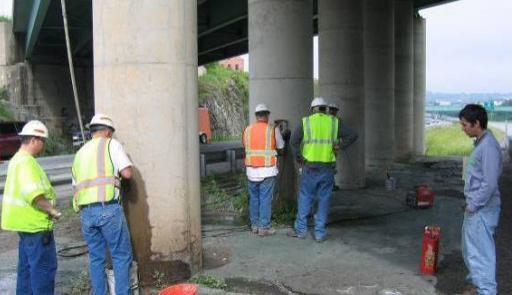
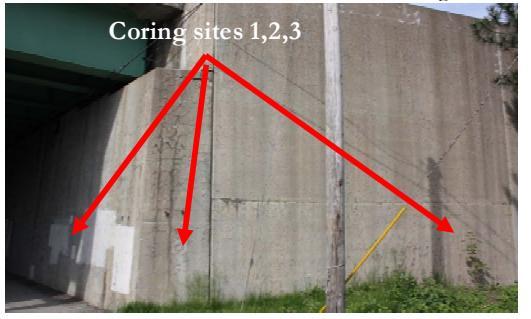
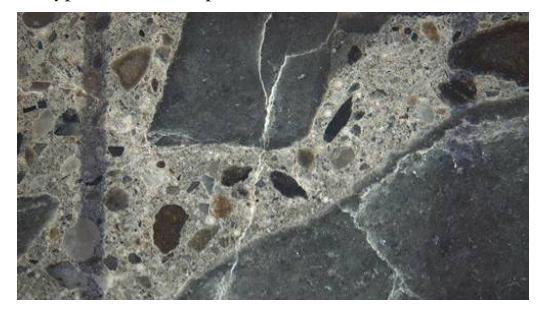
FIGURE 2: Highway bridges (Bangor/Brewer, Maine). A. Cracking in the exposed portion of a large reinforced concrete column. B&C. ASR-affected bridge elements (abutment and wing wall). D&E. Cracking in the external (exposed) reinforced concrete columns. F. Coring sites in the abutment (not exposed (1), exposed (2)) and the wing wall (exposed (3)) of an ASR-affected bridge structure. G. Condition rating of concrete for three walls according to indirect velocities measured in the impact-echo test. Recurences correspond to the number of measuring spots falling into the different condition categories. H. Typical signs of ASR (cracking in aggregate particles and cement paste) in polished concrete sections.

The condition (visual) survey carried out in 2009 on six bridge structures along the Interstate 395 (I-395) revealed the abundance of typical symptoms of ASR. Sections or elements of the structures sheltered from direct exposure to rain and sun showed no or light visible cracking, while those exposed to the above elements (e.g. wing walls and exposed parts of the abutments) showed moderate to severe map/vertical cracking (Figure 2). The differences noted from the visual survey were confirmed by NDT measurements (impact echo and UPV); however, nonlinear acoustics yielded poor results on moderately- to severely-cracked surfaces since this method has rather been designed to detect early cracking. Figure 2G shows an example of a condition rating based on impact echo results obtained on three walls (abutment, side and center; wing wall). It is clear that the wing wall (exposed, higher visual damage) has a much lower number of measurement spots classified as "good concrete" compared to the other walls. The center (unexposed) wall has no spots classified as "poor concrete", while the other areas exhibit some. None of the three walls fell in the "excellent" category for concrete quality.

The petrographic examination of the cores extracted from several deteriorated structural elements confirmed the presence of petrographic features of ASR in the reactive greywacke/argillite coarse aggregate particles (Figure 2H). A total of 24 polished core sections were subjected to the DRI, with values ranging from low (DRI < 250) to high degree of ASR damage (DRI of 627 to 882), with the extent of ASR generally correlating well with the severity of the exposure conditions of the structural element (e.g. Figure 3A). A similar correlation was obtained for the SDT results, with the highest dissipated energy values (J/m<sup>3</sup>) corresponding to the core samples extracted from severely exposed structural elements (Figure 3B).

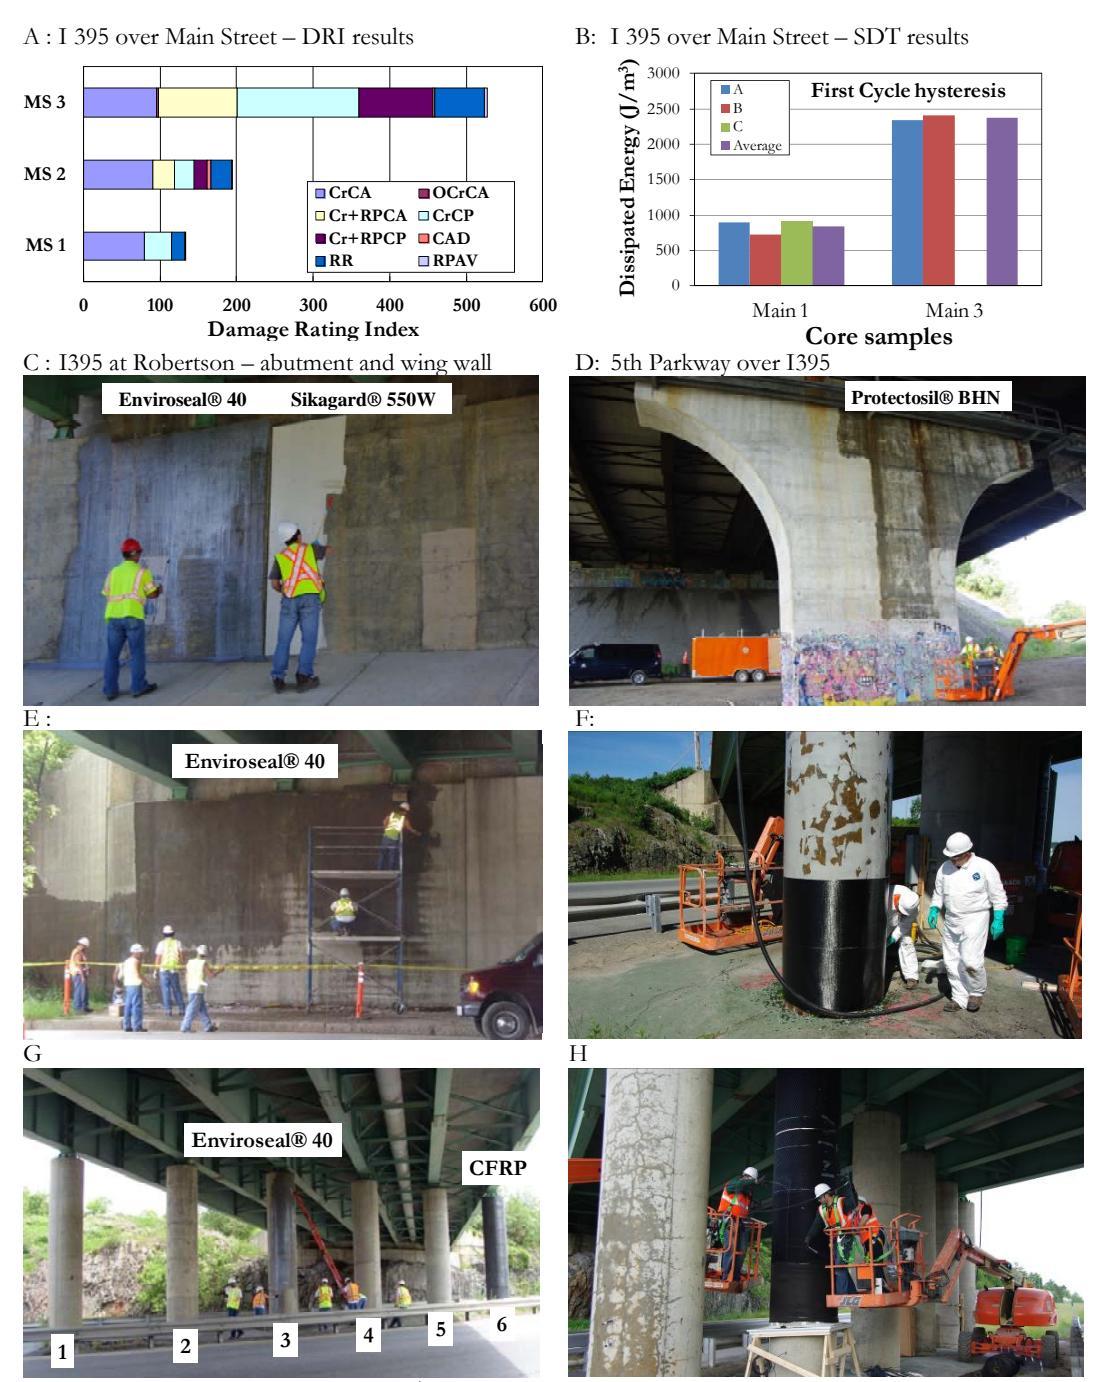
FIGURE 3: Highway bridges (Bangor/Brewer, Maine). Results of the petrographic examination (A) and mechanical testing (B) of samples from 3 coring sites (Figure 2G). C. Application of surface treatments (silane and elastomeric paint) on the abutment. D. Application of surface treatment (silane) on the reinforced concrete column. E. Application of surface treatment (silane) on the abutment and wing wall. F. Wrapping of column with carbon fibers (CFRP wrap). G. Various treatments on the reinforced concrete columns (see Table 2). H. Electrochemical (lithium) treatment on the reinforced concrete column no. 2 of figure G.

The six columns at mid-span of the South Parkway structure provided an opportunity to evaluate additional types of remedial actions on a series of 7m-tall columns exhibiting different levels of ASR (Table 3). The column exhibiting the highest degree of deterioration (column no. 6; moderate-to-severe cracking – Figure 2F) was encapsulated using 4 layers of carbon fiber reinforced polymer (CFRP) strengthening wrap (Sikawrap Hex 103C System) (Figures 3F-3G). Electrochemical (lithium) migration technique was applied on the column no. 2 (moderate degree of cracking)(Figure 3H). The treatment involved the installation of a temporary anode system consisting of a series of titanium anodes placed into holes drilled in a grid pattern in the upper 6-metre portion of the column and a titanium mesh layer sandwiched between layers of geotextile felt that covered the concrete surface of the column. Both the temporary anode system and the embedded reinforcing steel, which acts as a cathode, were then connected to an AC/DC rectifier, which, once energized, applies a low voltage DC potential between the anode and the cathode to migrate lithium into the concrete from the electrolyte (30%-lithium nitrate solution) that is pumped onto the surface of the concrete column through a temporary irrigation system. The lithium impregnation system was sealed with polyethylene sheets to prevent evaporation or dry out over the 8-week treatment period.

Finally, silane (Enviroseal® 40) treatment was applied on column no. 3 showing mild degree of cracking, while the other three columns (no. 1 (severe cracking), 4 and 5 (mild cracking) were kept as controls (Figure 3G). For all treated and untreated bridge elements, a monitoring program was implemented, involving regular (annual) length change, crack mapping and internal relative humidity measurements.

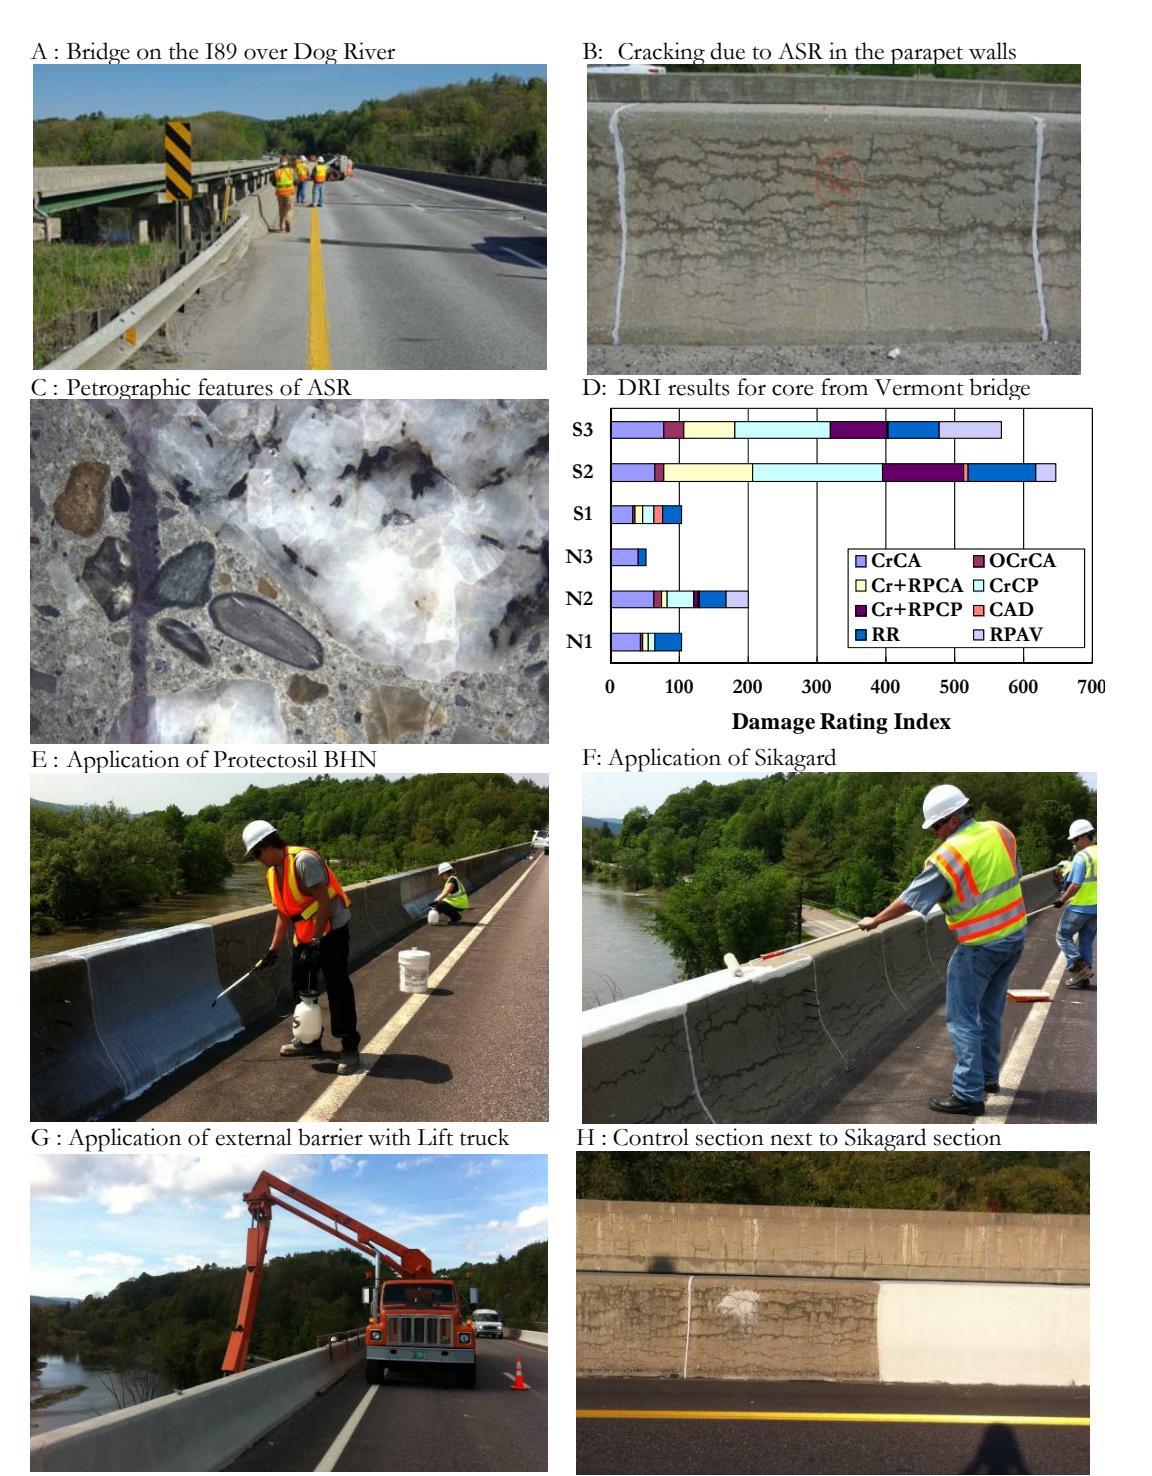
FIGURE 4: A. General view of the structure. B. Typical cracking in the parapet wall of the bridge structure (Section of sample S2). C. Cracking in the reactive sand particles (with silica gel) and in the cement paste. D. Summary of DRI results for the six core samples examined. E. to H. Application of different products.

The condition survey of two bridges (carrying two lanes in each direction) of Interstate I-89 over Dog River near Montpelier, Vermont (USA) was carried out in 2010 (Figure 4A). The parapet walls showed extensive map cracking consistent with ASR (Figure 4B), with no evidence of corrosion of embedded reinforcement or damage due to freeze-thaw. The petrographic examination of cores extracted from the barrier walls adjacent to the passing lane on both the northbound and southbound bridges revealed features of ASR associated to reactive particles in the coarse fraction of the sand (schist, microquartzite, sandstone and argillite)(Figure 4C). Moderate-to-high degree of deterioration due to ASR was obtained for cores S2 and S3, resulting in DRIs of 647 and 568, respectively; low to very low degree of deterioration/damage due to ASR was observed in cores I89-S1 and N1 to N3 (DRIs ranging from 53 to 202 - Figure 4D). No evidence of ASR was observed in the coarse aggregate consisting of a greyish granite.

Following the results of the petrographic examination of the cores, it was recommended that the barrier walls be treated with suitable coating/sealant systems to retard the rate of further deterioration due to ASR. The treatment program described in Table 3 was implemented on the Southbound bridge walls. The estimated length of the bridge wall is 955 feet long, and both bridge walls were treated. The bridge wall on the interior of the bridge had silane applied only to the side facing traffic while the outside bridge wall had both sides of the barrier wall treated with silane. The Enviroseal® 40 and Protectosil® BHN materials were applied, once again (as for the Maine demonstration project), with a hand held pump pressure sprayer at a rate of about 150 ft²/gallon, while the Sikagard® 550W material was applied with a paint roller with 2 coats at a rate of 100ft²/gallon(Figures 4E-H).
